On June 23, 2014, the Directorate of Public Works, Environmental Division conducted the annual Post-Closure Site inspection of the McGregor Range Camp Landfill, Solid Waste Management Unit (SWMU) No. 18/FTBL-013 as per NMED letter dated June 12, 2007. The correspondence indicated that the following information must be included in the site inspection; observations of the final cover, the surface water drainage system and vegetative cover. An inspection report must be submitted and include photographs and descriptions of the site to NMED annually.

# McGregor Range Camp Rubble Landfill Inspection

## SWMU-18/FTBL-013

Inspection Date: 06-23-2014

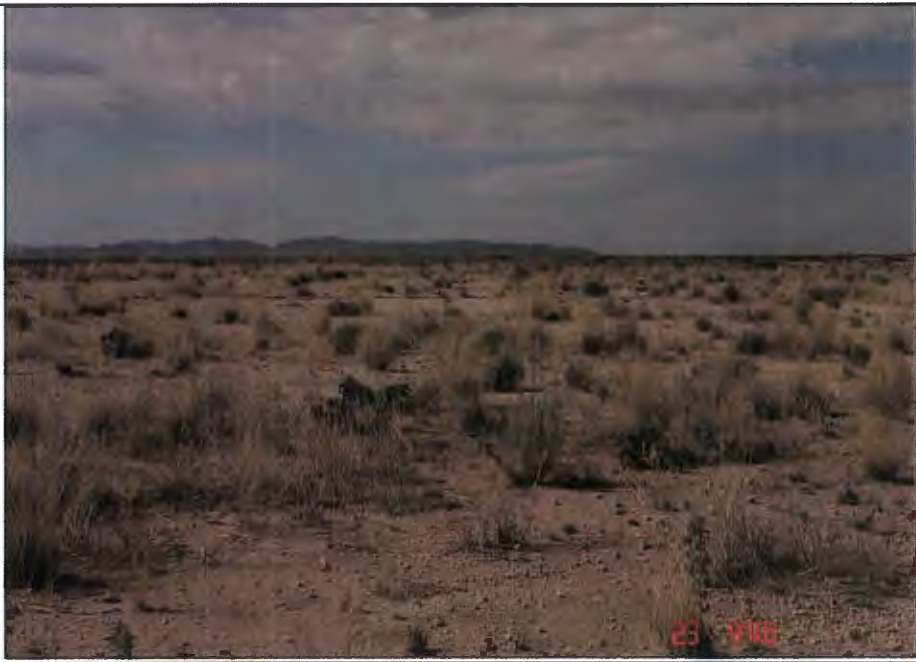
Observation #2	
Observation: Looking Southeast across SWMU-18/FTBL-013, Vegetation is very robust within the landfill permitted area and on the final cover
