On June 01, 2016, the Fort Bliss Directorate of Public Works, Environmental Division (DPW-ED) conducted the annual post-closure site inspection of the Dona Ana Range Camp Sanitary Landfill, Solid Waste Management Unit (SWMU) 29/FTBL-011. The inspection was conducted in accordance with the requirements stated in the New Mexico Environmental Department (NMED) Hazardous Waste Bureau letter, dated May 27, 2008.

Dona Ana Range Camp Sanitary Landfill - Inspection

SWMU-29/FTBL-011

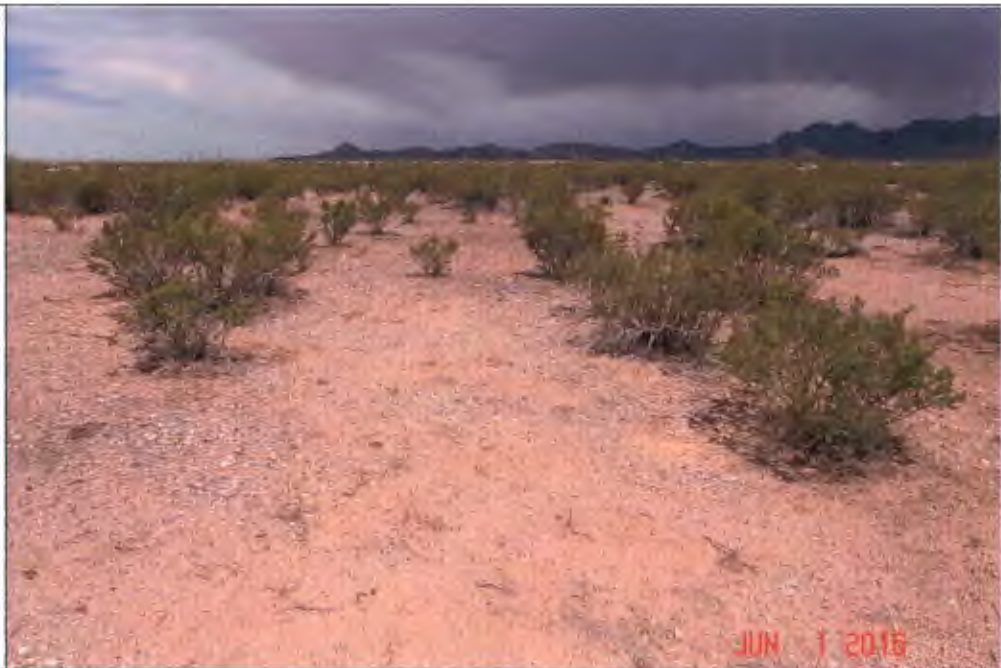
Photograph No. 1

View of landfill cap facing North.

No signs of erosion or depressions on landfill cap.
Vegetative layer was in good condition.

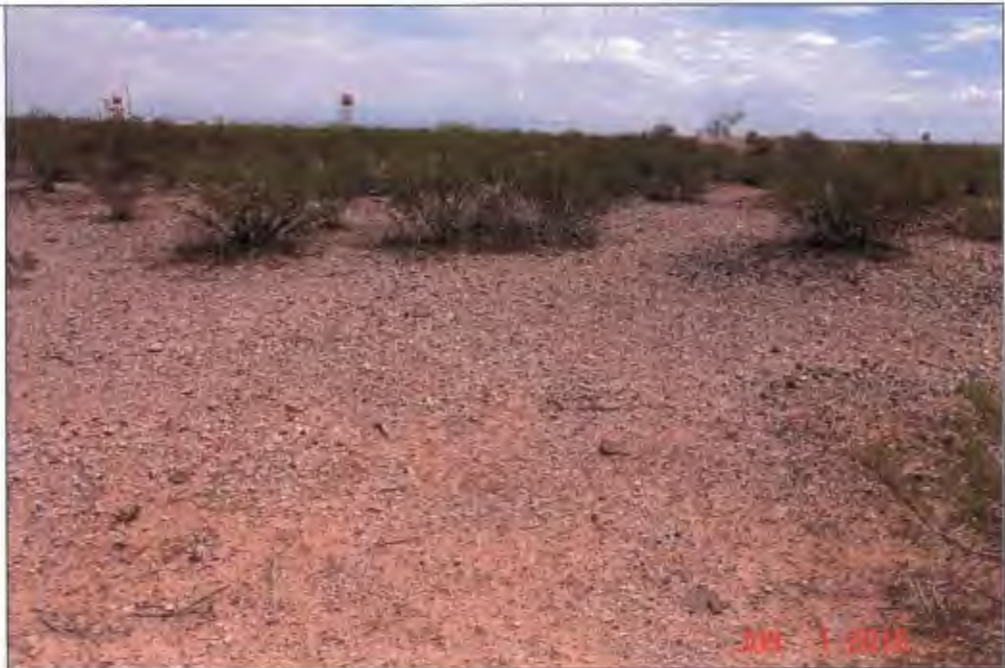
Photograph No.2

View of landfill cap facing East.

No signs of erosion or depressions on landfill cap.
Vegetative layer was in good condition.

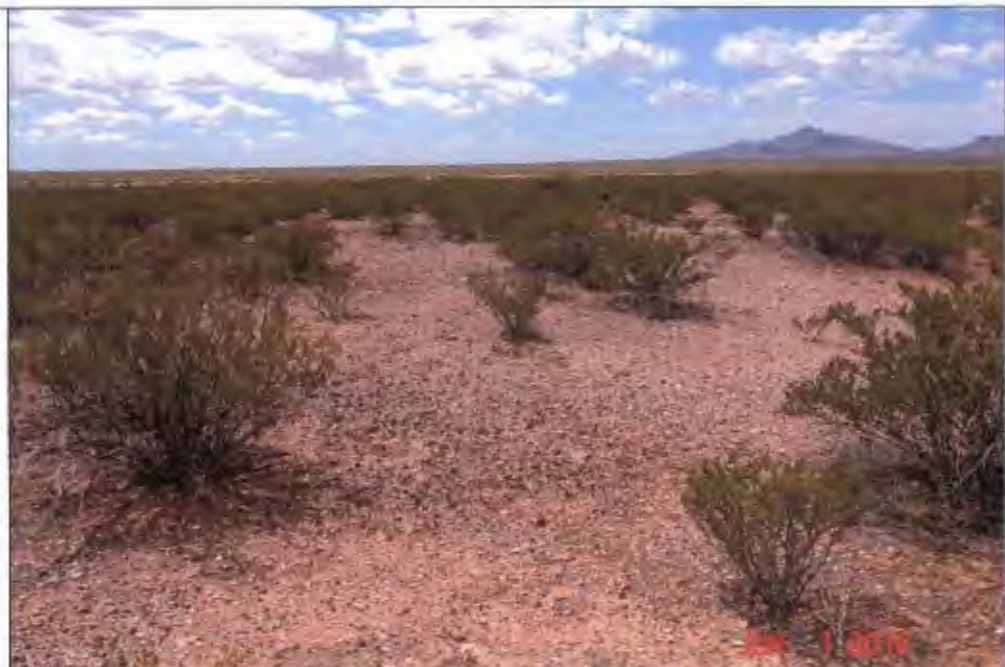
Photograph No. 3

View of landfill cap facing South.

No signs of erosion or depressions on landfill cap.
Vegetative layer was in good condition.

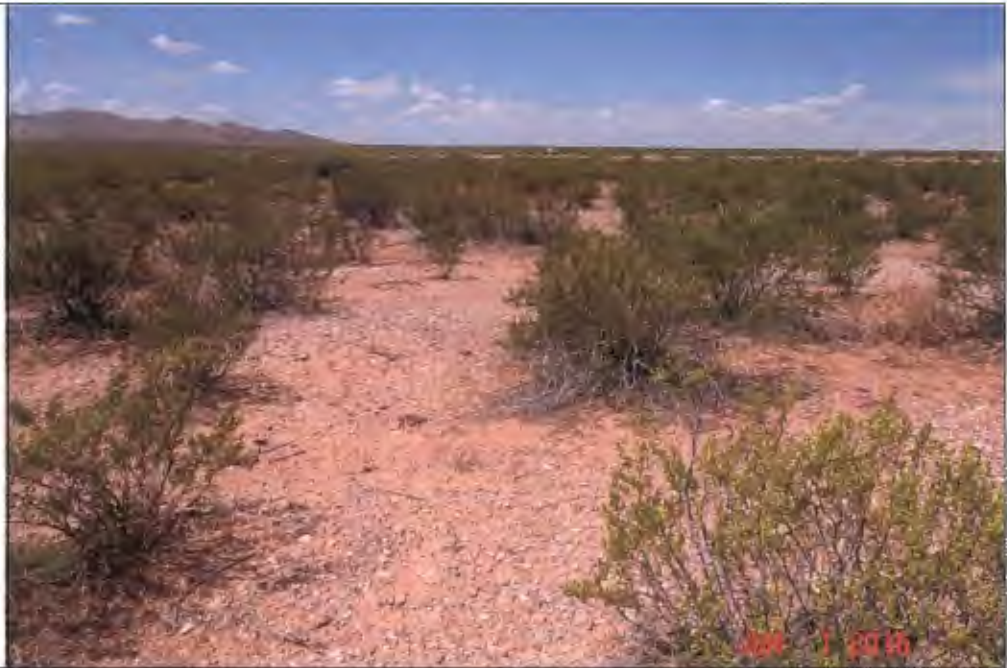
Photograph No. 4

View of landfill cap facing West.

No signs of erosion or depressions on landfill cap.
Vegetative layer was in good condition.

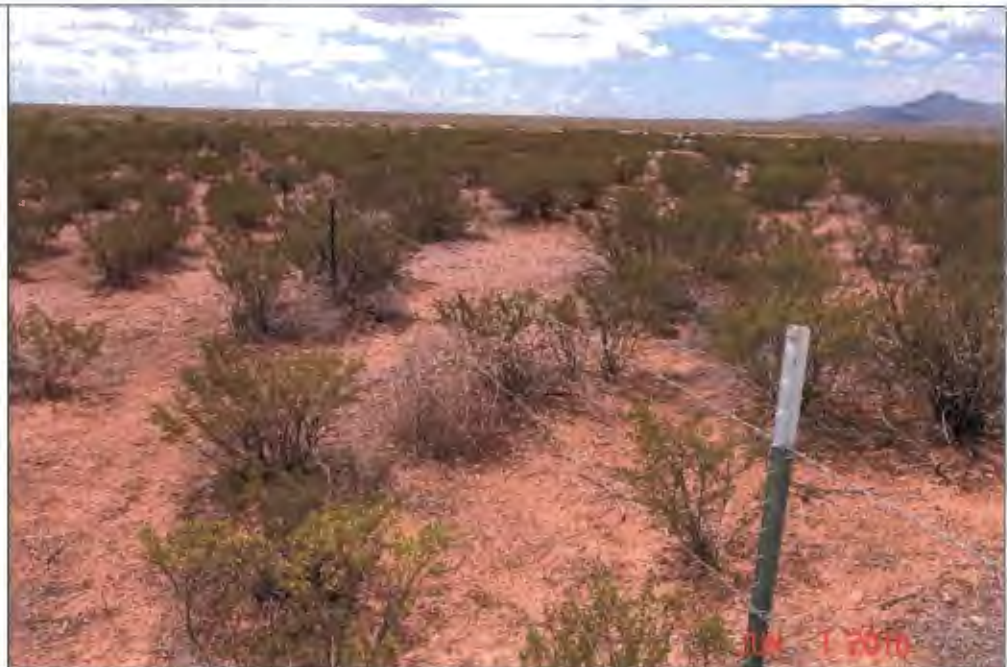
Photograph No. 5

View of Eastern fence facing South.

Site perimeter fence and warning signs were in good condition.

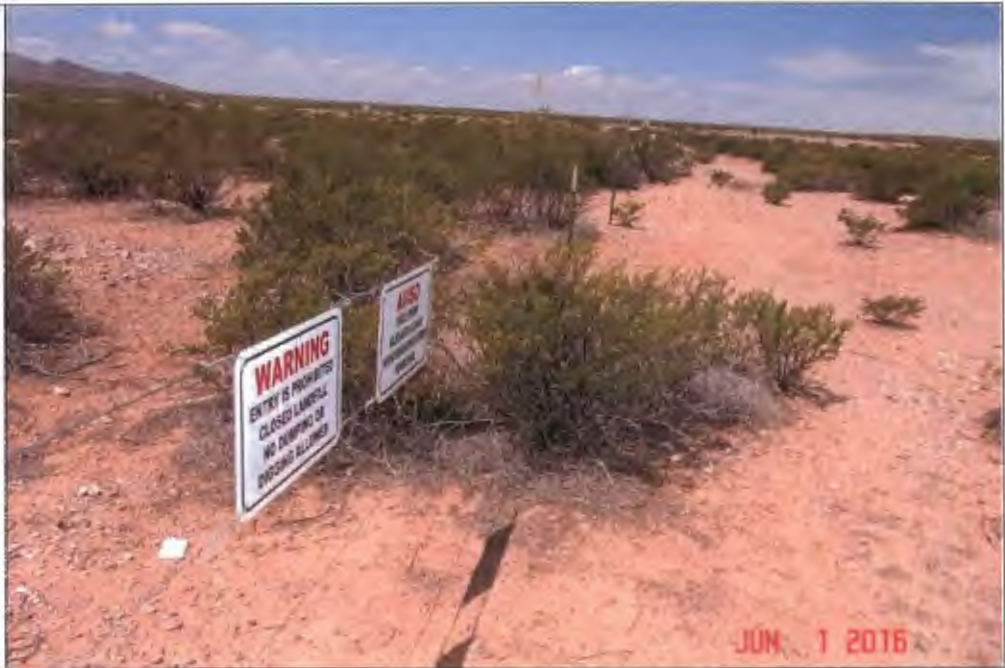
Photograph No. 6

View of Northern fence facing West.

Site perimeter fence and warning signs were in good condition.

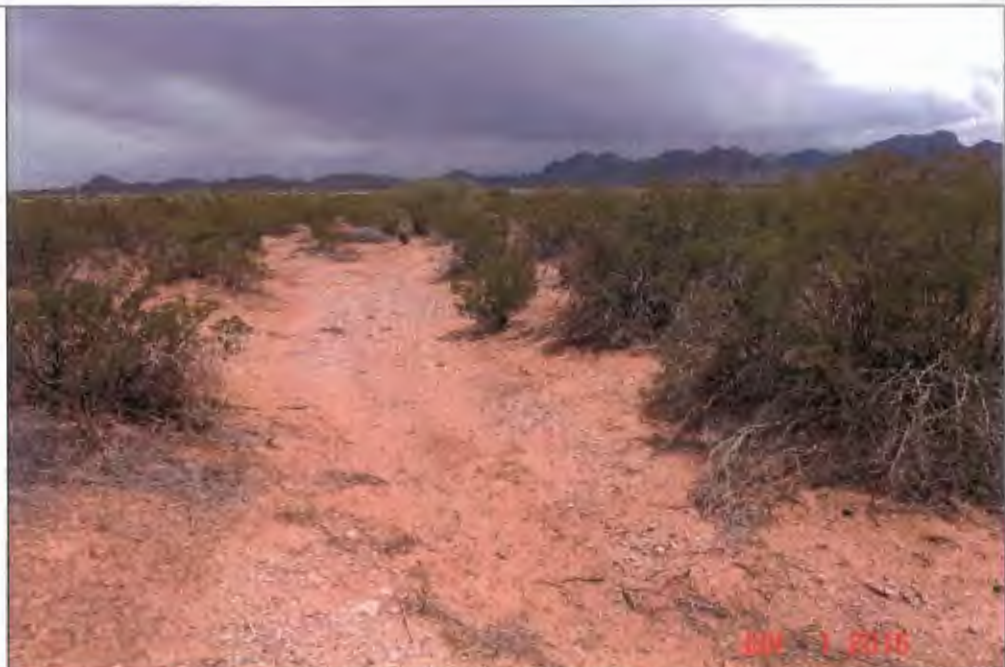
Photograph No. 7

Drainage structure facing Northwest.
