DEPARTMENT OF THE ARMY
US ARMY INSTALLATION MANAGEMENT COMMAND
HEADQUARTERS, UNITED STATES ARMY GARRISON, FORT BLISS
1741 MARSHALL ROAD
FORT BLISS, TEXAS 79916

On June 1, 2016 and October 14, 2016, the Fort Bliss Directorate of Public Works, Environmental Division (DPW-ED) conducted biannual post-closure site inspections of the Dona Ana Range Camp Rubble Landfill, Solid Waste Management Unit (SWMU) 27/FTBL-012. The inspections were conducted before and after the wet summer season respectively, in accordance with the requirements stated in the New Mexico Environmental Department (NMED) Hazardous Waste Bureau letter, dated October 30, 2007.

Dona Ana Range Camp Rubble Landfill - Pre-wet season Inspection

SWMU-27/FTBL-012

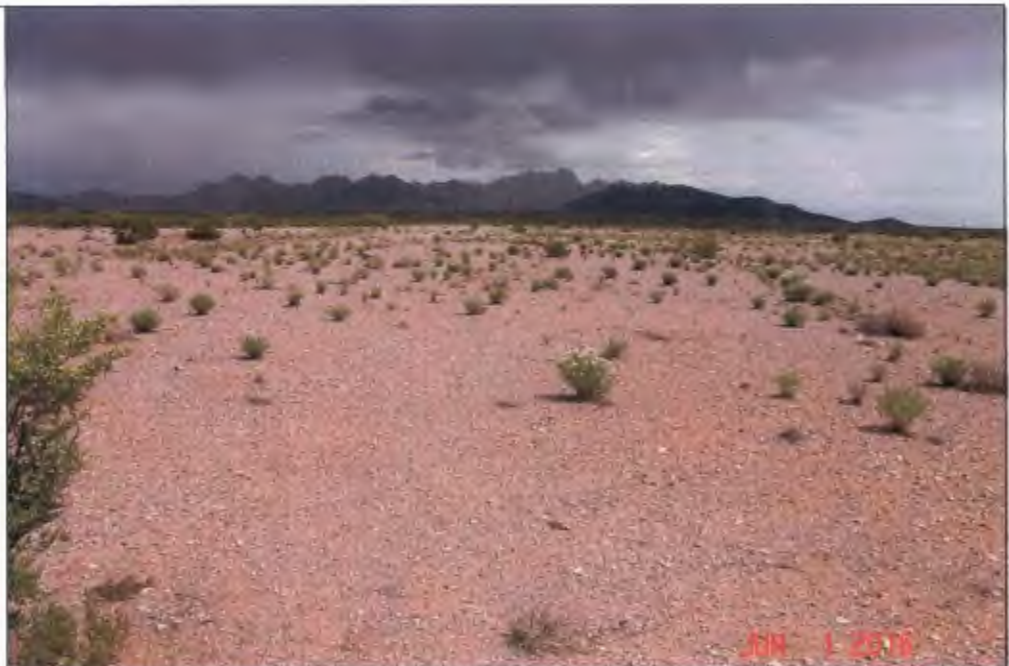
Photograph No. 1

View of landfill cap facing North.

No signs of erosion or surface depression on landfill cap. Vegetation on landfill cap in good condition.

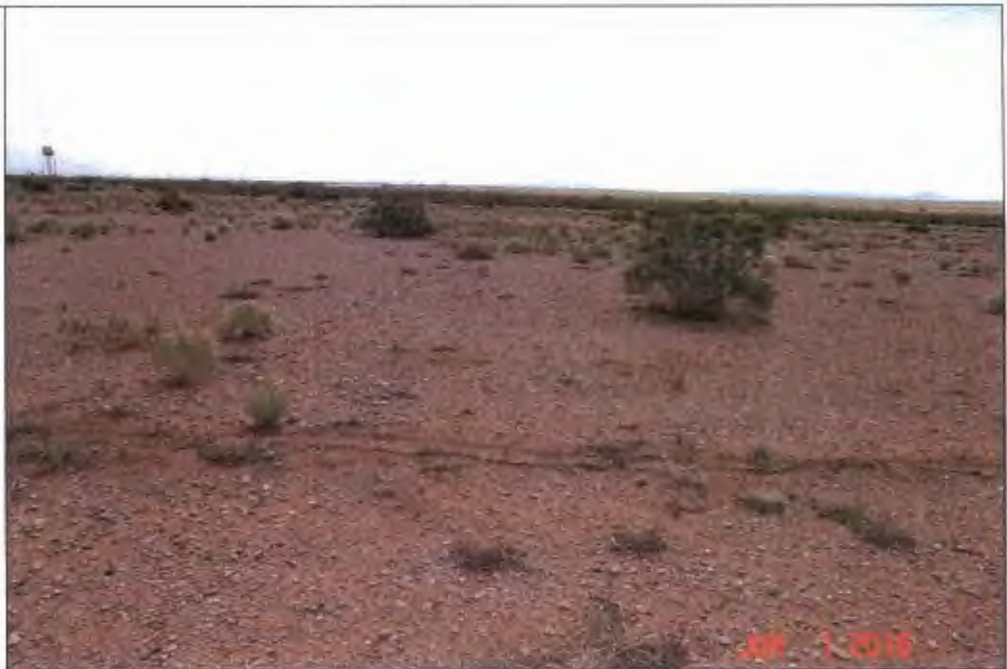
Photograph No.2

View of landfill cap facing East.

No signs of erosion or surface depression on landfill cap. Vegetation on landfill cap in good condition.

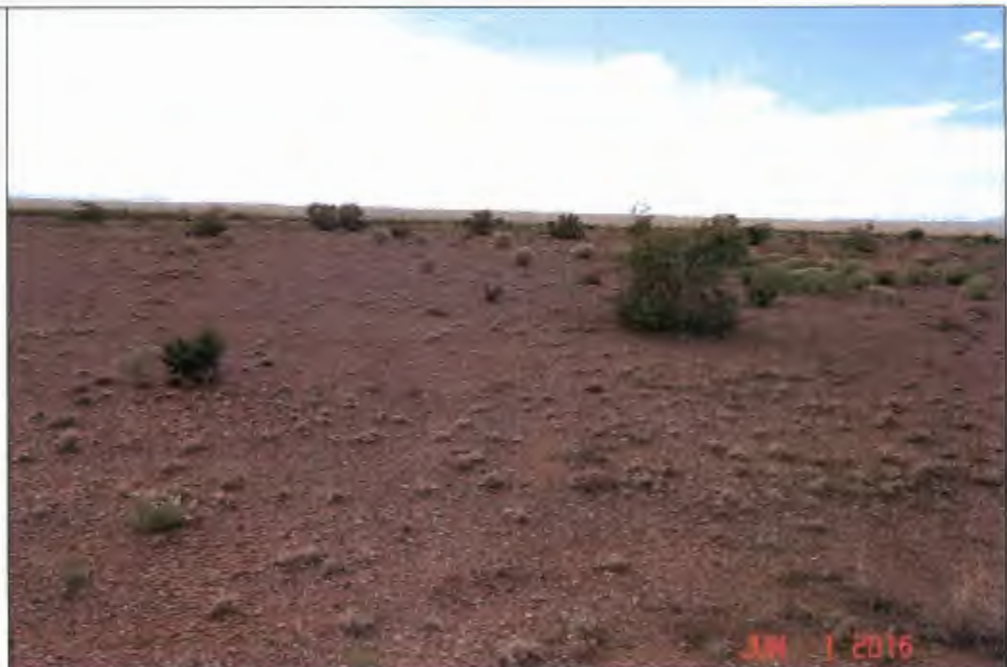
Photograph No. 3

View of landfill cap facing South.

No signs of erosion or surface depression on landfill cap. Vegetation on landfill cap in good condition.

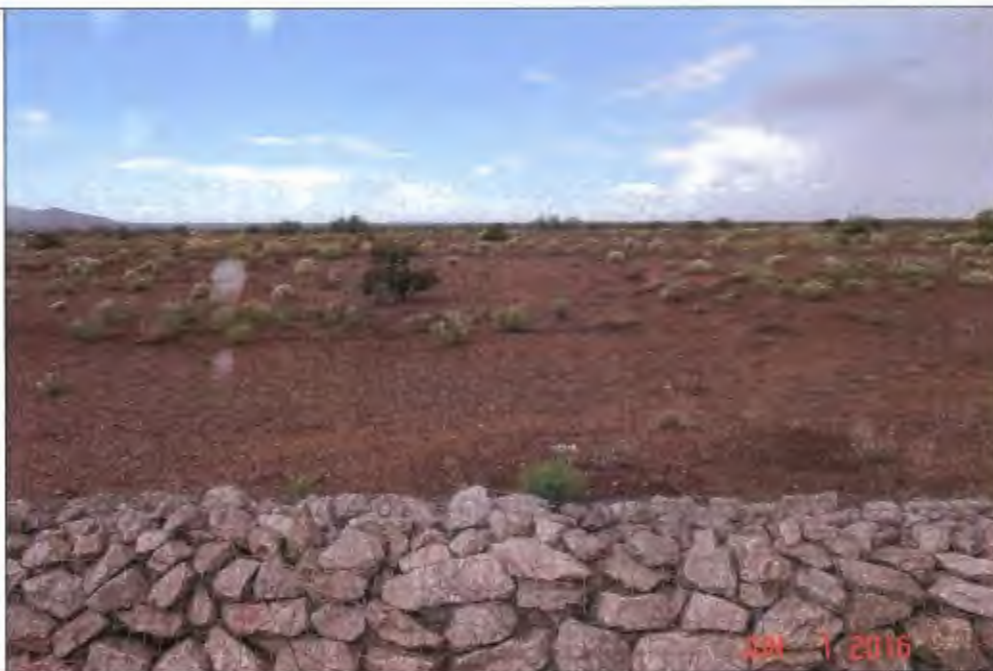
Photograph No. 4

View of landfill cap facing West.

No signs of erosion or surface depression on landfill cap. Vegetation on landfill cap in good condition.

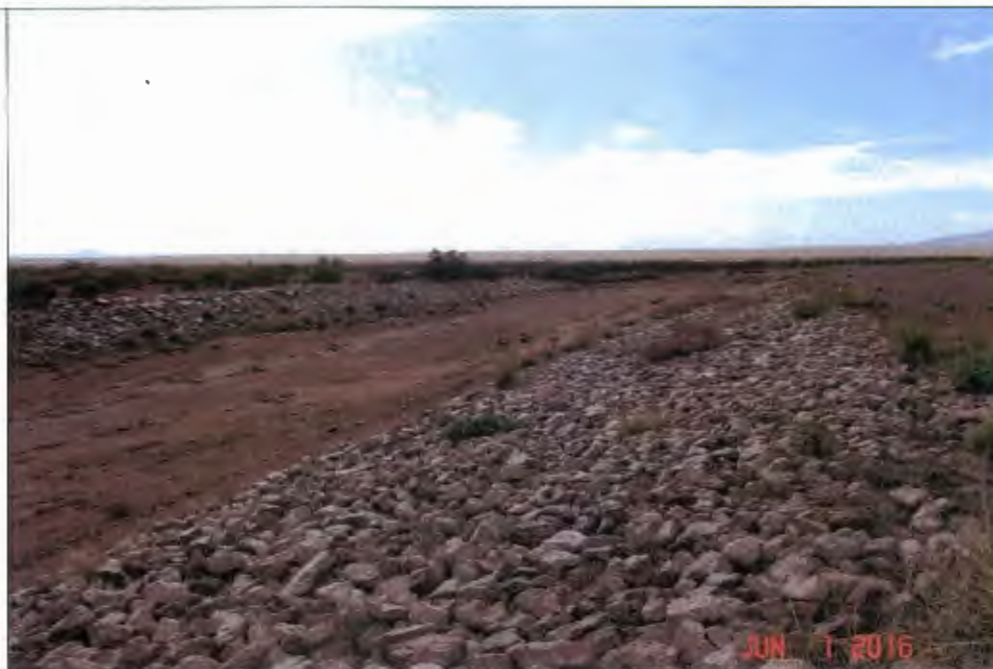
Photograph No. 5

View of arroyo facing South.

No sign of significant erosion caused by water runoff on arroyo.

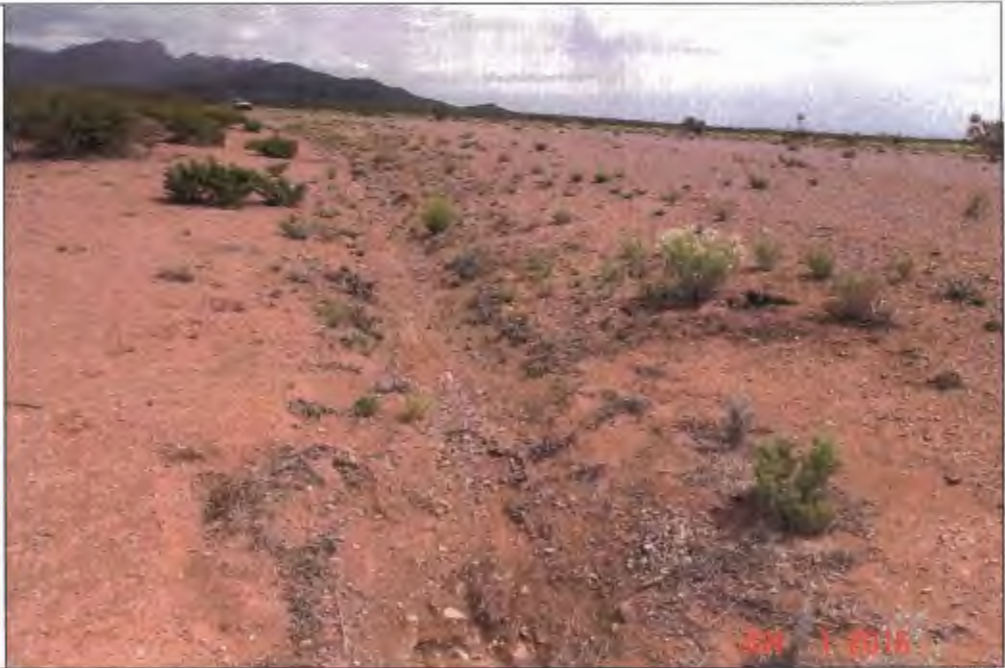
Photograph No. 6

View of swale facing North.

No sign of significant erosion or surface depression caused by water runoff on drainage swale.

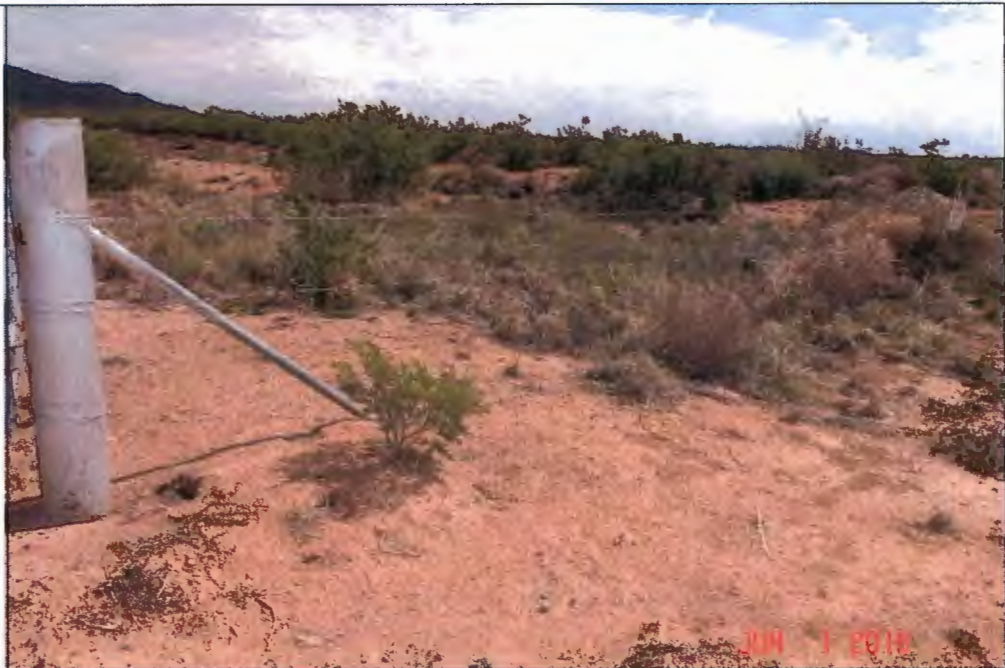
Photograph No. 7

During the inspection conducted in the pre-wet season on June 1, 2016, the landfill cover and side slopes showed no signs of erosion and the vegetative layer and warning signs were found to be in good condition (Enclosure 1). However, a section of the perimeter fence and the drainage system, both located on the Southside of the site, were damaged. The repairs were conducted on July 1, 2016 (Enclosure 1).

View of Southern perimeter fence damage.

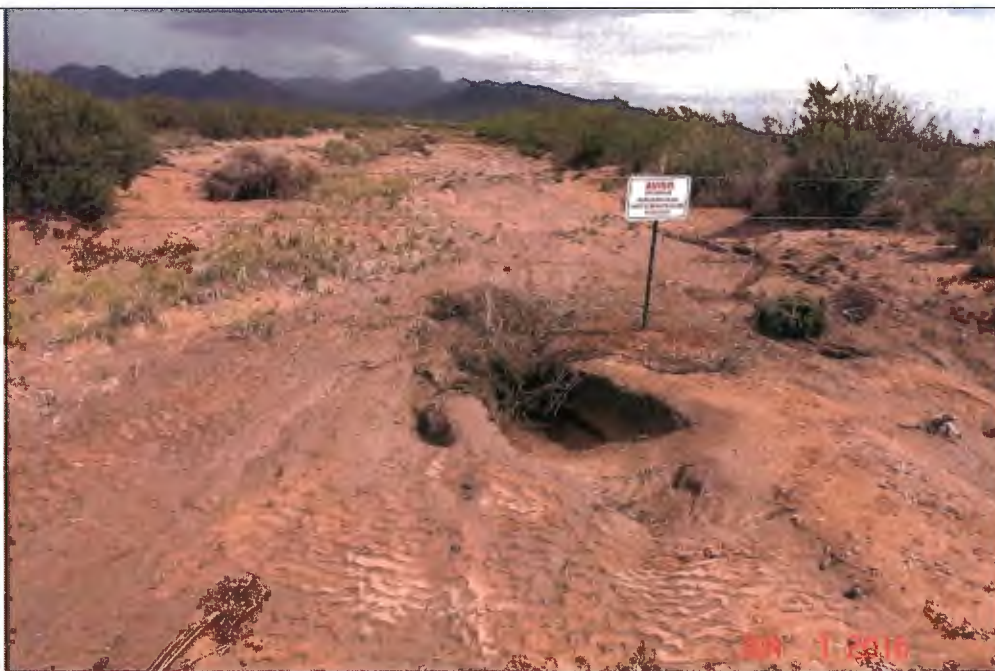
Photograph No. 8

View of South end drainage structure damage caused by water runoff.

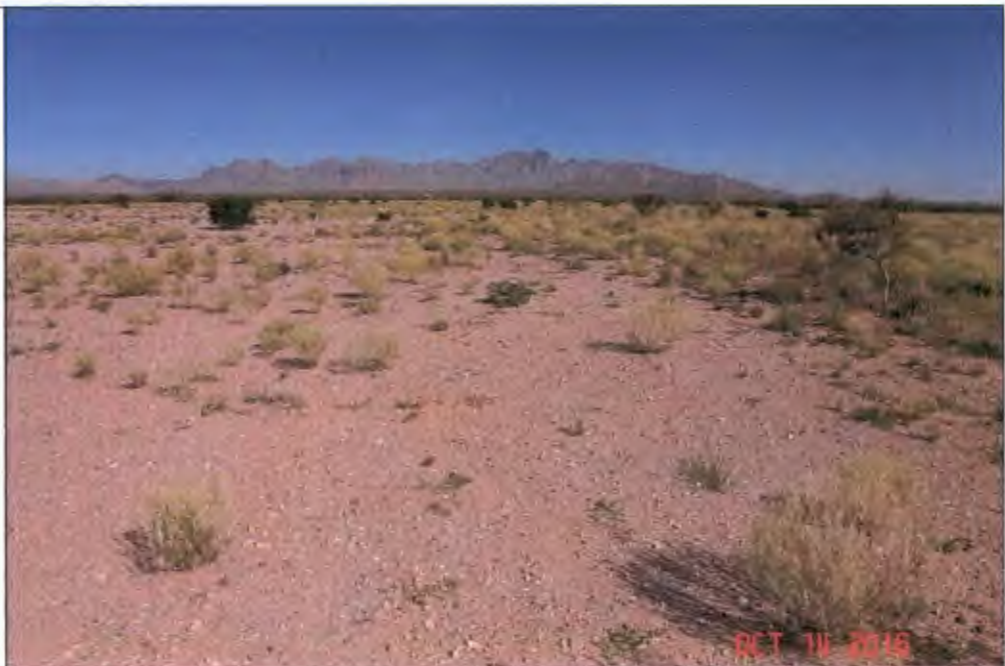
Photograph No. 1

View of landfill cap facing North.

No signs of erosion or surface depression on landfill cap. Vegetation on landfill cap in good condition.

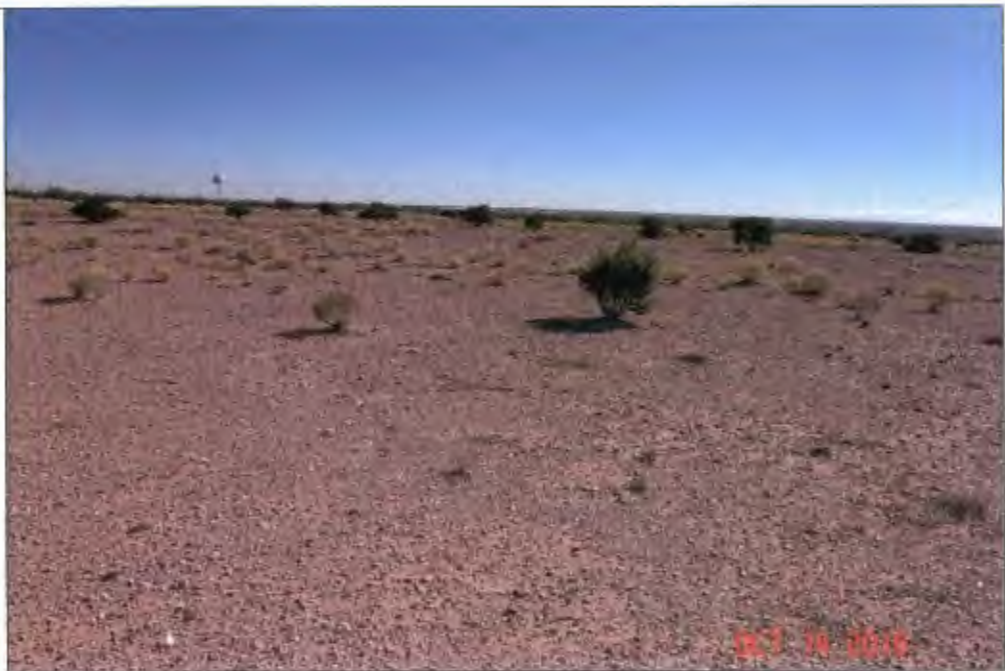
Photograph No.2

View of landfill cap facing East.

No signs of erosion or surface depression on landfill cap. Vegetation on landfill cap in good condition.

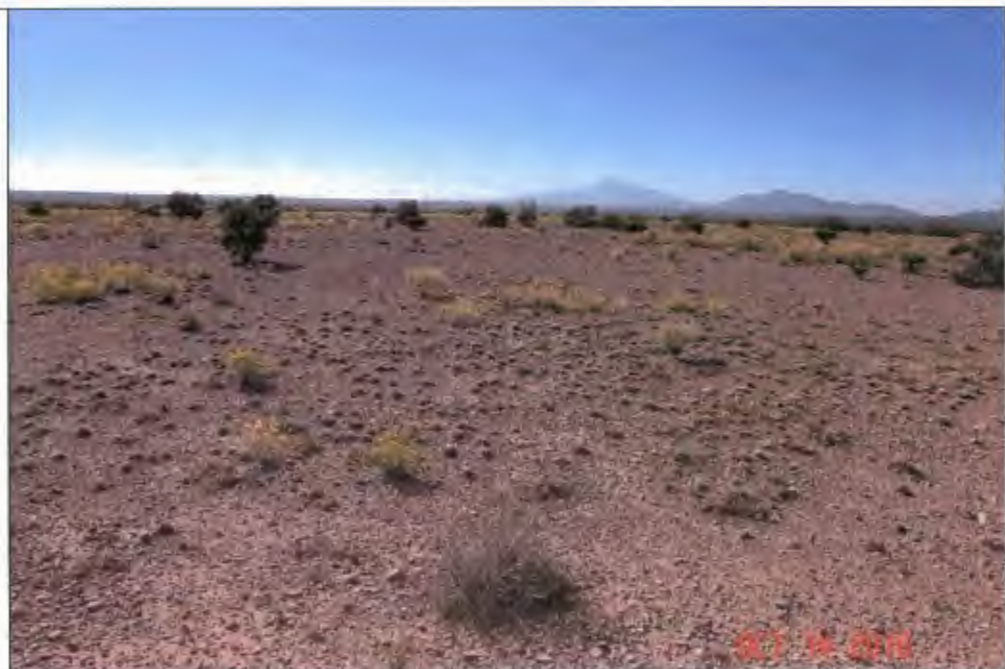
Photograph No. 3

View of landfill cap facing South.

No signs of erosion or surface depression on landfill cap. Vegetation on landfill cap in good condition.

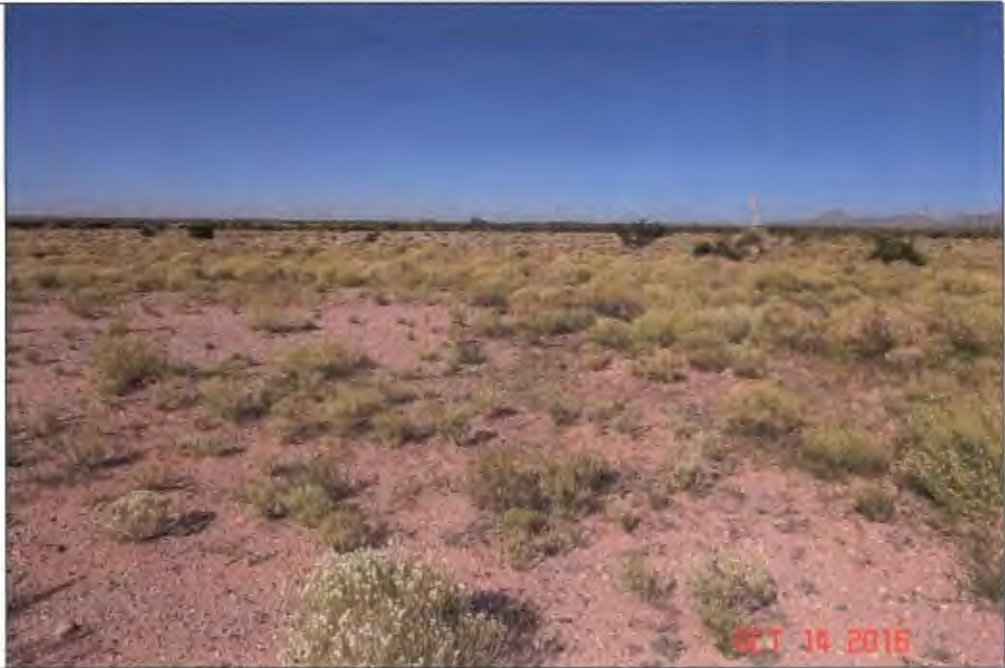
Photograph No. 4

View of landfill cap facing West.

No signs of erosion or surface depression on landfill cap. Vegetation on landfill cap in good condition.

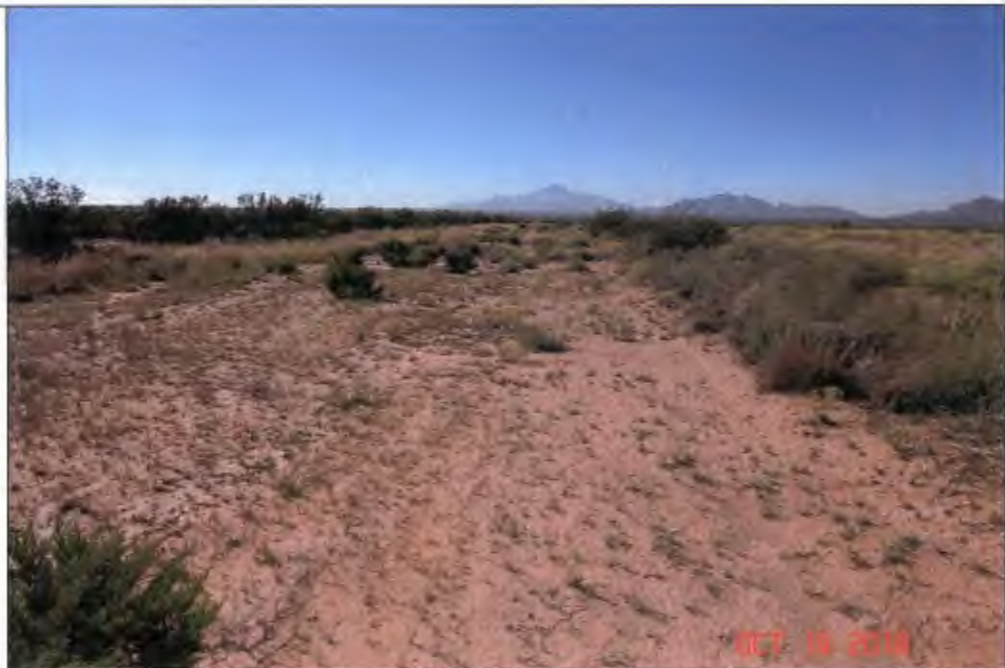
Photograph No. 5

View of arroyo facing South.

No sign of significant erosion caused by water runoff on arroyo.

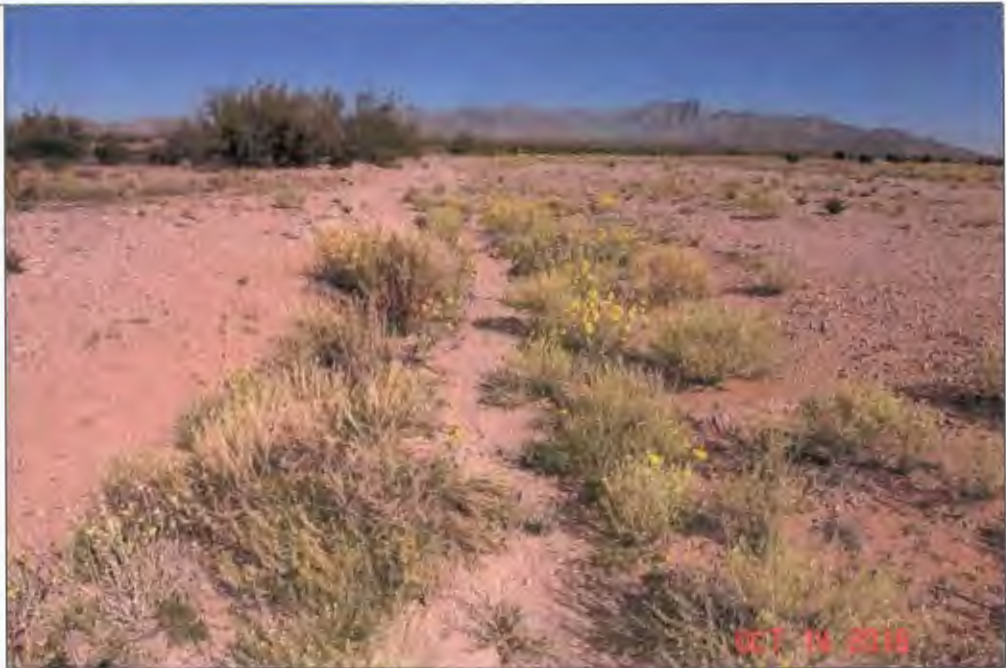
Photograph No. 6

View of swale facing North.

No sign of significant erosion or surface depression caused by water runoff on drainage swale.

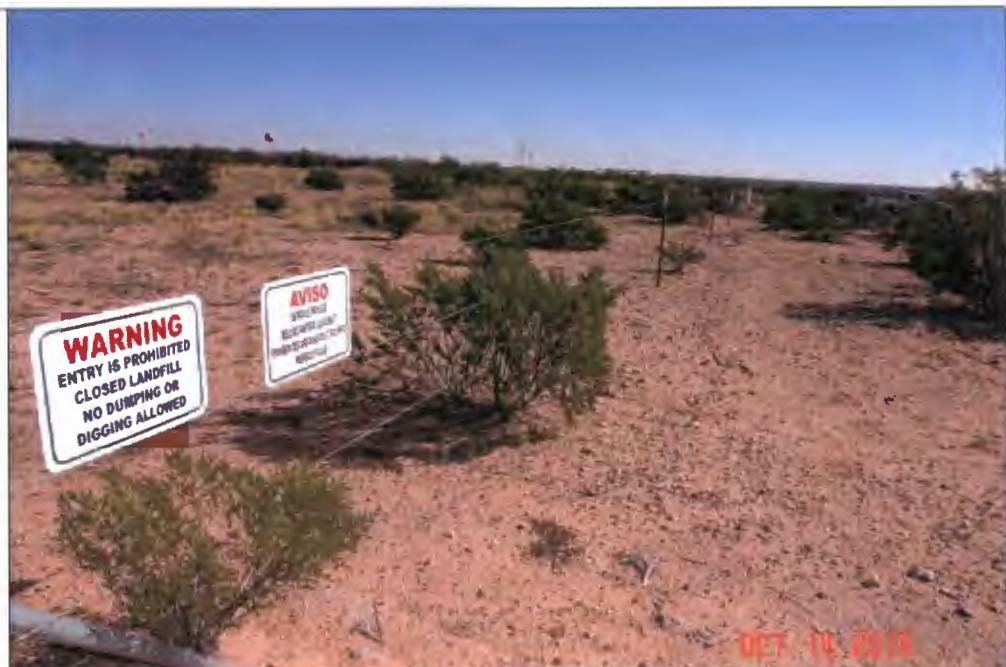
Photograph No. 7

View of southern fence facing East.

Perimeter fence and warning signs remain in good condition.

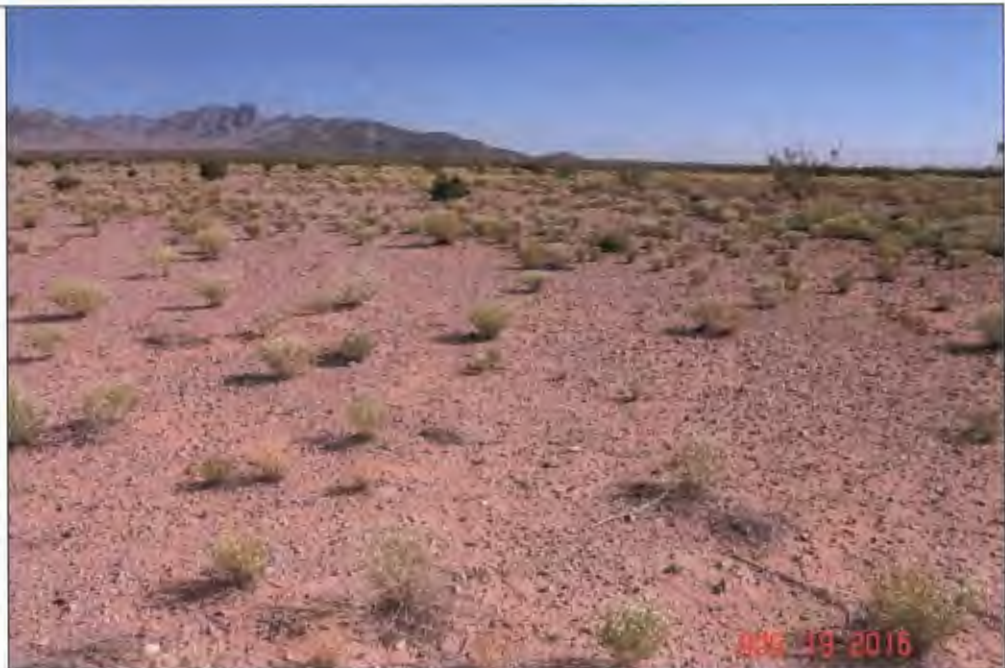
Photograph No. 1

View of landfill cap facing North.

No signs of erosion or surface depression resulting from the rain event.

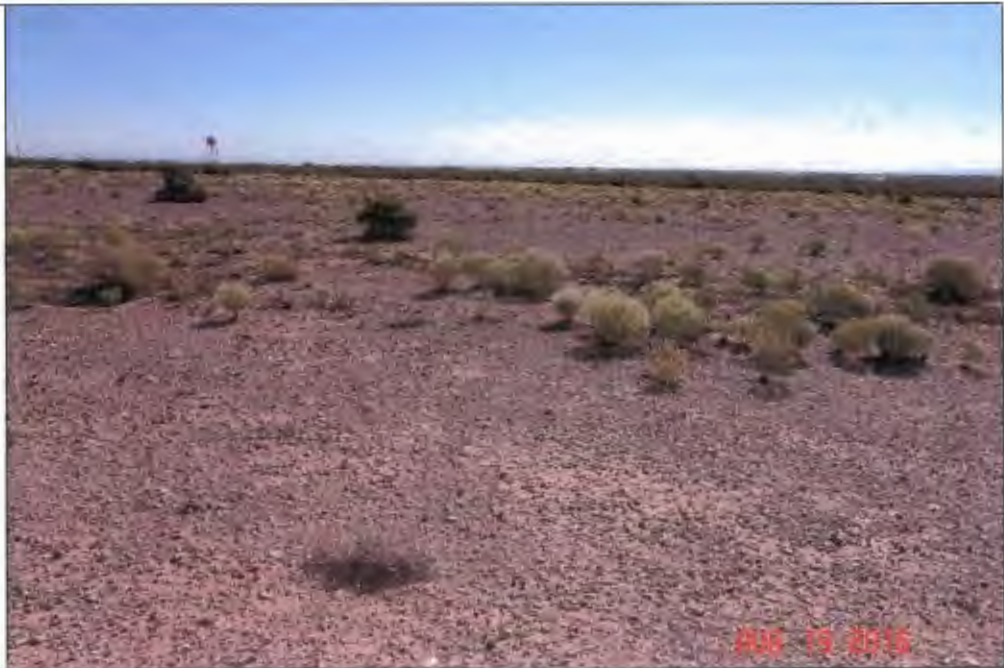
Photograph No.2

View of landfill cap
facing East.

No signs of erosion
or surface
depression resulting
from the rain event.

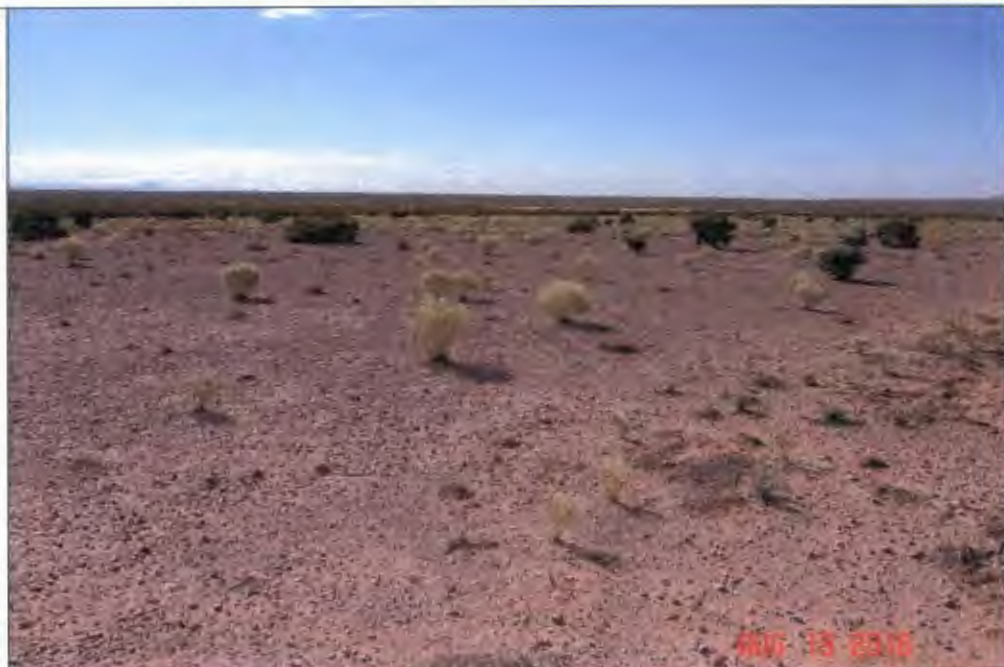
Photograph No. 3

View of landfill cap
facing South.

No signs of erosion
or surface
depression resulting
from the rain event.

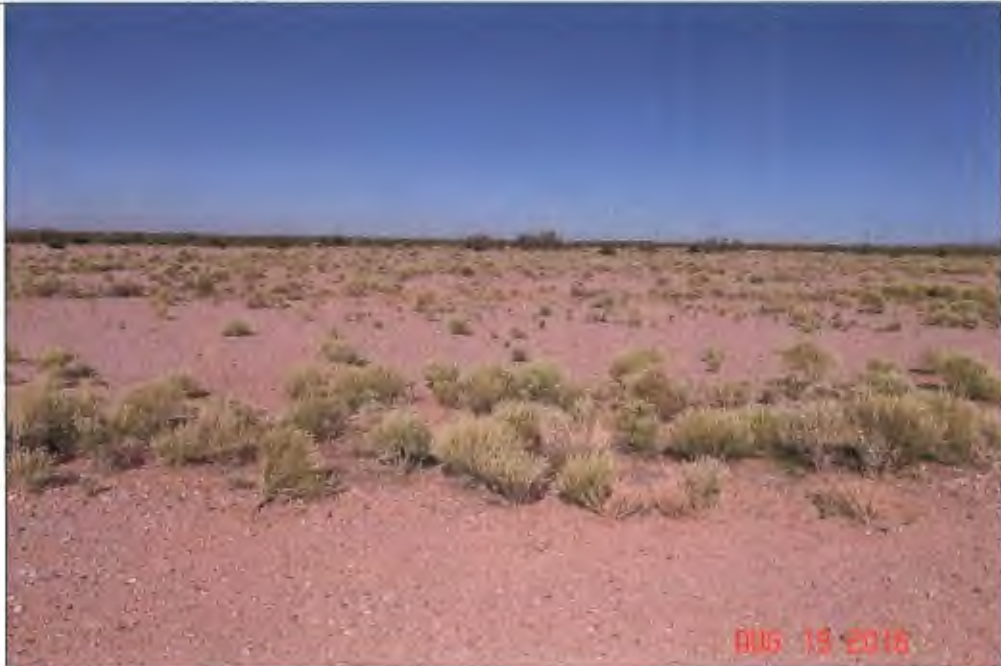
Photograph No. 4

View of landfill cap
facing West.

No signs of erosion
or surface
depression resulting
from the rain event.

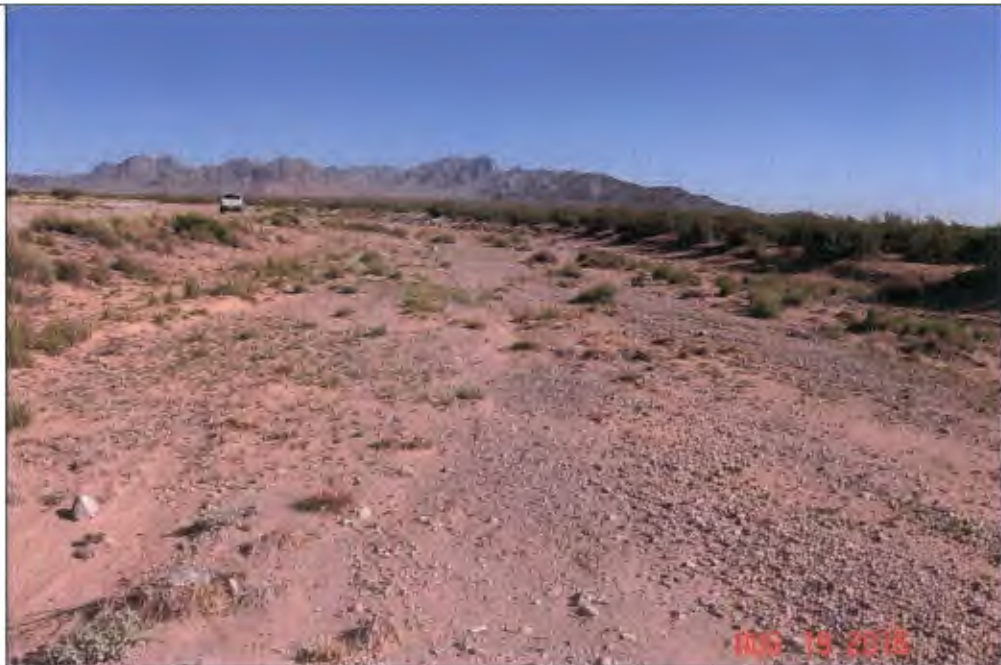
Photograph No. 5

View of arroyo
facing North.

No signs of
significant erosion
or surface
depression on
arroyo resulting
from the rain event.

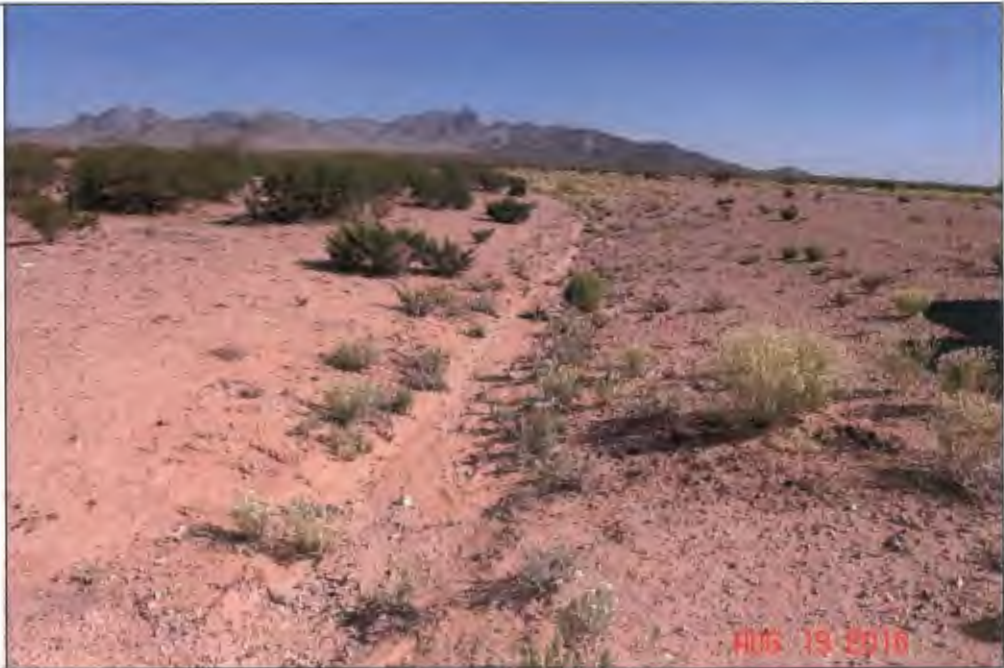
Photograph No. 6

View of swale facing
North.

No signs of
significant erosion
or surface
depression resulting
from the rain event.

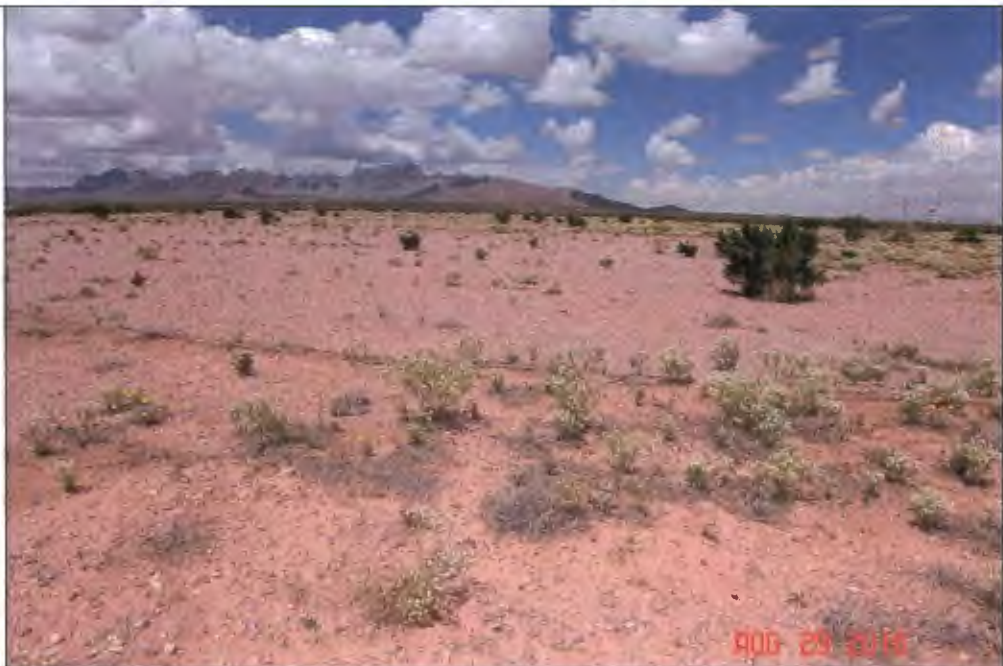
Photograph No. 1

View of landfill cap
facing North.

No signs of erosion
or surface
depression resulting
from the rain event.

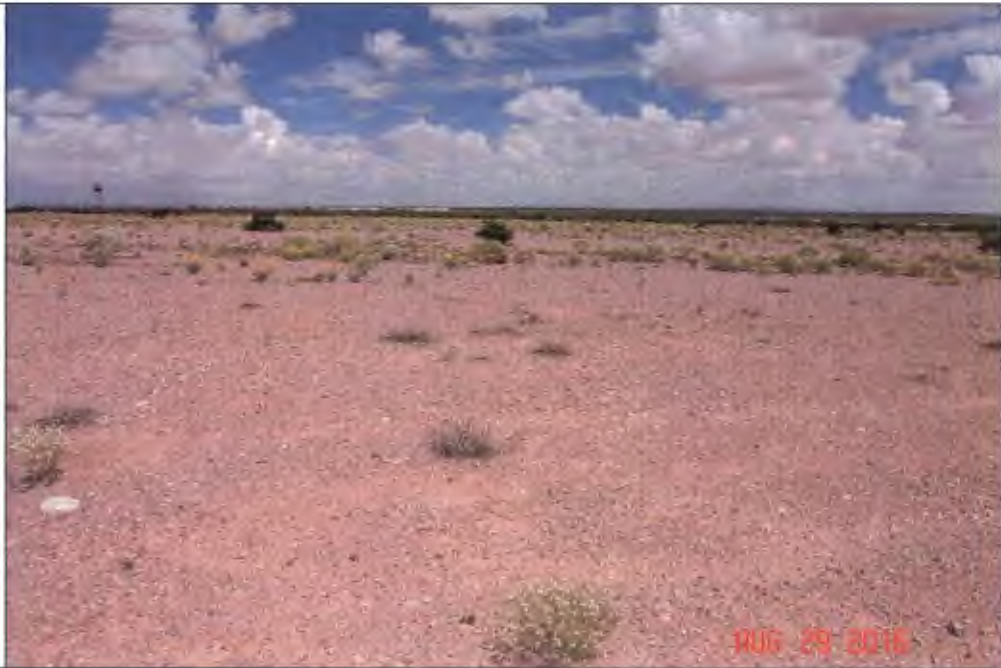
Photograph No.2

View of landfill cap facing East.

No signs of erosion or surface depression resulting from the rain event.

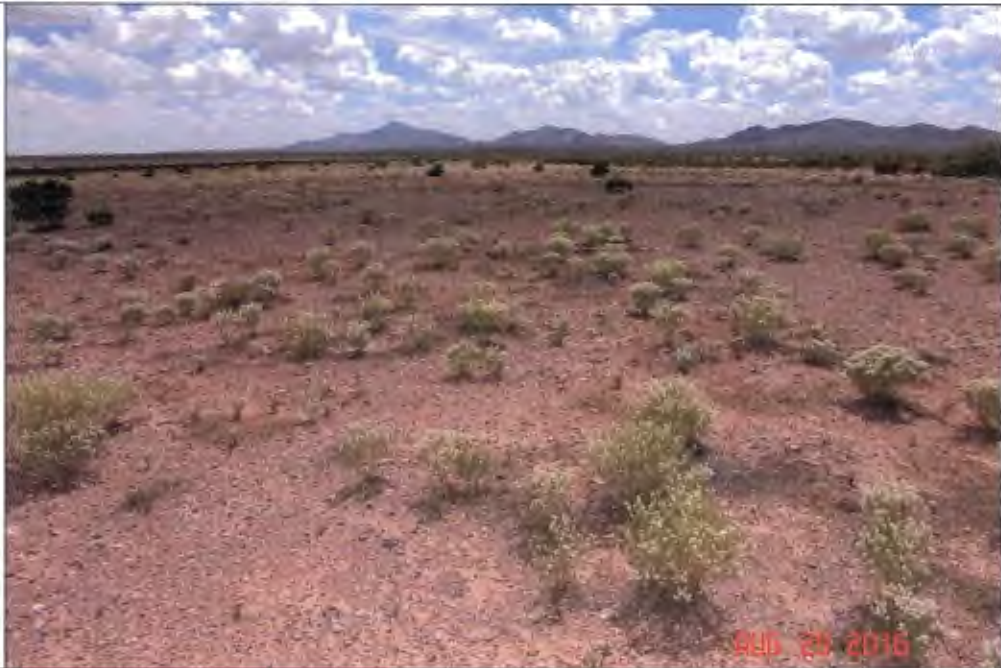
Photograph No. 3

View of landfill cap facing South.

No signs of erosion or surface depression resulting from the rain event.

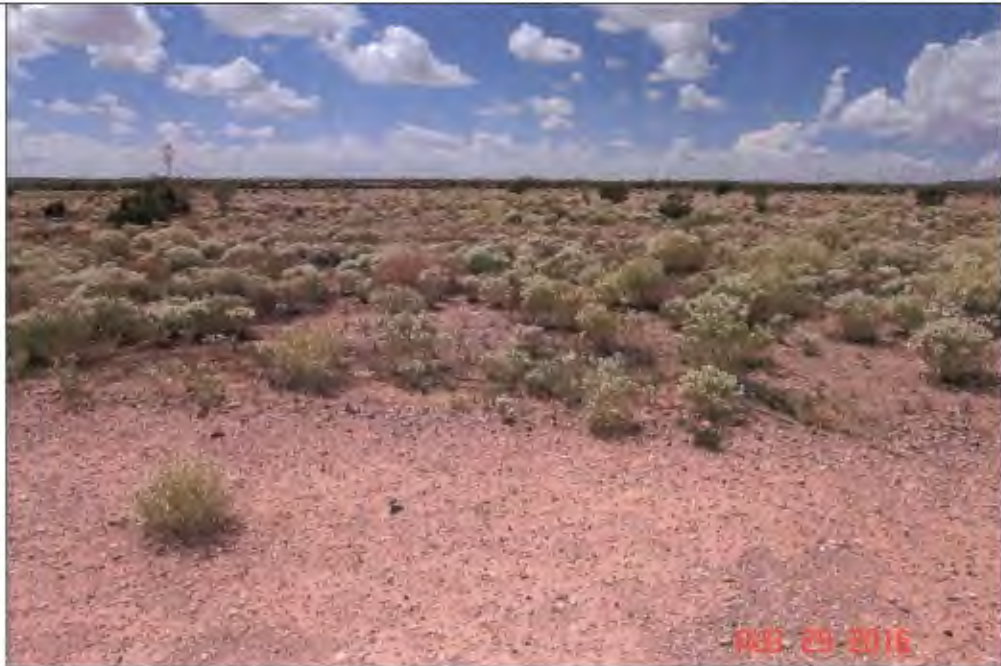
Photograph No. 4

View of landfill cap facing West.

No signs of erosion or surface depression resulting from the rain event.

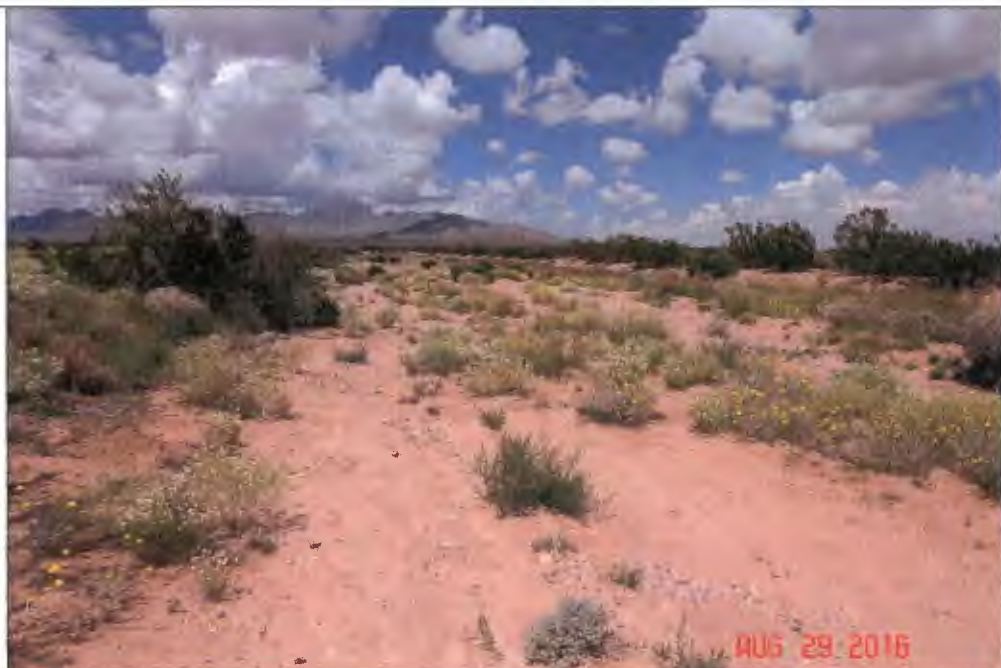
Photograph No. 5

View of arroyo facing North.

No signs of significant erosion or surface depression on arroyo resulting from the rain event.

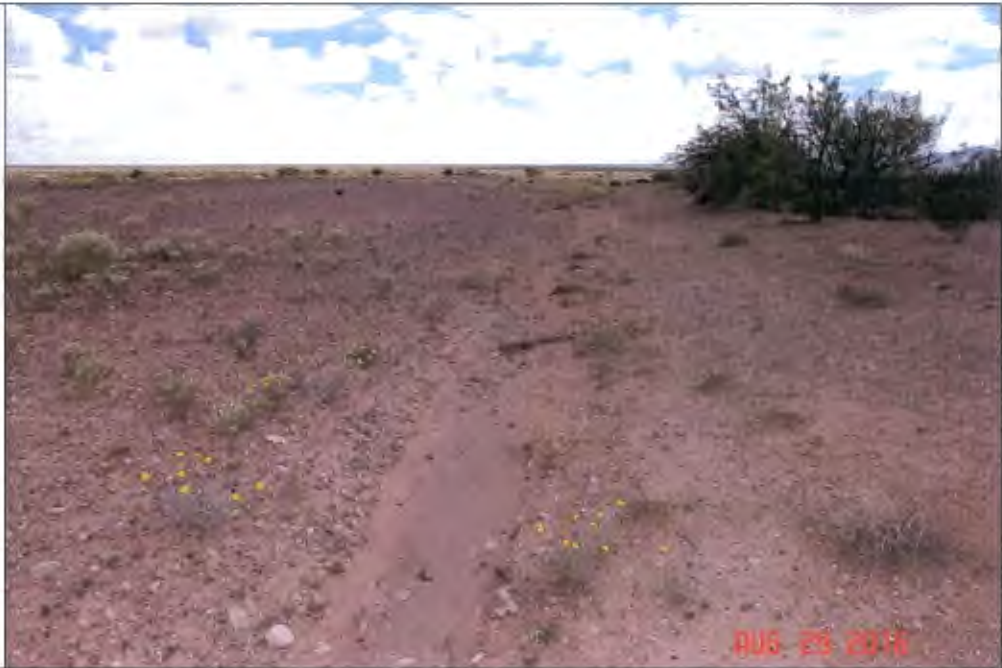
Photograph No. 6

View of swale facing
South.

No signs of
significant erosion
or surface
depression resulting
from the rain event.
