The following narrative outlines the events leading to and involving the remediation of the JP-4 spill at Holloman Air Force Base per the Emergency Permit dated July 15, 1992.

Re: Results of TCLP Analyses of Soil Material
 JP-4 Fuel Spill
 Holloman Air Force Base, New Mexico

IHP Spill Remediation

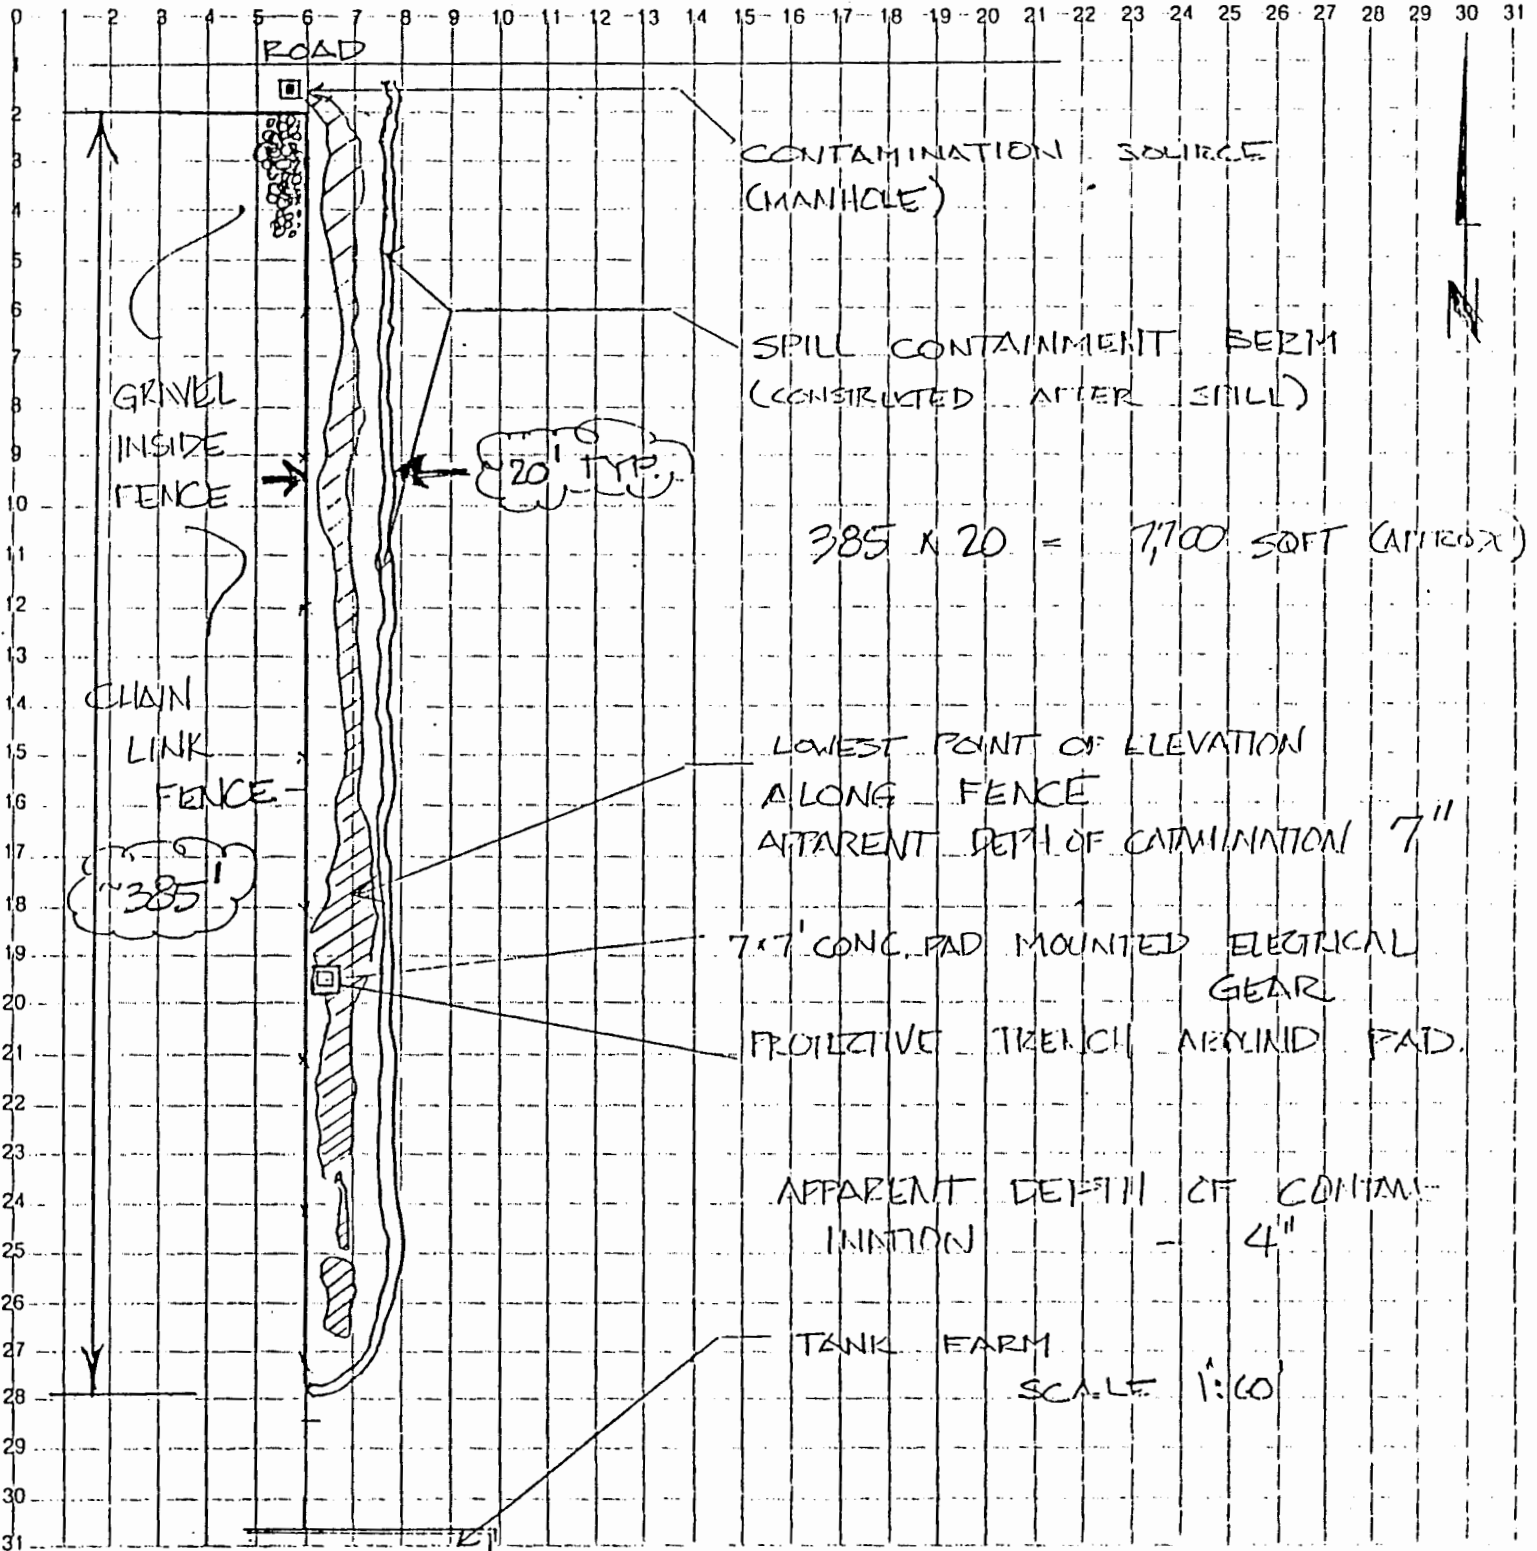
Immediately after the spill was detected, a berm was placed to contain the spill in a strip approximately 20' x 320' (see attachment "A"). On July 10, 1992, David Fitzpatrick of IHP Industrial, Inc., took soil samples per directions from Sargents, Haskins & Beckwith to them for TCLP testing (attachment "B").

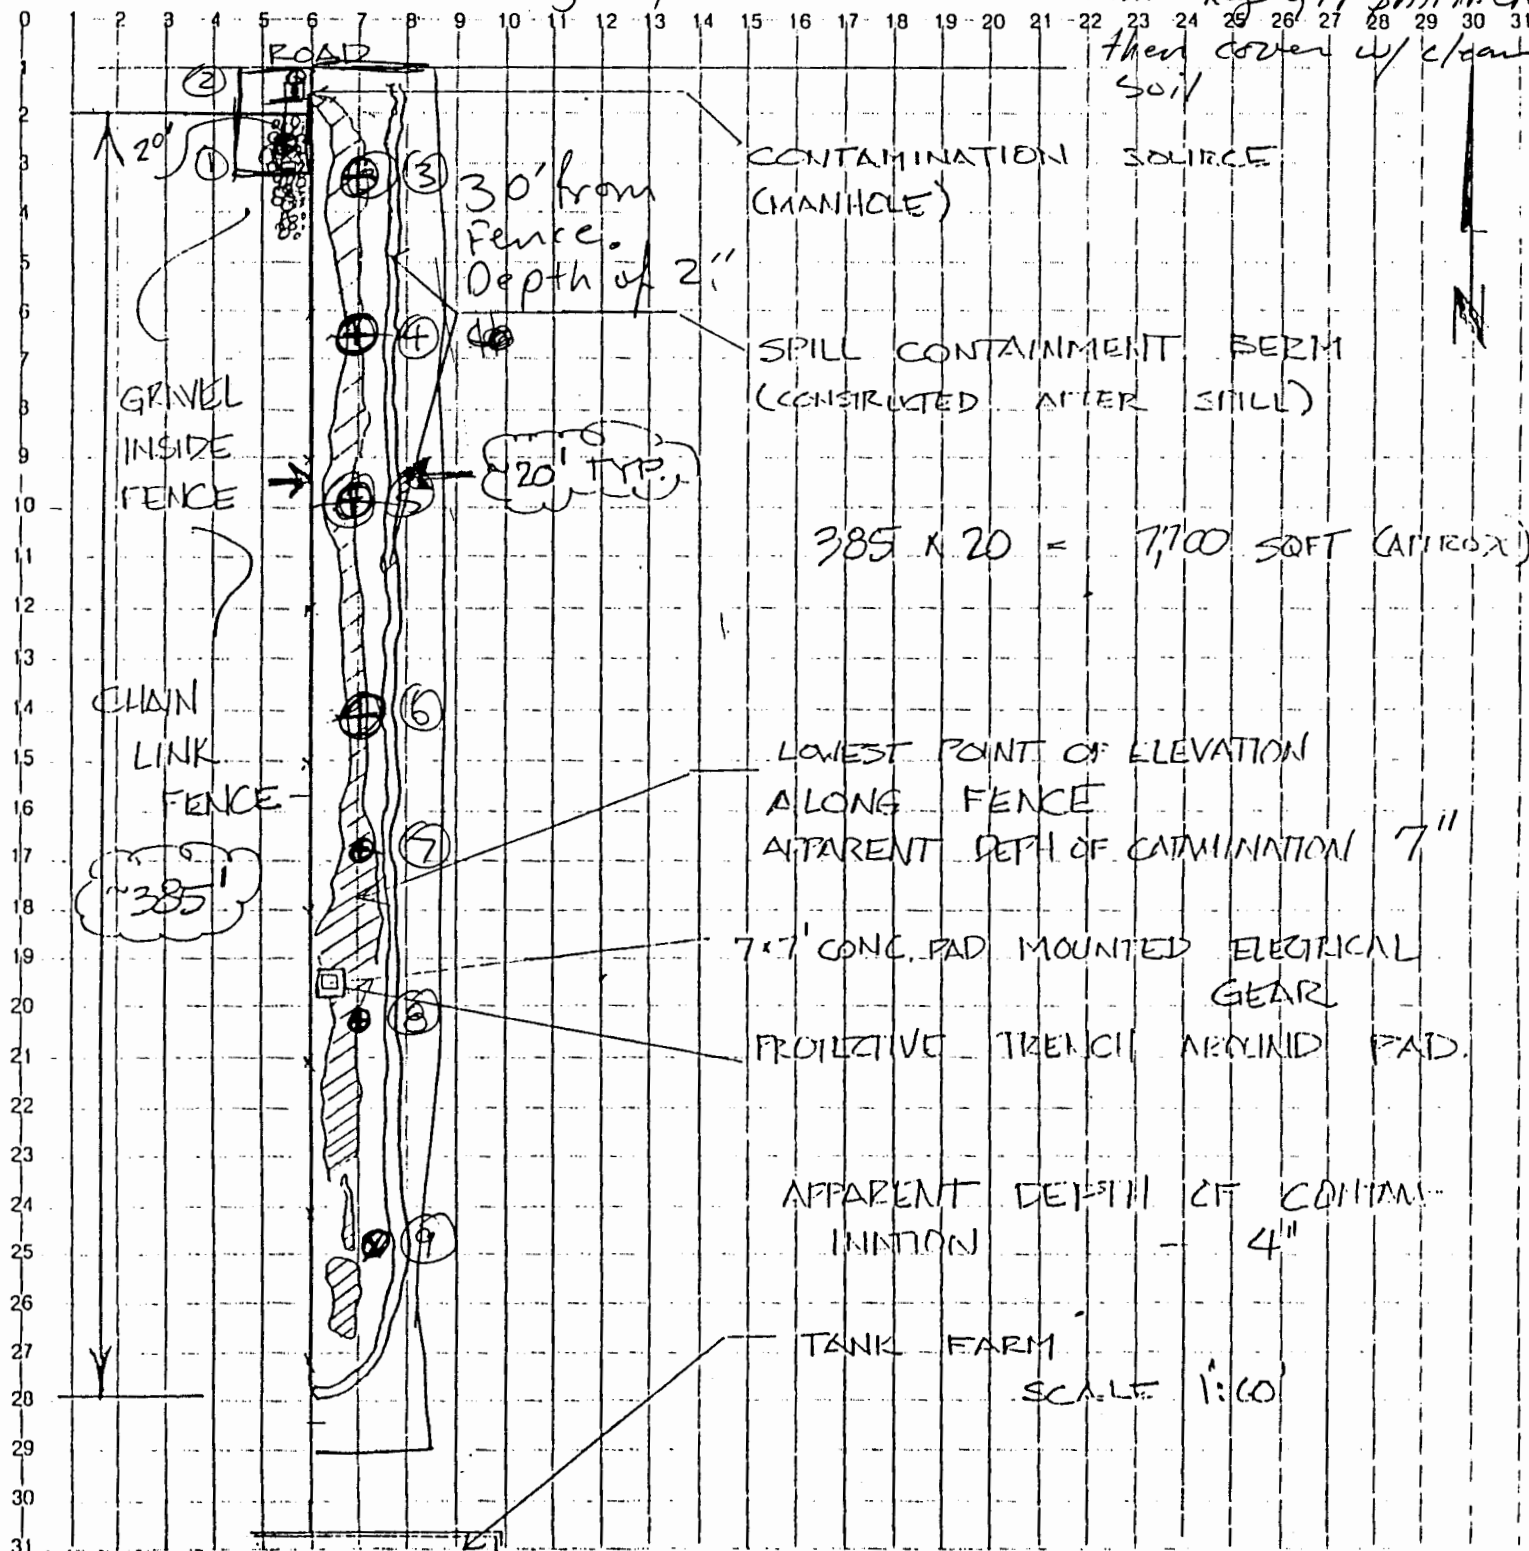
Test station before starting every 50', remove 2" test / inspect visually by HPE and Roger, if satisfactory then cover w/ clean soil
