**RE: REMEDIATION OF 9 JULY 92 JP-4 FUEL SPILL: 11 AUGUST 92 LETTER
FROM HENSEL PHELPS CONSTRUCTION COMPANY**

The following narrative outlines the events leading to and involving the remediation of the JP-4 spill at Holloman Air Force Base per the Emergency Permit dated July 15, 1992.

Re: Results of TCLP Analyses of Soil Material
 JP-4 Fuel Spill
 Holloman Air Force Base, New Mexico

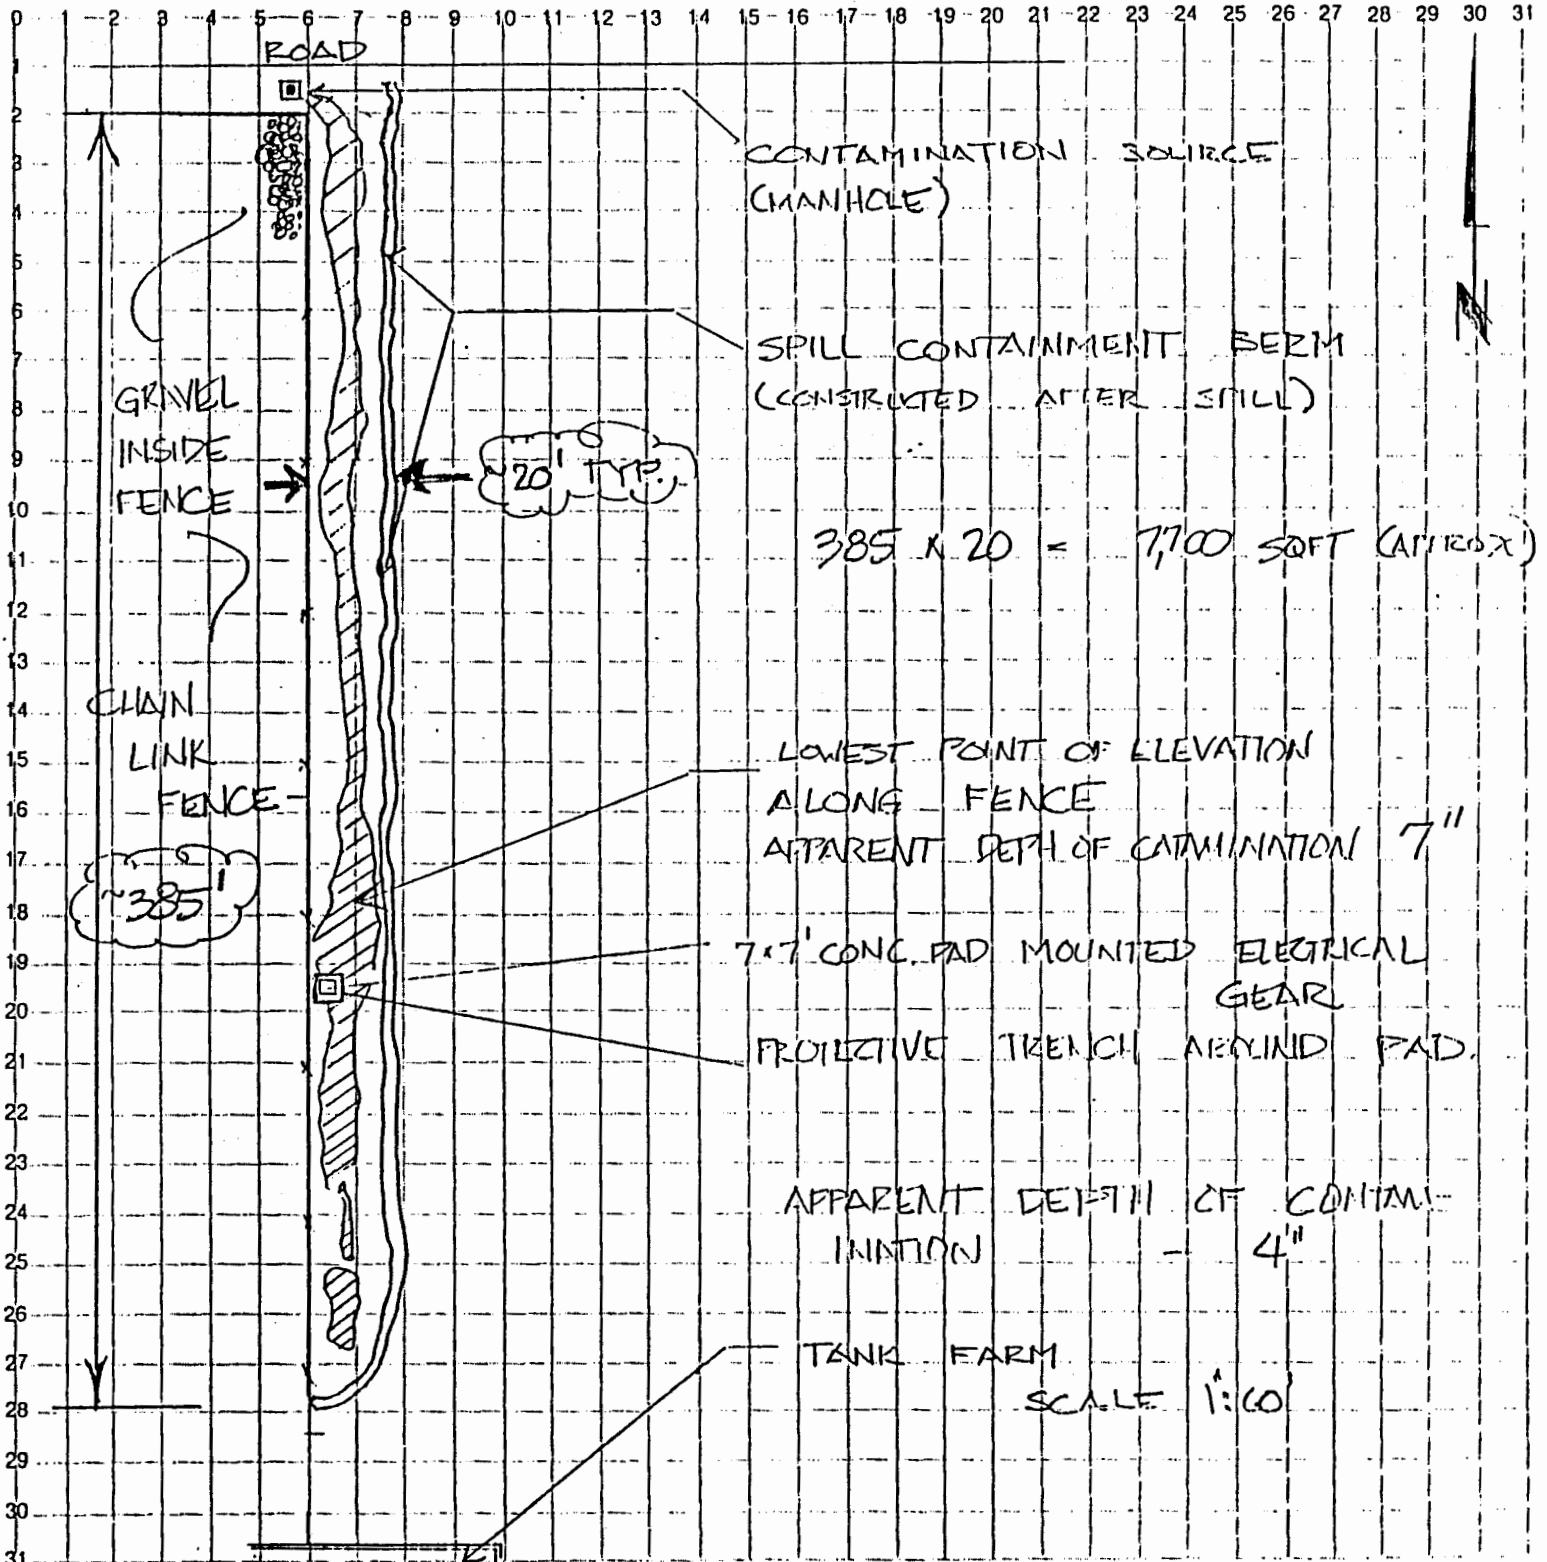
Immediately after the spill was detected, a berm was placed to contain the spill in a strip approximately 20' x 320' (see attachment "A"). On July 10, 1992, David Fitzpatrick of IHP Industrial, Inc., took soil samples per directions from Sargents, Haskins & Beckwith to them for TCLP testing (attachment "B").

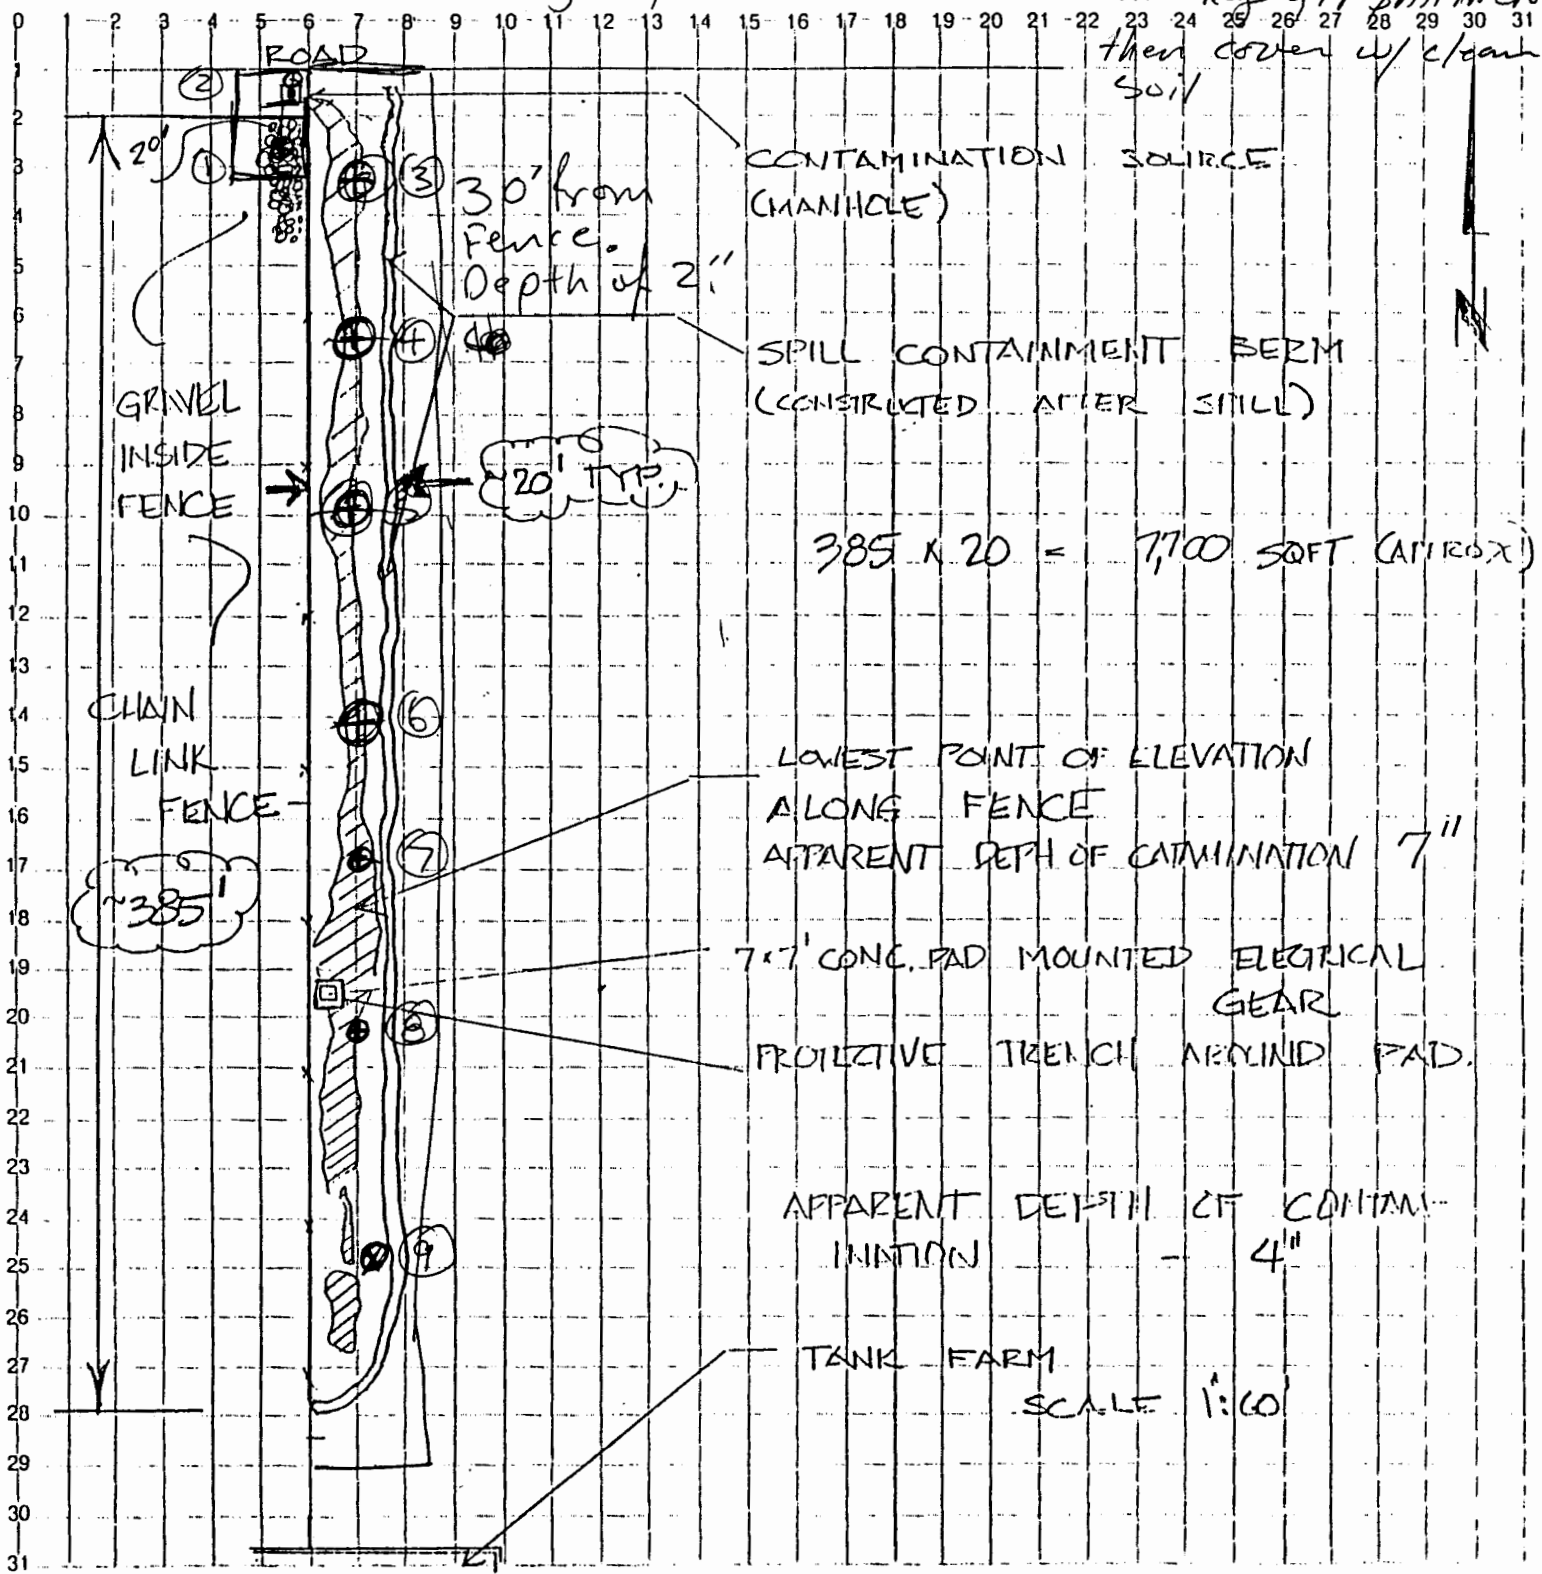
Test station before starting every 50', remove 2" test/inspect visually by Hfe and Roger if satisfactory then cover w/ clean soil
