*State of New Mexico*  
**ENVIRONMENT DEPARTMENT**  
*Hazardous & Radioactive Materials Bureau*  
2044 Galisteo Street  
P.O. Box 26110  
Santa Fe, New Mexico 87502  
(505) 827-1557  
Fax (505) 827-1544

M E M O R A N D U M

John Tymkowych, RCRA Enforcement Program  
Subject: Closure Verificaiton/Certification Inspection  
Date: May 25, 1999

On May 4, 1999 Anna Maestas and Chris Serazio of my staff conducted a closure verification inspection on an Open Burn (OB) Unit at Holloman Air Force Base (HAFB).

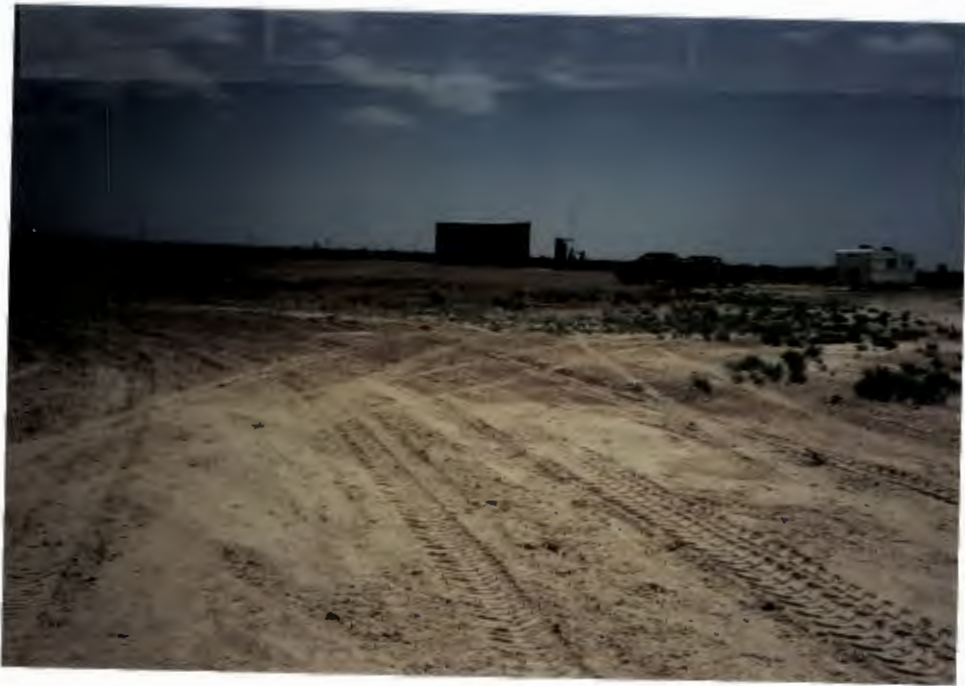
PHOTO #: 1

DESCRIPTION: LOOKING APPROX. SOUTH

POST-CLOSURE - RCRA

PHYSICAL INSPECTION <sup>(FORMER)</sup>

VIEW OF OB/DB AREA'S

1-3, REMEDIATED W/ CLEAN FILL

VIOLATION: N/A

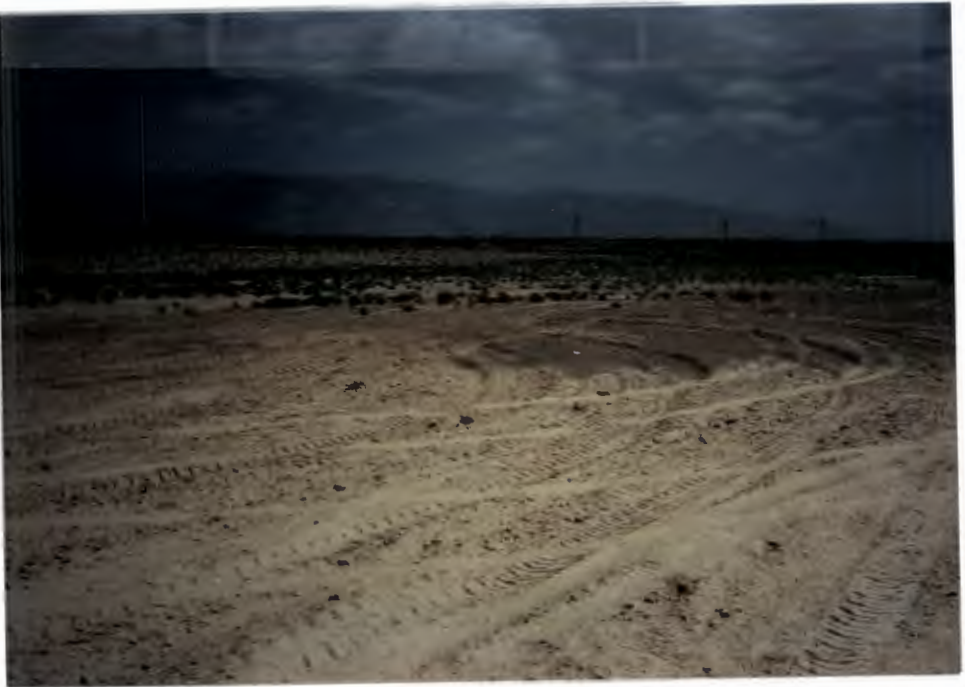
PHOTO #: 2

DESCRIPTION: PHOTO VIEW

±45° TO THE LEFT OF #1

AREA'S OF 1/2 FORMER OB/DB

MIXTURE OF SILTY SANDS W/ SOME

WELL GRADED BASE COARSE GRAVEL

BLADES ON TOP OF CAP FILL S. EDGE

VIOLATION: N/A

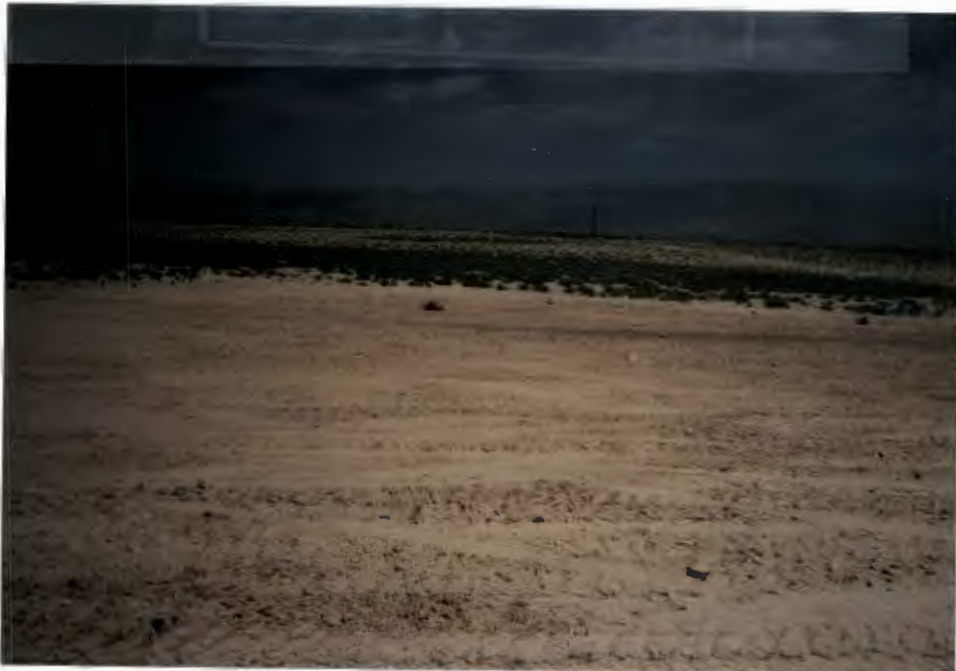
PHOTO #: 3

DESCRIPTION: PHOTO VIEW  $\approx$  45<sup>o</sup> TO  
LEFT #2 (EAST VIEW) OF  
OB/DB FORMER UNITS 1/2

VIOLATION: N/A

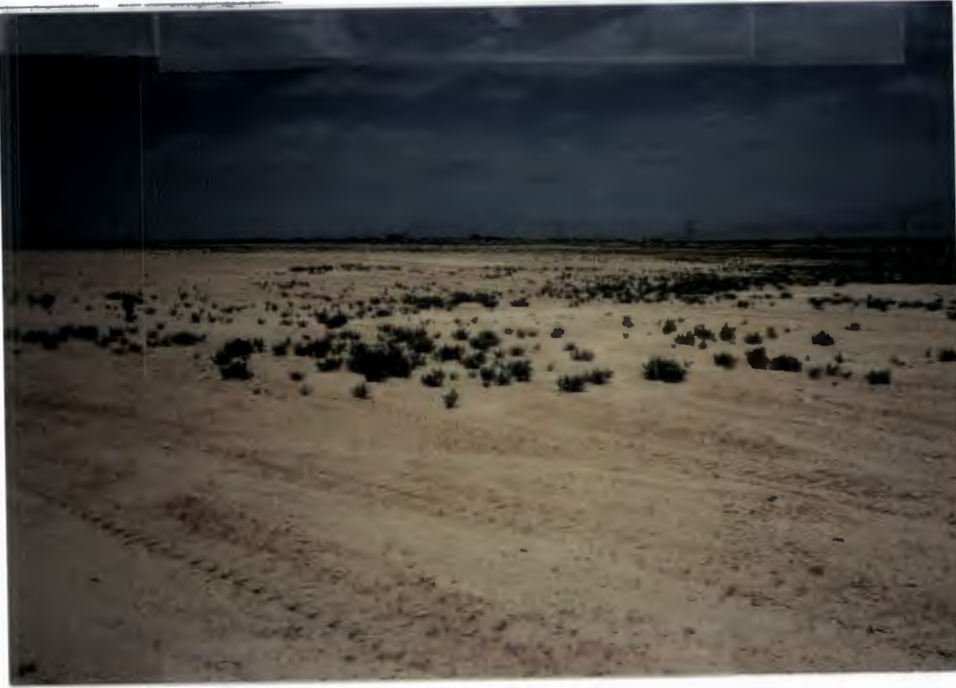
PHOTO #: 4

DESCRIPTION: PHOTO VIEW  $\approx$  45<sup>o</sup>  
TO LEFT #3 (WE VIEW) OF  
OB/DB FORMER TRENCH UNITS  
1/2

VIOLATION: N/A

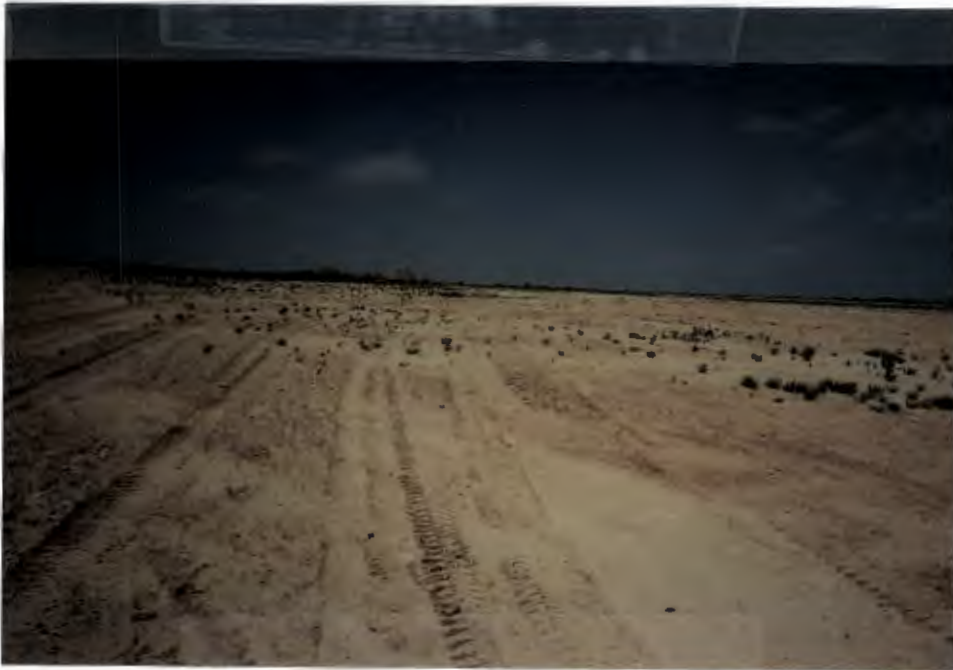
PHOTO #: 5

DESCRIPTION: PHOTO VIEW  $\approx$  45<sup>o</sup>  
TO LEFT #4 (LOOKING APPROX.  
NORTH) IN AREA #3 TRENCH  
OF FORMER OB/OD.

VIOLATION: N/A

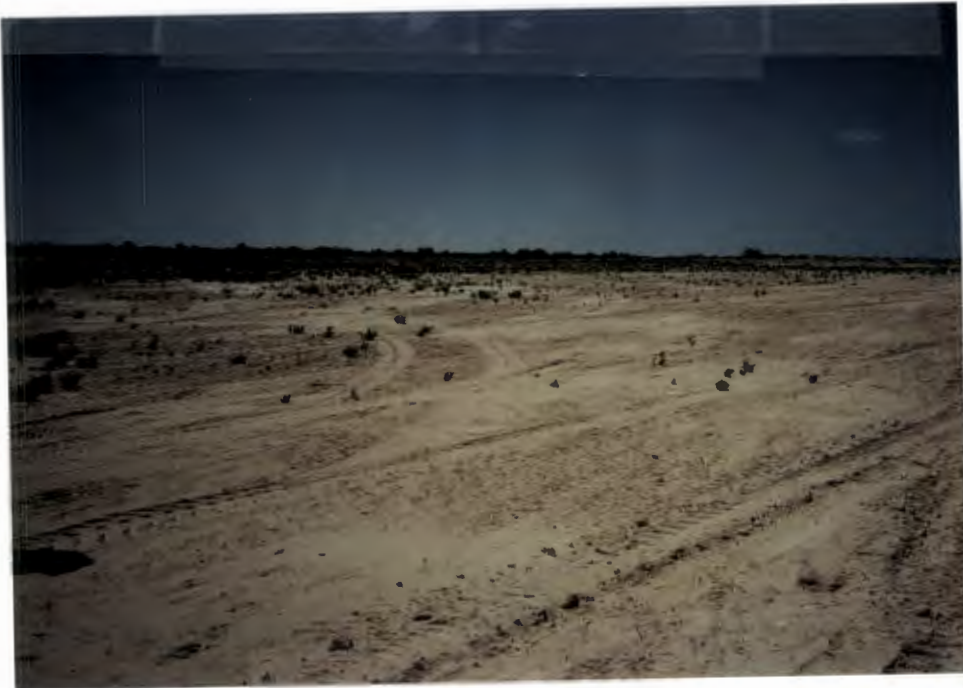
PHOTO #: HAFB #6

DESCRIPTION: PHOTO VIEW  $\approx$  45<sup>o</sup>  
TO LEFT #5, VIEW NW  
& WHERE OB/OD TRENCH  
#3 WAS LOCATED

VIOLATION: N/A

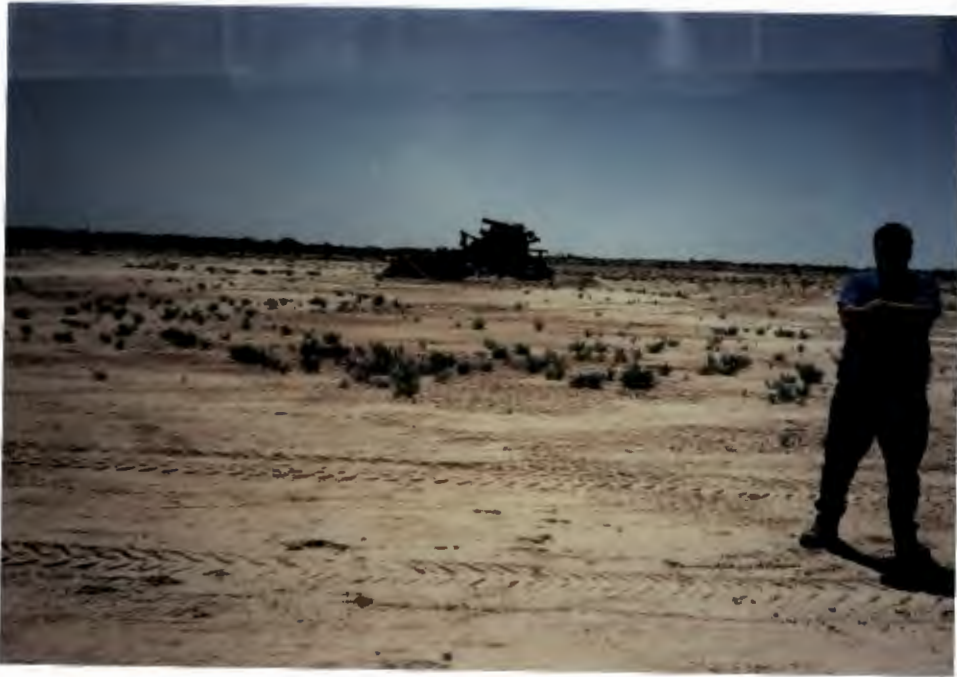
PHOTO #: 7

DESCRIPTION: PHOTO VIEW  $\approx 45^\circ$

TO LEFT #6, WEST EDGE

OF REMEDIATED TRENCH

AREAS. SCRAP PILE LOCATED

ADJ. UP-GRADE AREA.

VIOLATION: SCRAP PILE

NEEDS TO BE REMEDIATED

FROM AREA. UP-GRADE TO

PREVENT POSSIBLE SURFACE OUTFLOW

TO CLEARED UNITS

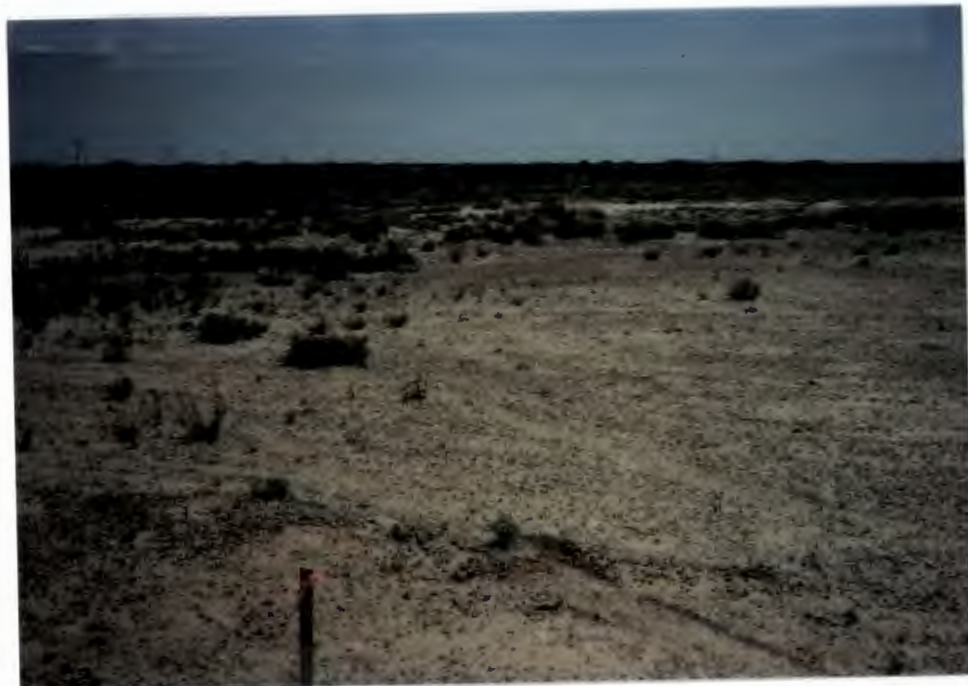
PHOTO #: 8

DESCRIPTION: PHOTO VIEW

OF FORMER <sup>(OB/OD) CS</sup> TRENCH AREA

#4 (VIEW N TO S)

VIOLATION: N/A

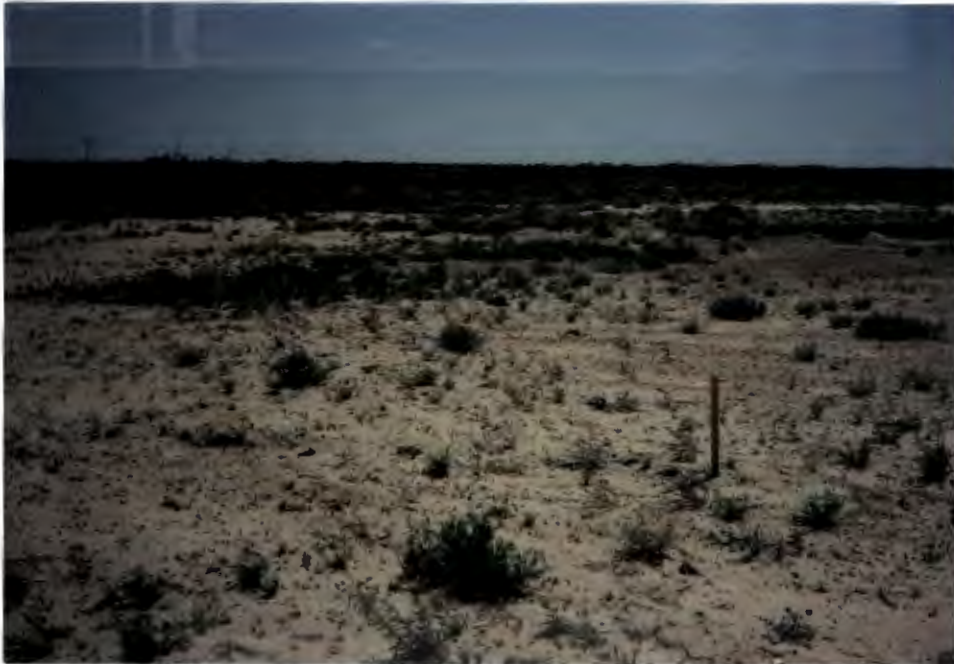
PHOTO #: 9

DESCRIPTION: FORMER TRENCH AREA #4  
W/ CLEAN FILL. LOCATED  
EAST OF TRENCH UNIT 1-3

VIOLATION: N/A

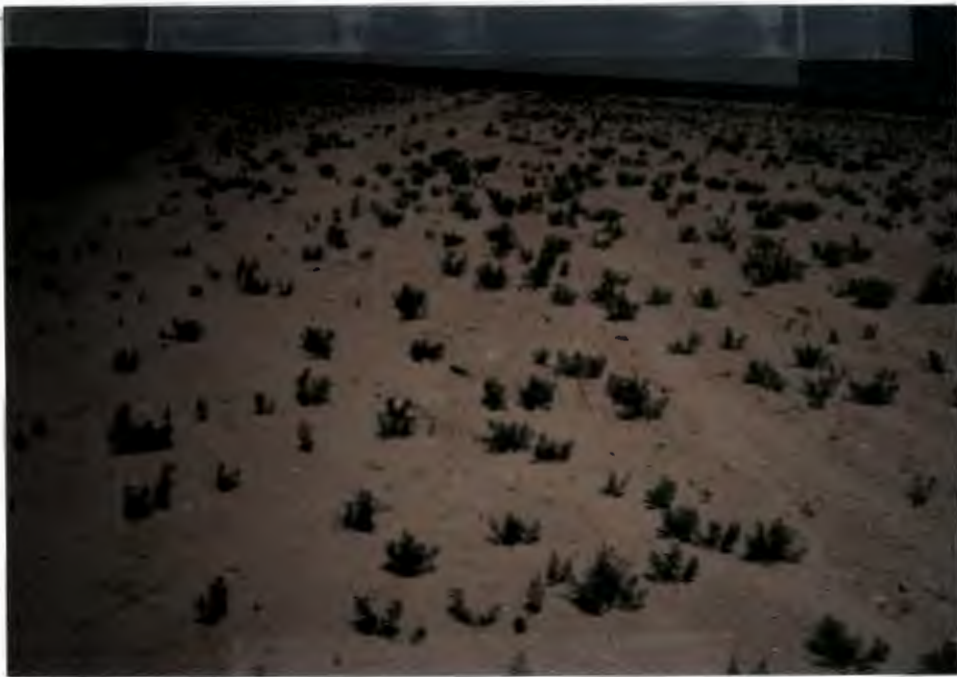
PHOTO #: 10

DESCRIPTION: VIEW OF ACCESS  
ROAD BETWEEN FORMER  
OB/OD TRENCH AREAS #1-3  
LOOKING TO EAST TOWARDS  
#4

VIOLATION: N/A

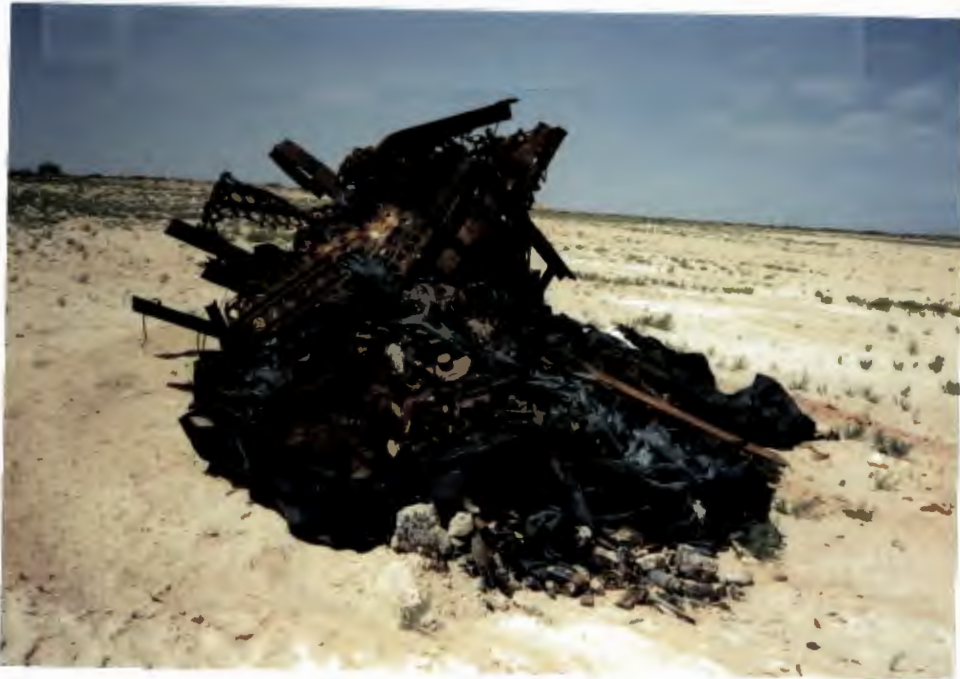
PHOTO #: 11

The inspection was conducted to verify that physical closure activities at the OB have been completed in accordance with the closure plan. Upon review of the inspection, the OB area consisted of 4 small trenches each containing 300lb. capacity which had no visible contamination. However, one area of concern was the 6X18 scrap metal remains upgradient from the four small trenches. Our recommendation was to remove the scrap metal then test for possible contamination.

LOCATION: ADJACENT UP-  
GRADIENT AREA TO FORMER  
OB/DS UNITS 1-3

DESCRIPTION: SCRAP METAL  
PILE REMOVED FROM  
TRENCH UNITS REMEDIATED  
ALREADY

Certification of physical closure is contingent upon clean-up of the scrap metal. Please see attached photos of the area.

VIOLATION: SCRAP METAL PILE TO  
BE CLEARED <sup>UP</sup> W/ PHOTO'S TO VERIFY  
ALONG W/ SDIL SAMPLES (IF PERMIT  
MGR. REQUESTS)

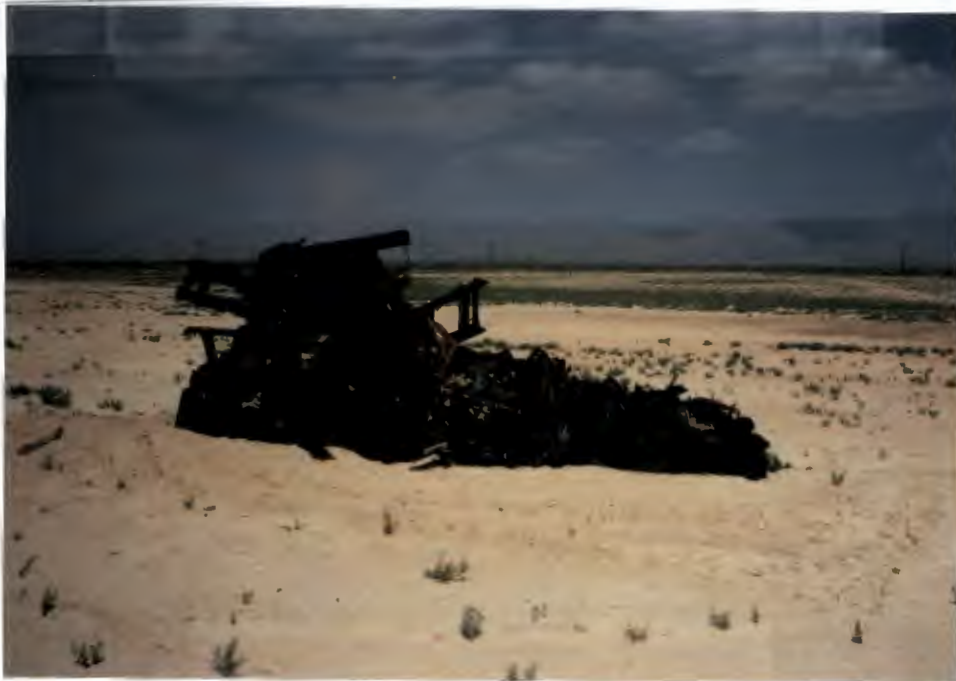
PHOTO #: 12

LOCATION: VIEW OF SCRAP METAL  
WASTE PILE LOCATED UP-  
GRADIENT OF FORMER OB/DS  
UNITS 1-3 W/ 4 IN BACKGR.

DESCRIPTION: SCRAP ~~PILE~~ PILE W/ NO  
BERM AROUND IT TO PREVENT  
RUN-OFF TO DOWN-GRADIENT  
REMEDiated OB/DS TRENCH AREAS

VIOLATION: SCRAP PILE TO  
RECYCLER OR SCRAPYD. OR  
BUT A SUFFICIENT BERM AROUND IT  
FOR RUN-OFF CONTROL.

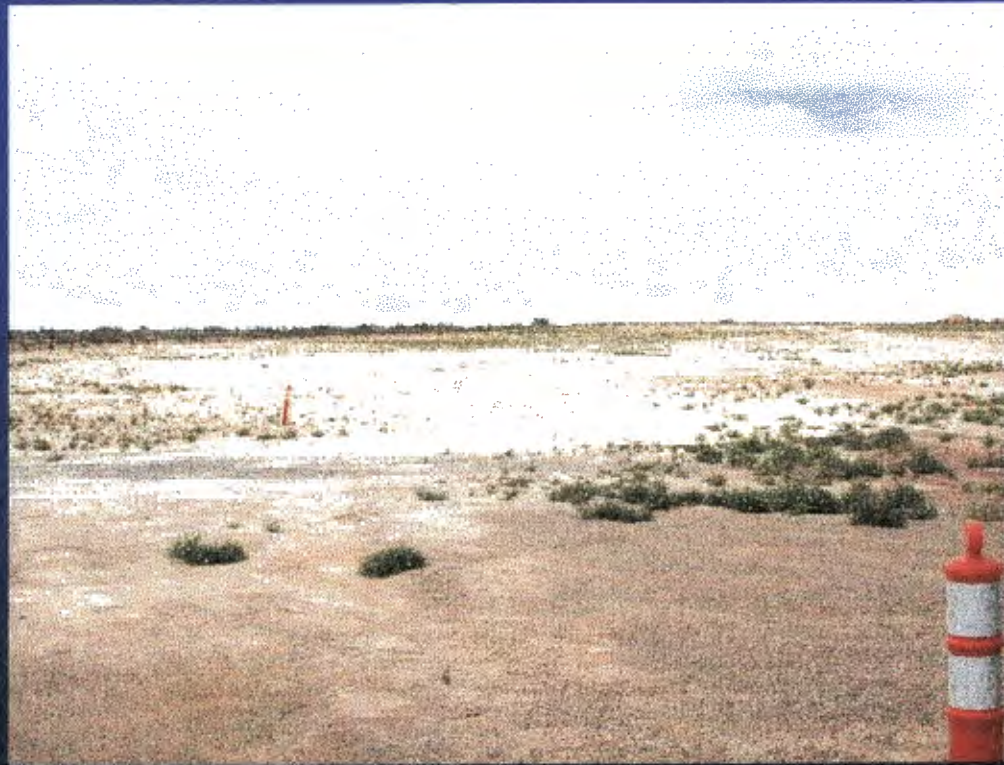
# 300 lb OBU - 14 May 99

View of area looking Northwest from the thermal decontamination unit

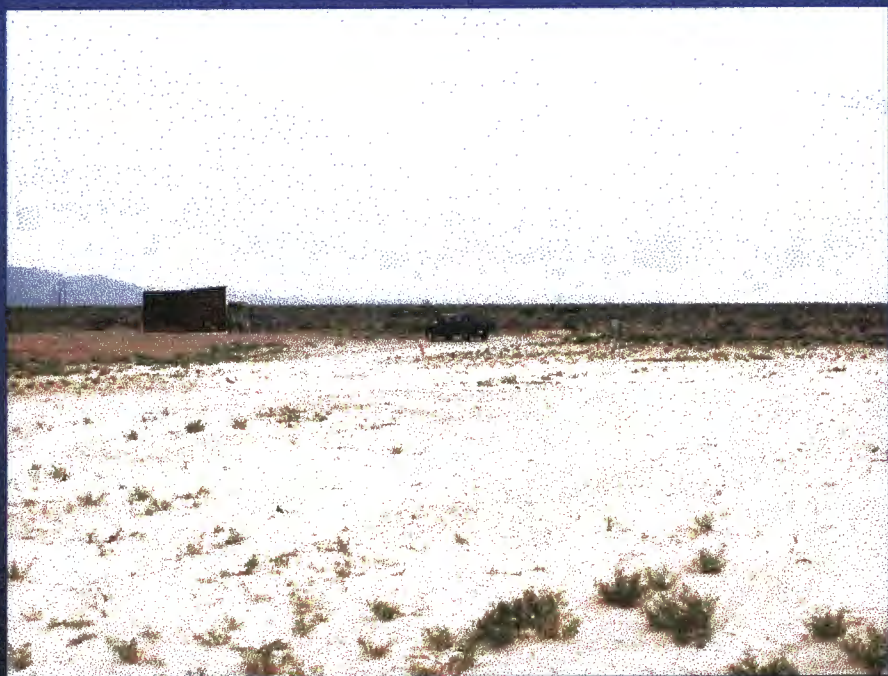
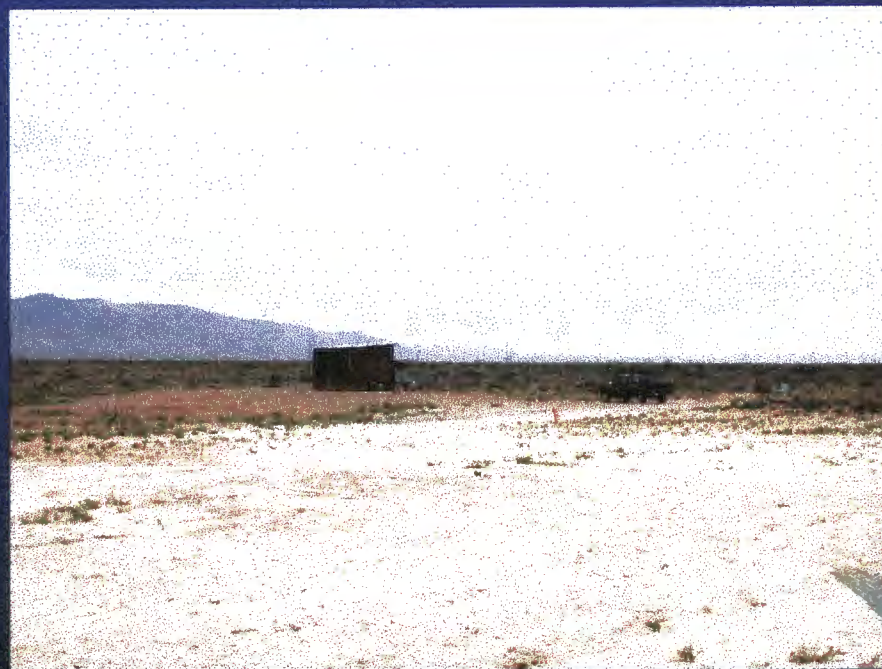
# 300 lb OBU - 14 May 99

View of area looking Southeast towards thermal decontamination unit
