MEMORANDUM TO FILE

DATE: January 28, 1993

SUBJECT: **Summary and Review of Investigations at KAFB-Battery Shop
French Drain**

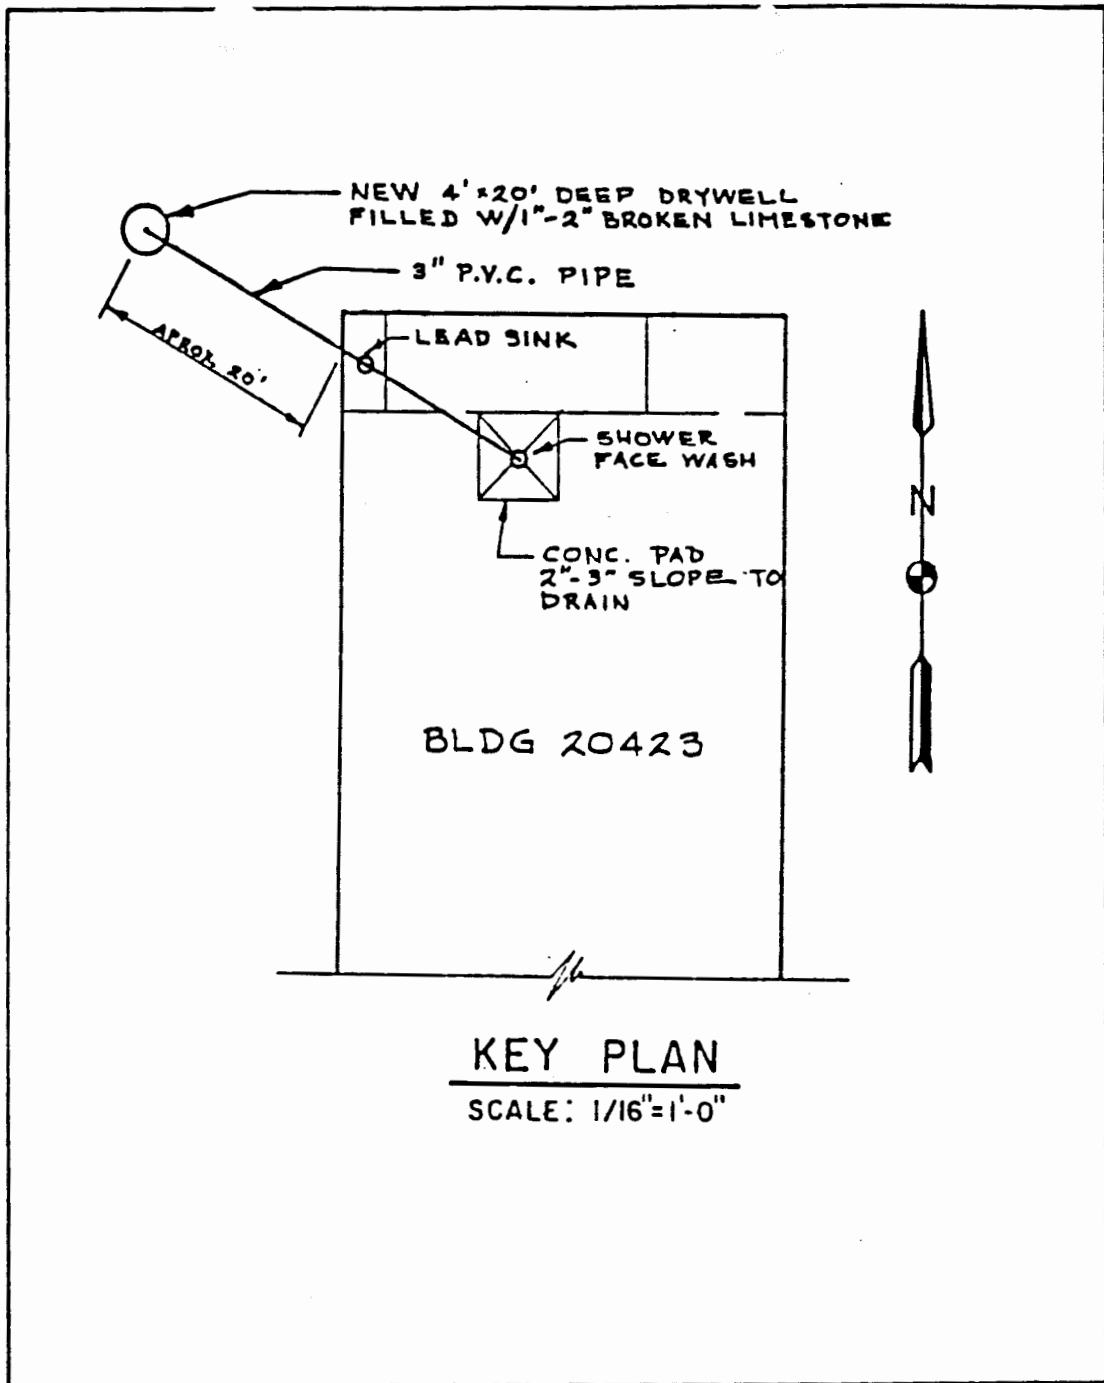
FIGURE 1
DETAIL LOCATION OF FRENCH DRAIN (DRY WELL)

The Waste Management Unit has a FD located approximately 30' northwest of Bldg. 20423, a Battery Shop (Fig. 1). The FD was constructed to receive wastewater, battery acid, and wash water from vehicle maintenance operations conducted in Bldg. 20423.

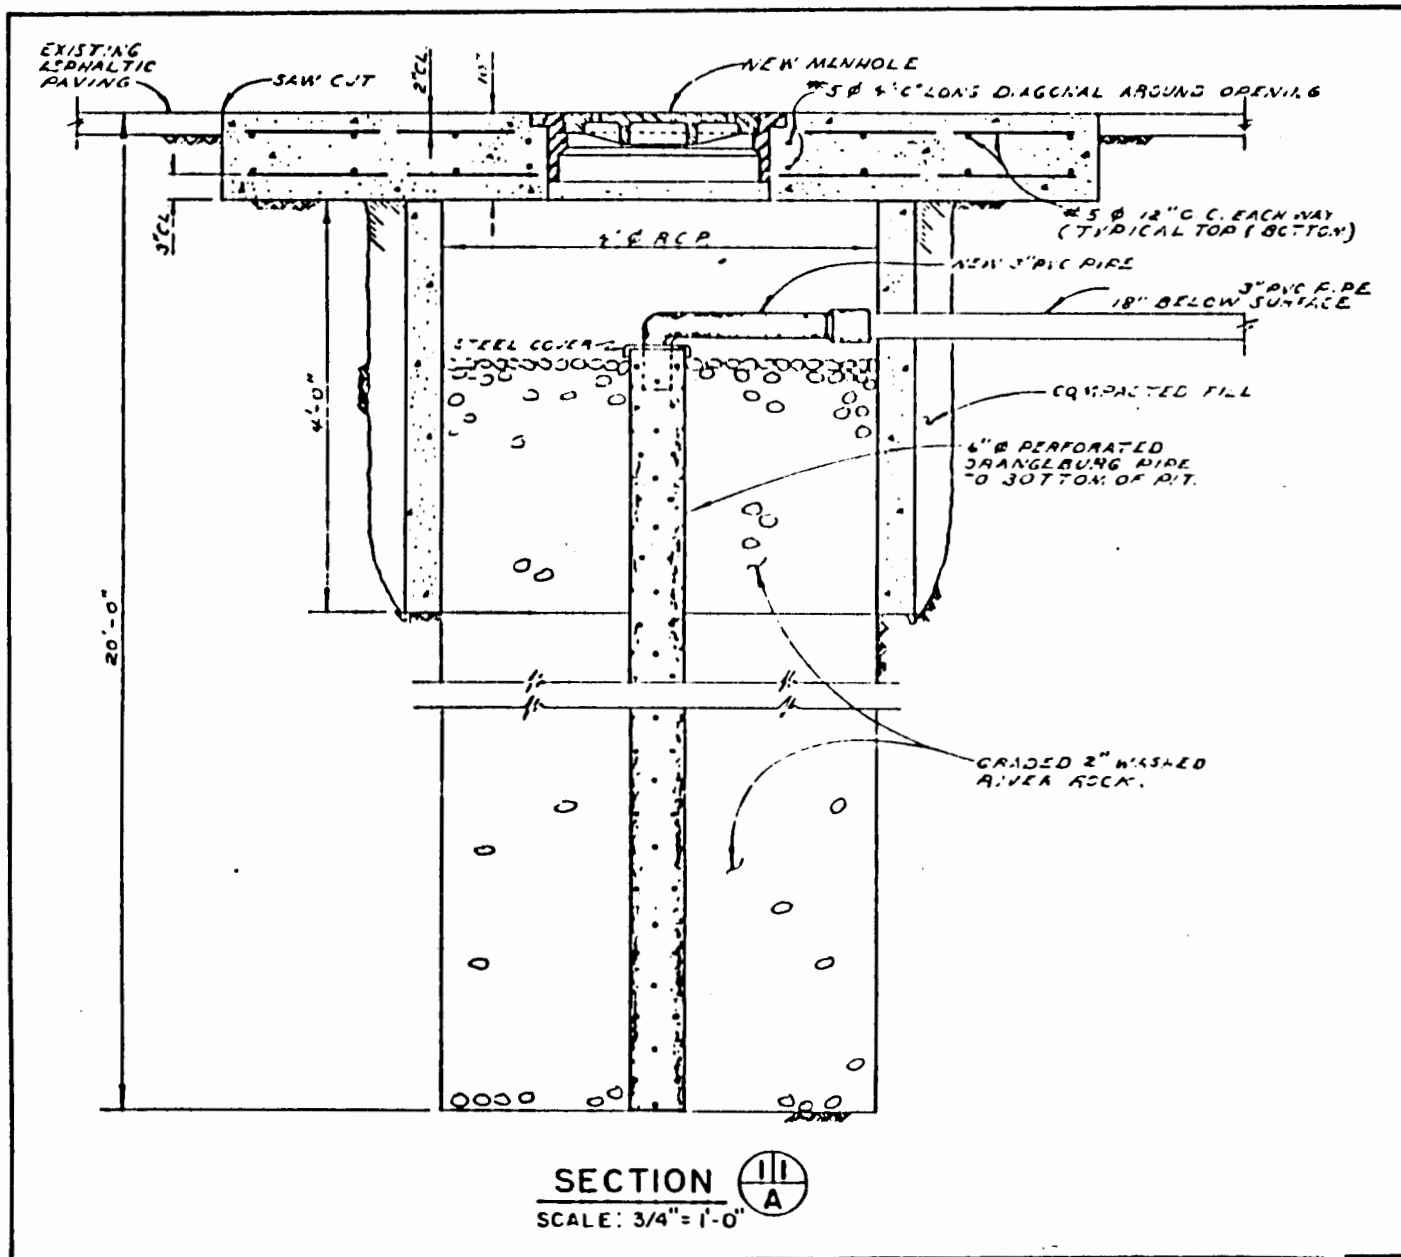
CROSS-SECTION OF FRENCH DRAIN

The FD was built in 1977. The FD was constructed of precast concrete pipe (4' diameter X 4' length) set vertically in the ground at 10" below surface (Fig. 2). Wastewater flowed to the FD through two 3" PVC pipes buried 18" below surface. The original excavation (4' diameter) extended to 20' underground and was filled with gravel and limestone (LS) chips to neutralize acid. Discharges to the FD ceased in June, 1988. The FD was subsequently closed by filling and capping with concrete (date unknown).

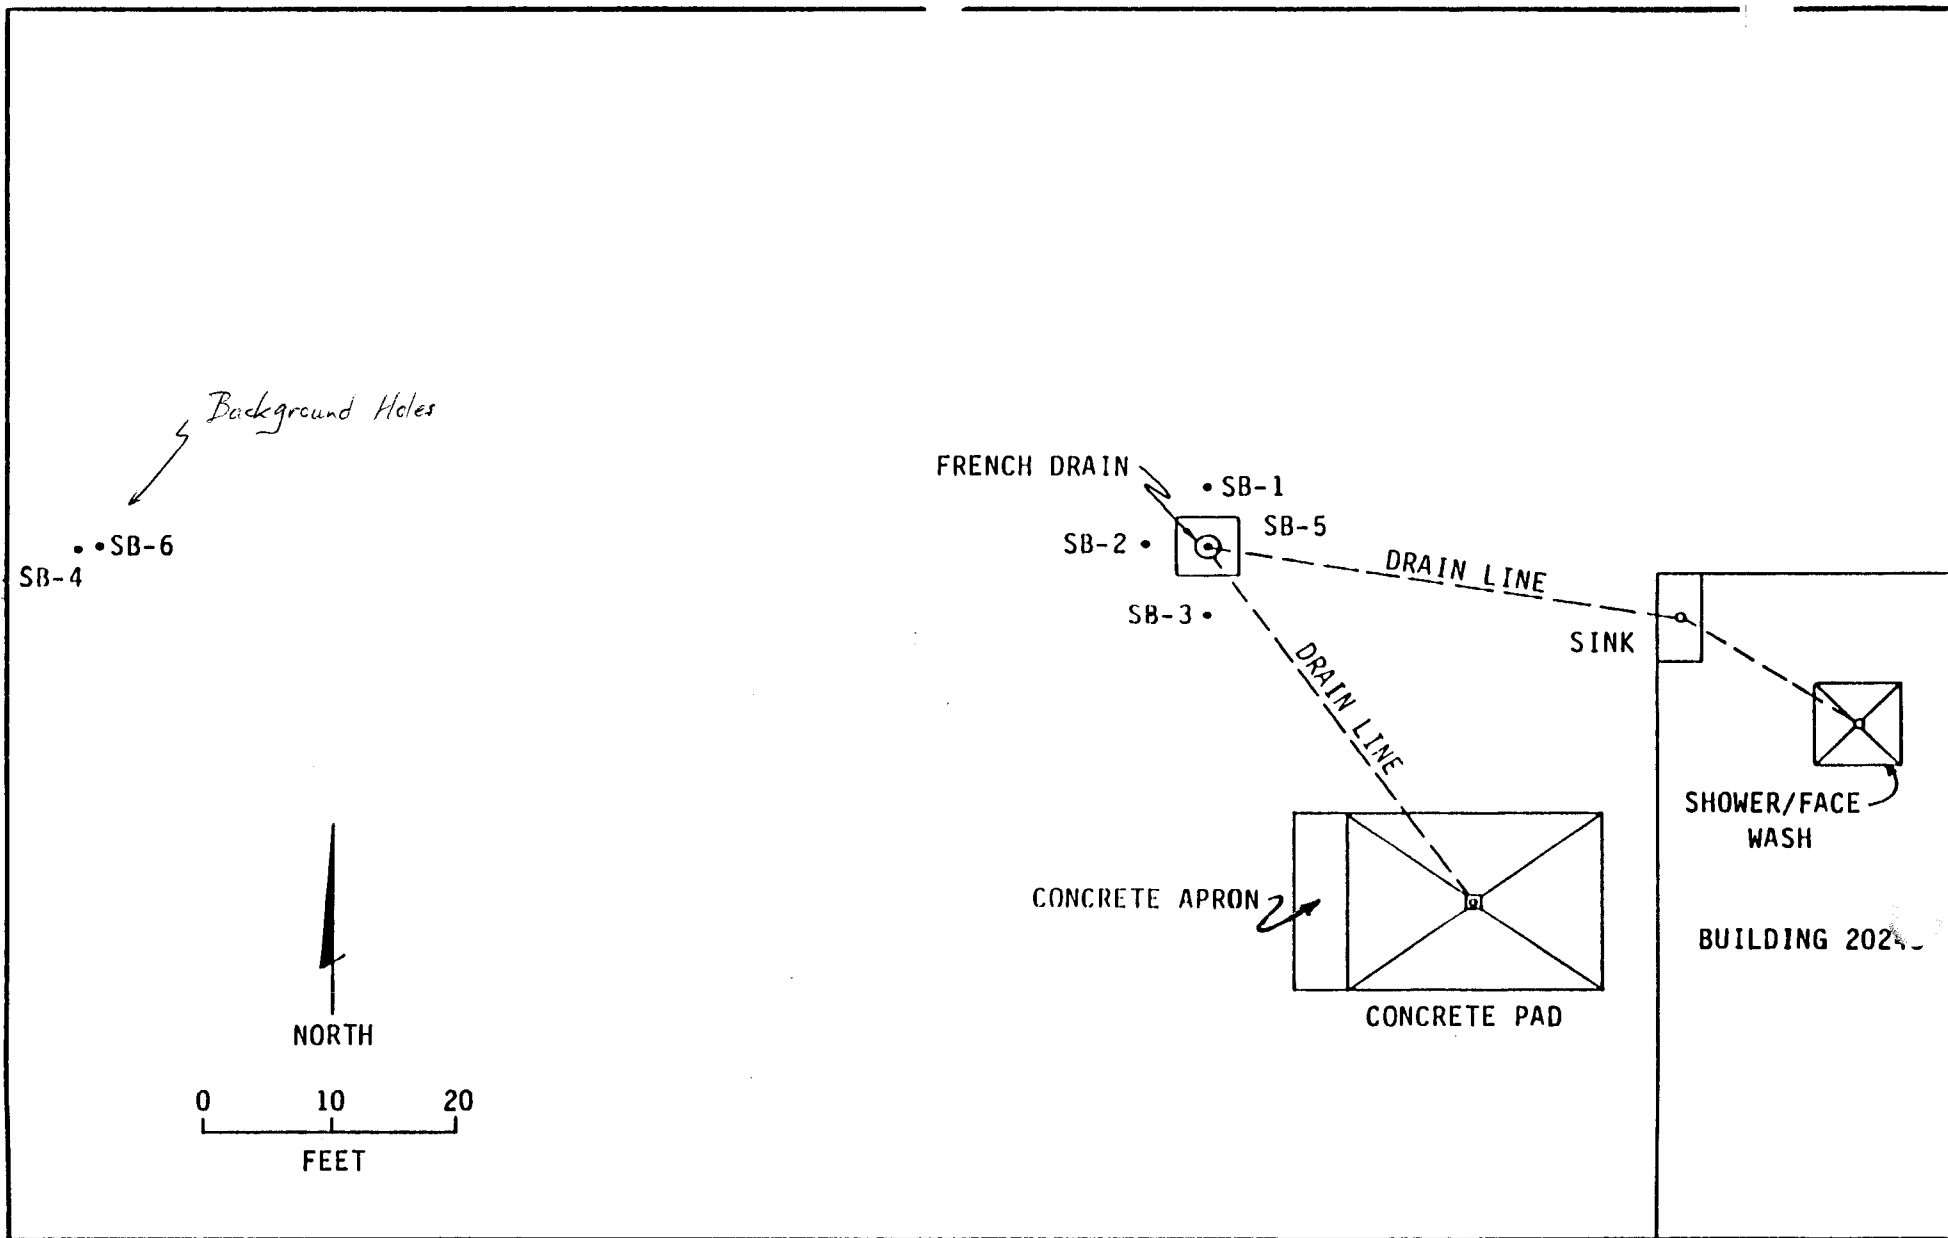
BOREHOLE LOCATION MAP
(MARCH, 1989 PROGRAM)

Program was designed to determine lateral and vertical extent, plus magnitude, of any hazardous constituent(s). Six boreholes were drilled and sampled to a depth of 50' (see Fig. 3 for borehole locations). Samples were collected using a hollow-stem auger rig with a continuous-core sampling device (5' length). Samples were analyzed accordingly for EP Toxicity levels of Pb, for pH, and for chlorinated and aromatic solvents.

Pb (**36.6 mg/kg**) was detected in the FD hole (**SB-5**) at a depth of 30'. Pb values of 3.2 mg/kg or less occurred in other sampling intervals and holes. VOC's (**Methods 8010 & 8020**) detected included measurable amounts of toluene, xylene, methylene chloride (**MeCl**), chloroform, ethylbenzene, and 1,2-trans dichloroethane.

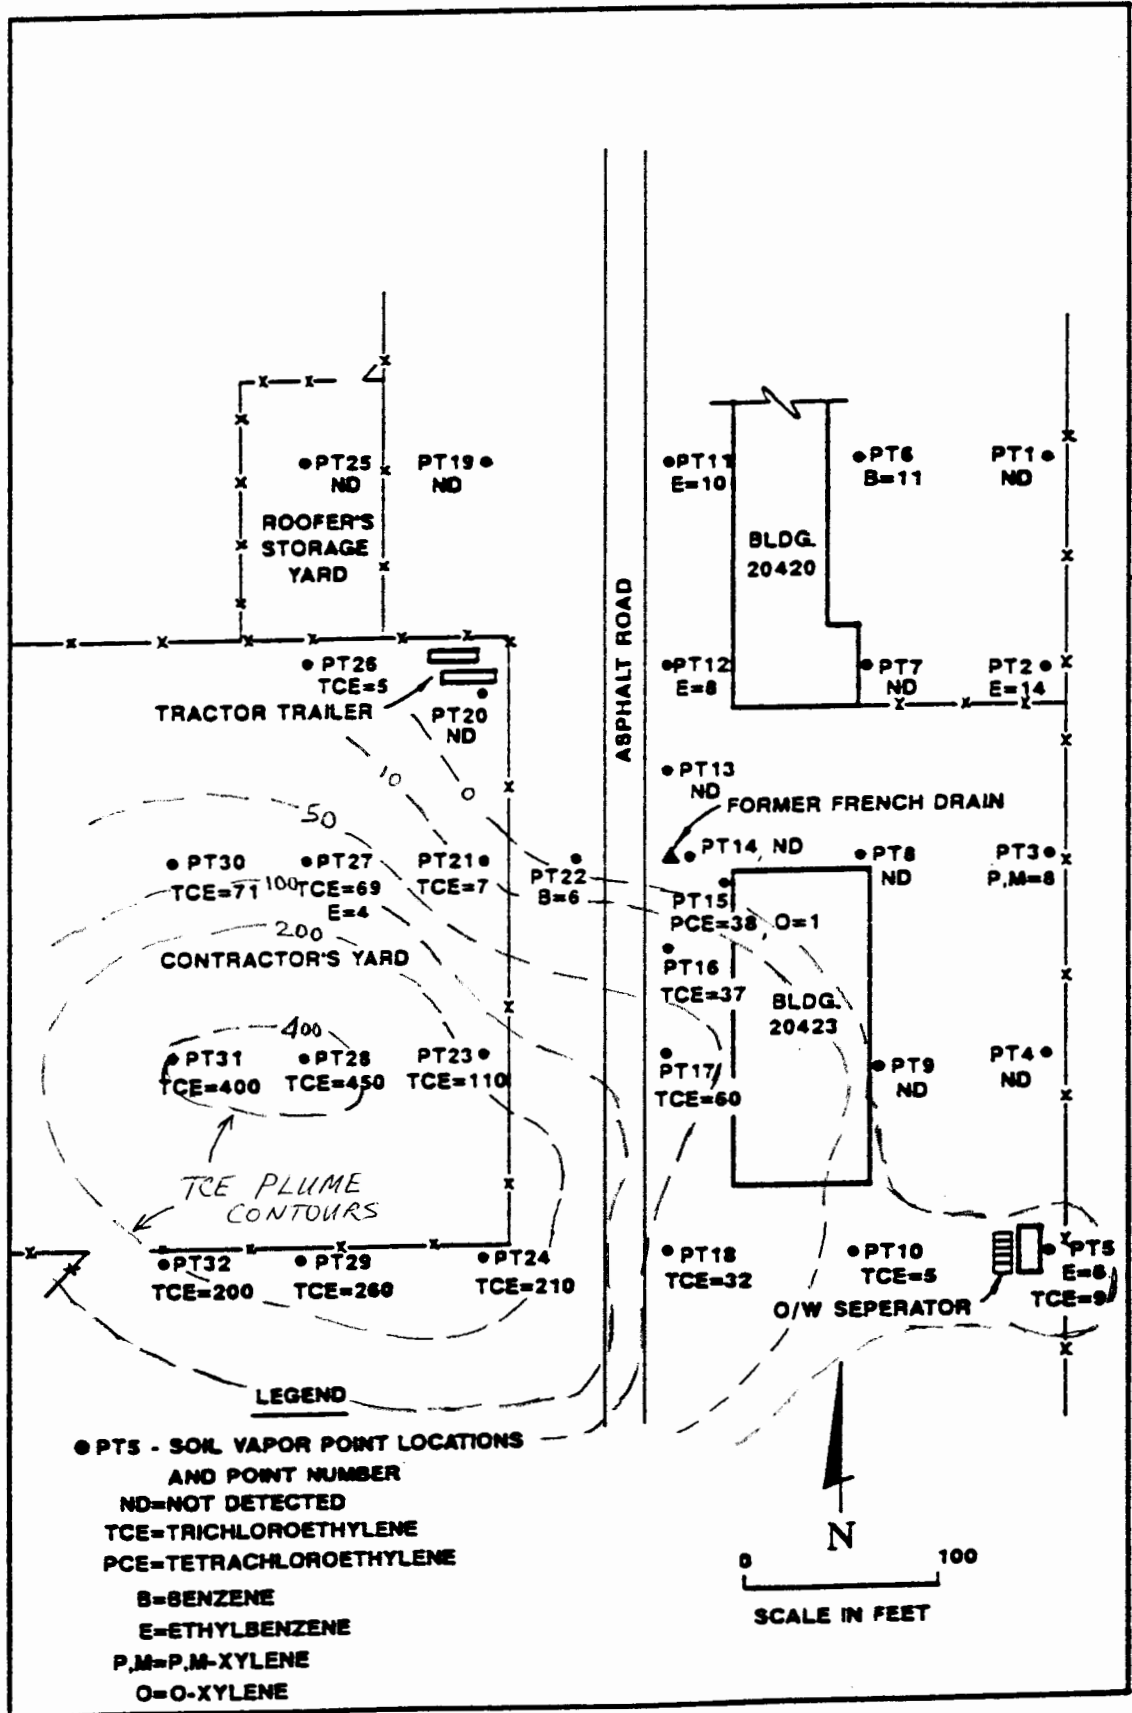
FIGURE 4

Survey points were placed on a 100' X 100' grid centered on the FD. Samples were taken from a 5' depth using a probe and portable gas chromatograph. There were 32 sample stations. Survey results are shown in Fig. 4. TCE occurs in 15 of 32 samples and is apparently sourced in the Contractor's Yard west of Bldg. 20423. Analysis also indicated 38 ppb of PCE and 1 ppb of O-Xylene near the PVC pipes that led to the FD. Ethylbenzene was detected in 5 of 32 samples, located at 100' to 300' to the west, north, northeast, and southeast of the FD (Fig. 4). Benzene and P,M Xylene were also detected in some samples of the survey.

2. During H+GCL's soil-vapor survey, there was an apparent "halo" of ethylbenzene (5 of 32 samples) within 100' to 300' of the FD. The last program of soil boring and analysis may not have tested for this possible contamination.

3. During H+GCL's soil-vapor survey, PCE and O-Xylene were detected near the former pipes (removed) leading from Bldg. 20423 to the FD. Subsequent borehole drilling and analysis may not have addressed this possible contamination.

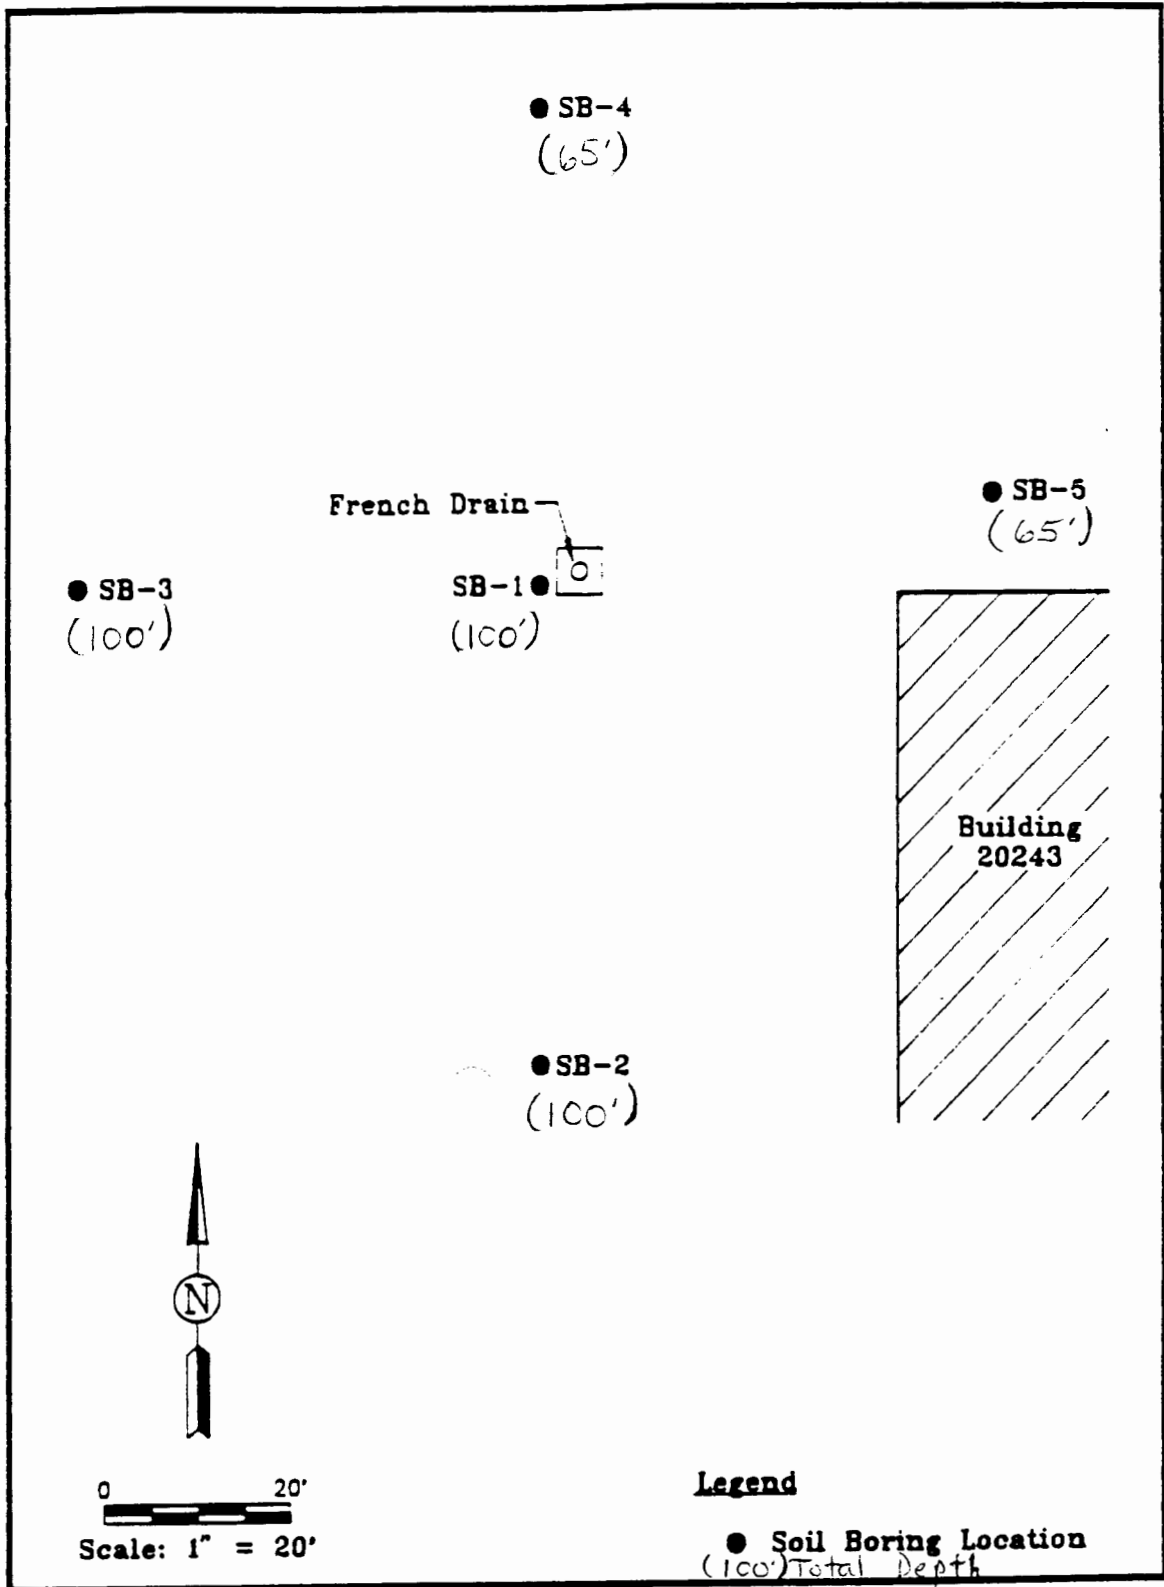
FIGURE 5

Program was designed to determine horizontal and vertical extent of soil contamination at the battery shop. Five boreholes were drilled and sampled to depths ranging from 65' to 100' below surface (see Fig. 5 for borehole locations and depths). Soil samples were obtained using split spoon sampling (2' length) at 10' intervals in advance of auger

Pb values in analyzed samples (not all samples were analyzed) varied from less than 5 ppm to 11 ppm (mg/kg). H+GCL concluded that these values were well below interim action level of 200 ppm level for total Pb stipulated by NMED and Superfund.

MeCl was the only VOC detected and it was found in 2 samples (Table 1). H+GCL concluded that these detectable levels of MeCl were probably due to laboratory contamination.

4. Detectable MeCl occurred in two samples from hole SB-4 in the last drilling program. H+GCL assumed laboratory contamination, but there was no support for this contention (**analytical reports for those samples are not included in NMED's copy of H+GCL's last report**).
