DEPARTMENT OF THE AIR FORCE
HEADQUARTERS 377TH AIR BASE WING (AFMC)

In our 7 February 1994 letter to you, we identified three sites which are areas of concern as potential SWMUs. As a follow-up, we are enclosing the SWMU assessment reports, which include lab reports and maps, on the deionizing unit leach field at Building 1026, drain pit serving the test cell in Building 756, and a buried 55-gallon drum near Building 768.

DEIONIZING UNIT LEACH FIELD

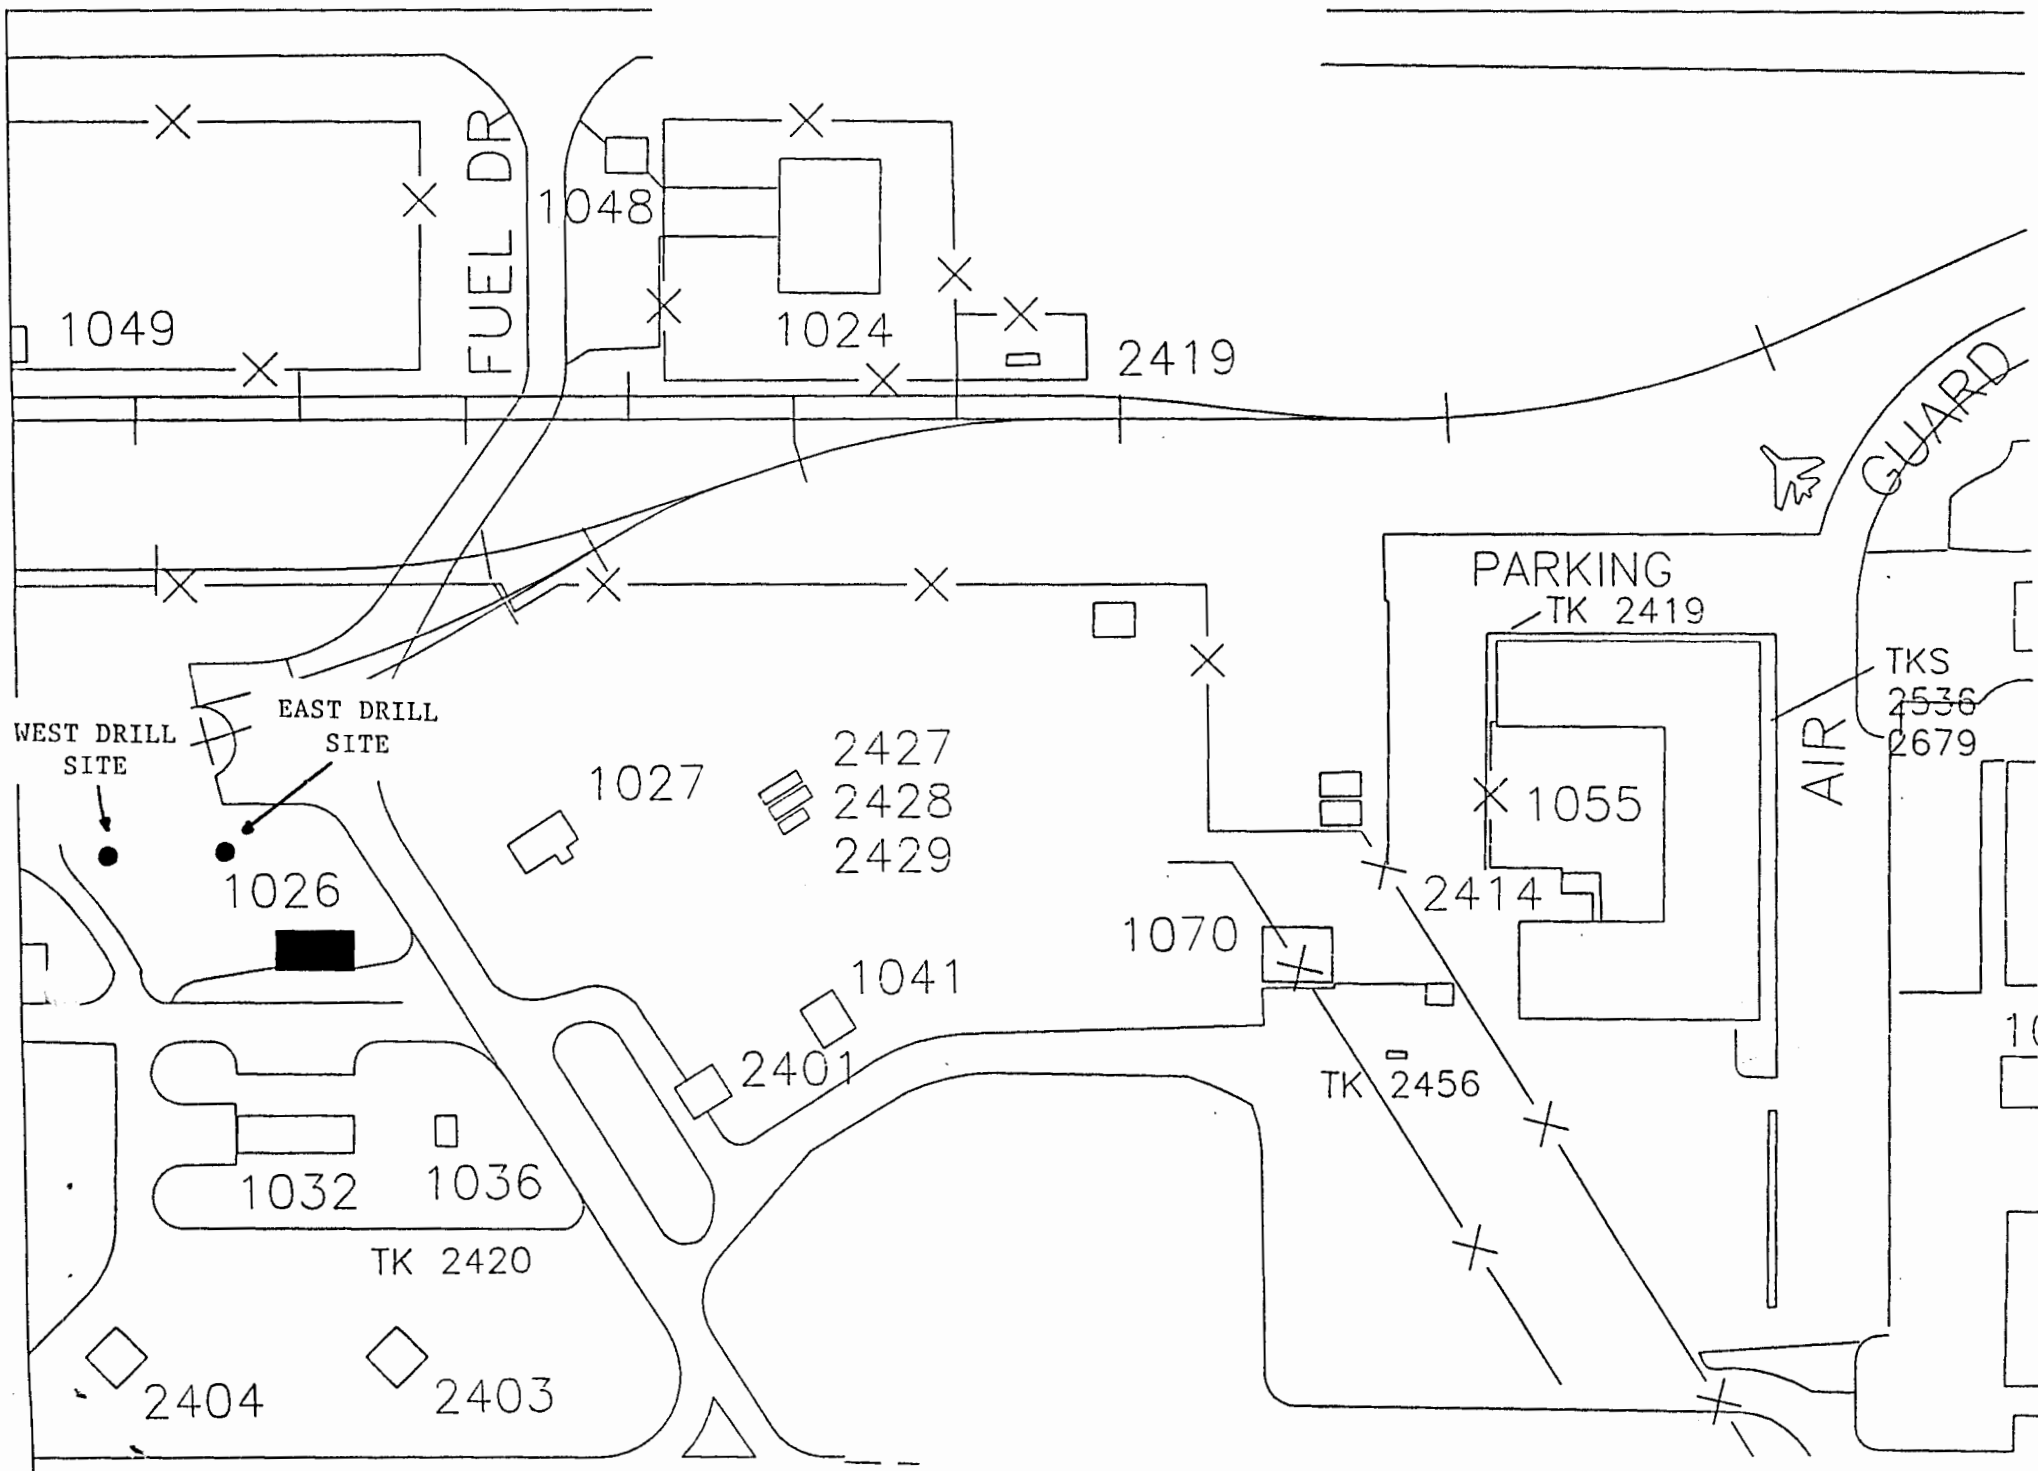
BUILDING #1026 AREA

There are no drawings available which show how the leach field is constructed or showing the discharge line into the field. It is believed that an engineered leach field was not constructed and, instead, a discharge line was installed to dispose of the waste directly into the subsurface. At times when the discharge was taking place, it would manifest itself at a low spot about 50 feet northwest of Building 1026.

In conjunction with this investigation, two boreholes were drilled with samples taken from the 5-foot, 10-foot, and 20-foot depths, respectively. The borehole locations were selected based on where the discharged waste manifested itself and where it accumulated at the site. Boring 1, designated the East Drill Site, is located about 50 feet northwest of Building 1026; Boring 2, designated the West Drill Site, is located about 75 feet west of Boring 1.

After reviewing the data for the deionizing unit leach field at Building 1026, we feel this area is not a hazard; therefore, we believe it should not be identified as a SWMU.
