**From:** Kieling, John, NMENV  
**Sent:** Friday, July 13, 2018 3:43 PM  
**To:** Allen, Pam, NMENV  
**Cc:** Cobrain, Dave, NMENV  
**Subject:** FW: Pressure Washer Release 12 Jun 18 Notification  
**Attachments:** Pressure Washer Spill\_12JUL18.pdf

**From:** KOTTKAMP, SHEEN T GS-12 USAF AFCEC AFCEC/CZOW [mailto:sheen.kottkamp.1@us.af.mil]  
**Sent:** Friday, July 13, 2018 2:20 PM  
**To:** Hunter, Michelle, NMENV <Michelle.Hunter@state.nm.us>; McQuillan, Dennis, NMENV <dennis.mcquillan@state.nm.us>; Yurdin, Bruce, NMENV <Bruce.Yurdin@state.nm.us>; Kieling, John, NMENV <john.kieling@state.nm.us>  
**Cc:** LYNNEs, KATHRYN D HQE USAF AFGSC 377 MSG/SAF/IEE <kathryn.lynnes@us.af.mil>; CLARK, SCOTT C GS-13 USAF AFCEC/CZO <scott.clark@us.af.mil>; Behnaum.Moayyad@usace.army.mil  
**Subject:** Pressure Washer Release 12 Jun 18 Notification

**Written Notification of Release pursuant to 20.6.2.1203.A NMAC:** Water with some residual diesel fuel leaked from pressure washer during drilling equipment cleaning at the Truman Laydown Yard.

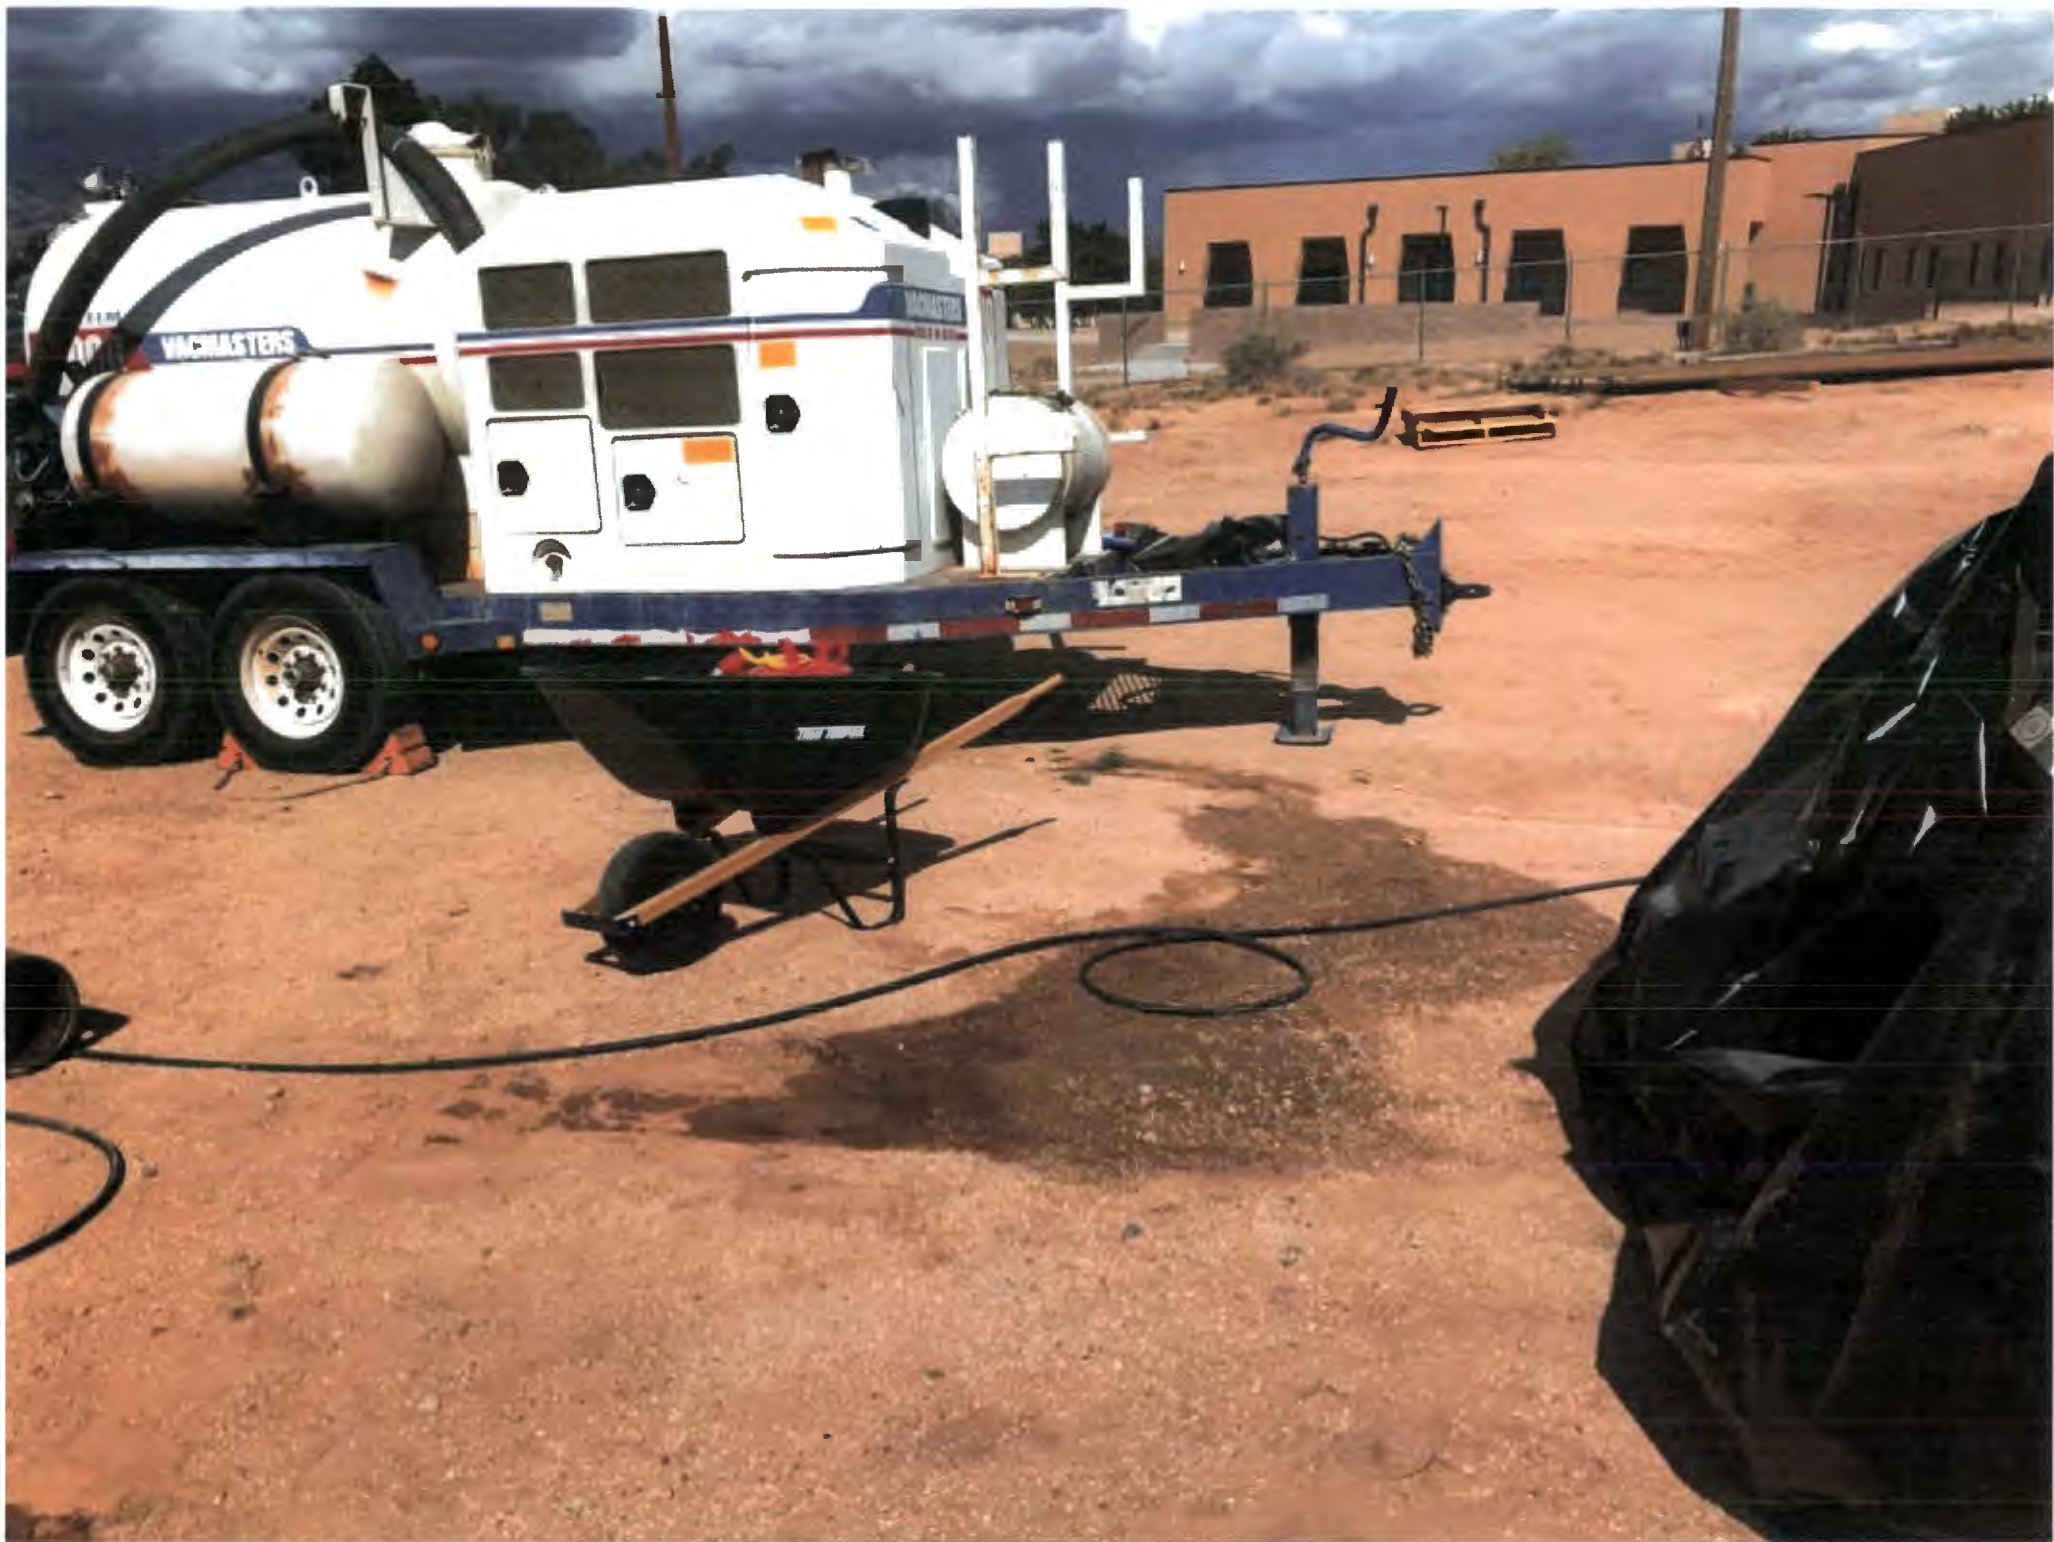
**(d) Source and Cause of Discharge:** Water tank on pressure washer leaked and the leaked water picked up residual diesel fuel in the equipment drip pan under the fuel tank, then flowed out to ground surface

**(e) Description of Discharge:** Water with some residual diesel ran onto the soil surface near the pressure washer.

**(f) Estimated Volume:** 20-30 gallons (water and residual diesel); area irregular but approximately 4 ft in width by 15 ft in length (see photograph)

- Pressure washer moved to new secondary containment
- Water tank drained and clean water placed in on-site roll off. Water leak stopped
- Diesel and gasoline tanks were inspected and NO leaks were discovered
- Excavated by hand 1 full 55-gallon drum and @1-yd of soil that was placed in their drilling hopper. Hopper was covered with visqueen and secured to prevent rain intrusion.
- Excavation at the source (pressure washer) to @14" bgs indicating water may have begun as slow leak that had been occurring for some time in vicinity of pressure washer.
- Excavation of soil occurred until no visual sign of wet soil and/or odor was present
- Excavation area marked with rocks in case rains wash out excavated boundaries before sampling 13JUL18.

**Planned actions for 13JUL18:** Three (3) confirmation samples will be collected from the excavated area to confirm no contaminants released to surrounding soil media. Soil samples will be analyzed for EPA Methods 8260, 8270, and 8015 (GRO/DRO/RRO). Requesting seven (7) day turn-around-time. Excavated soil disposal pending receipt of laboratory analyses.
