SUBJECT: Site Investigation Report of the Organ Mountain Meteorological Station **SWmu 81**

**ORGAN MOUNTAIN METEOROLOGICAL STATION (FTBL-081)
SITE INVESTIGATION REPORT**

FORT BLISS, NEW MEXICO

September 2000

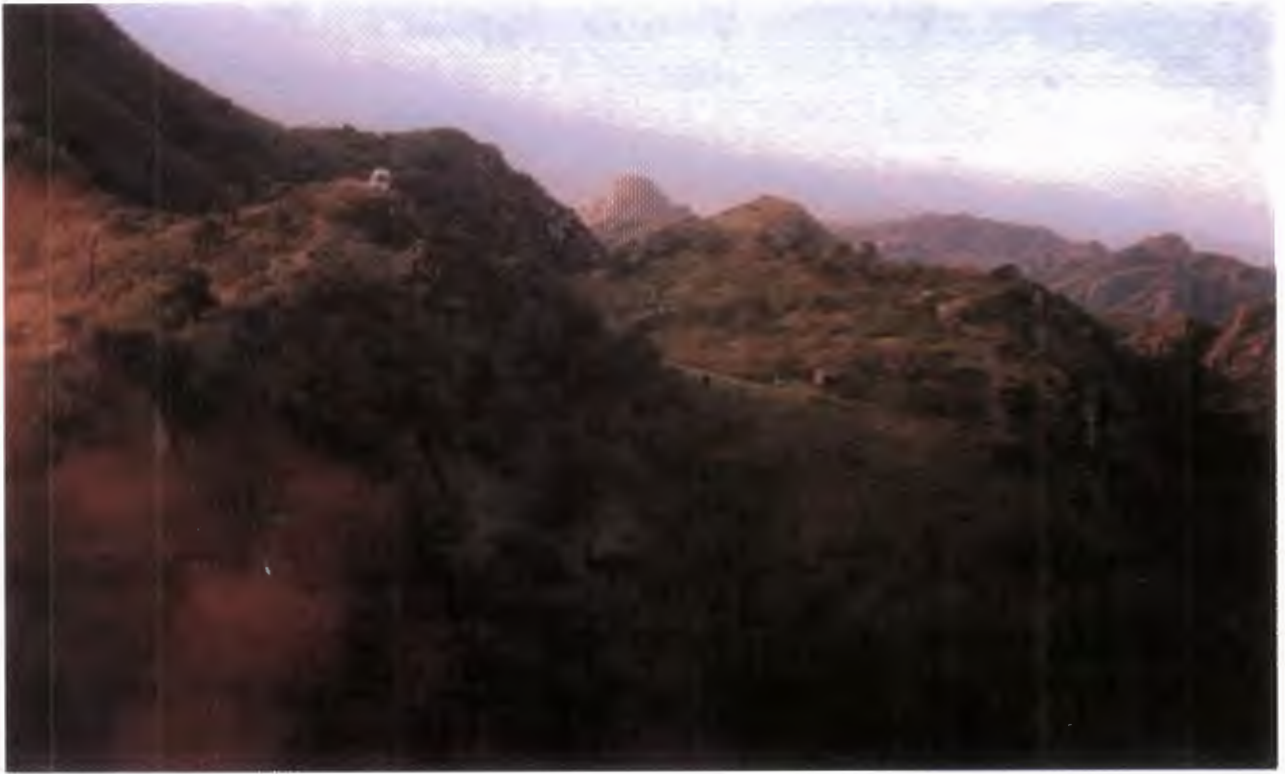
Overview of Organ Mountain Meteorological Station

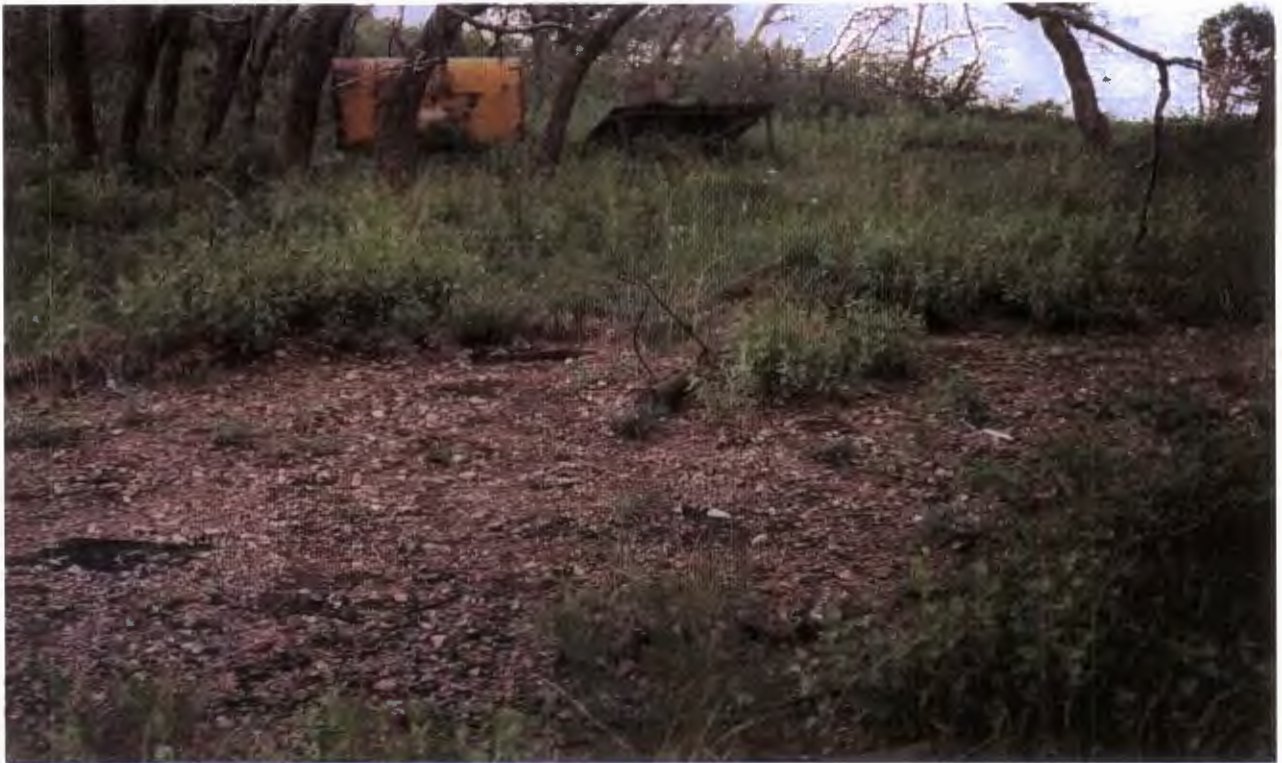
- One surface soil sample (OM-1) was collected in the apparent burn area down slope of the fuel storage tank. Debris including nails, electrical-related items (wires), bolts, spark plugs, and charred wood were observed in the burn area. The apparent burn area was measured to be approximately 6' x 12' in size.

Fuel Storage Tank in Background, Apparent Burn Area in Foreground

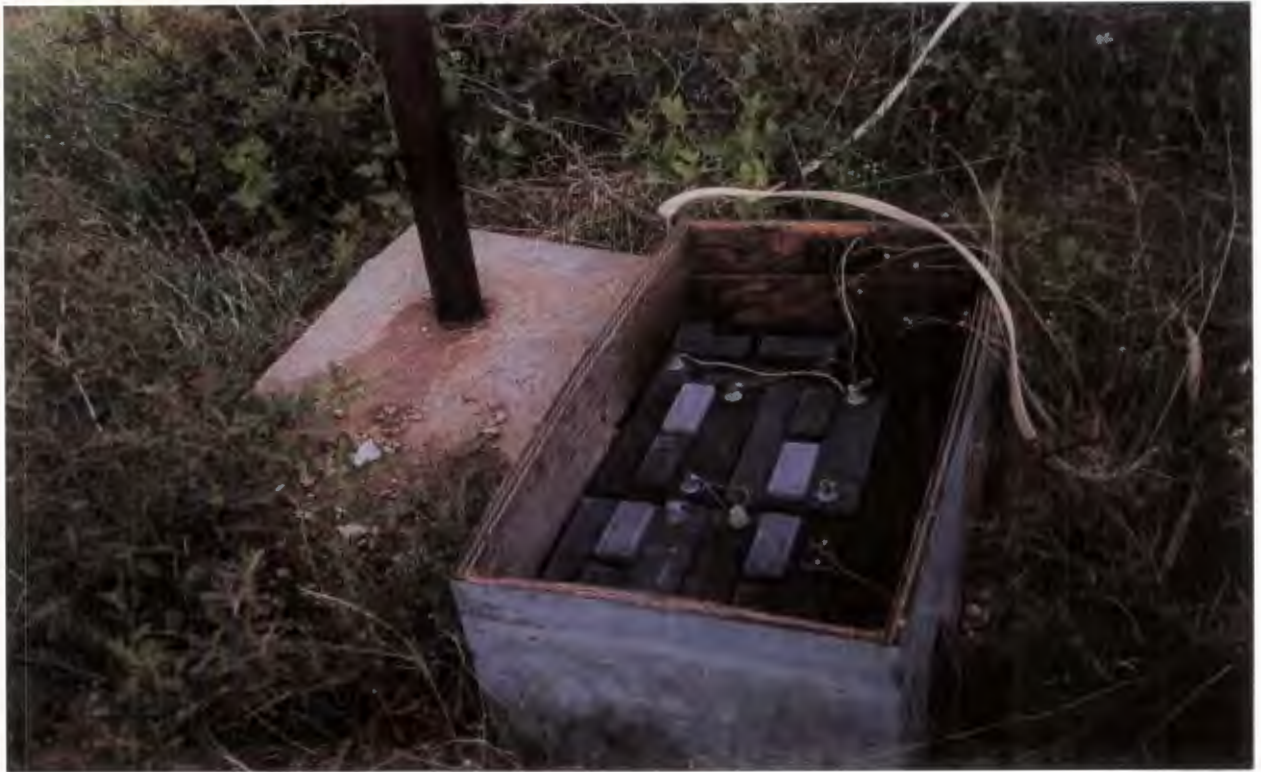
- One surface soil sample (OM-5) was collected adjacent to the battery box where the potential location of the meteorological recording equipment was located.

- Lead was reported in one sample above the Residential Soil Screening Level established by the EPA. This location is near the area where batteries were apparently stored for supplying power to the meteorological equipment. The lead result is below the Industrial Soil Screening Level established by the EPA. Given the limited and non-residential use of the Station and surrounding area and the remoteness of the Station, the Industrial Screening Level appears appropriate for evaluating the soil conditions with respect to this constituent.

Battery Box Near the Wind Vane

- a. Remove the batteries and other loose military debris and hardware from the site.
 - b. Excavate and remove up to 8 cubic feet of soil generally 8 inched under and three feet square around the box that contained the lead acid batteries.

- c. Take confirmatory soil samples of the undisturbed soil after the excavation is complete.
 - d. If, as we suspect, the confirmation results are near or below the Residential Soil Screening levels we will prepare a petition for No Further Action Required under NMED Criterion #5. This petition will of course, contain the required ecological risk screening per your guidelines.

- Considering removing the batteries, and a potential continuing source of lead, from the Station. Additional sampling around the battery box may be prudent to demonstrate that the presence of elevated lead is limited.
- Conduct an ecological risk screening using the results of the Site Investigation since the higher elevations within the Organ Mountains are known to be habitat for several species of raptors and other animals.

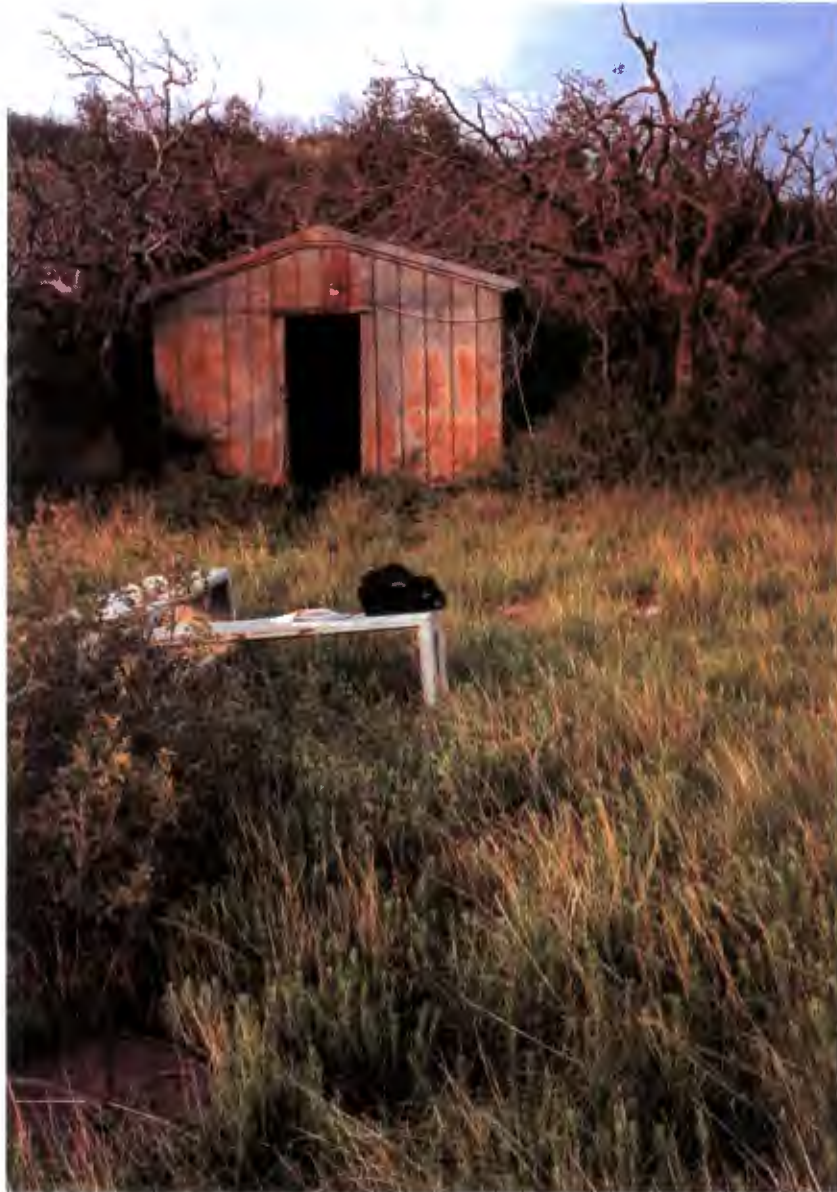
- One surface soil sample (OM-2) was collected inside of the metal shack where evidence of former burning was noticed and where materials storage most likely occurred. The empty metal shed was measured to be approximately 12' x 12' in size, and was constructed with an earthen floor.

One PCB constituent, Arochlor-1260, was reported in sample OM-2 at a concentration of 0.16 mg/kg. The EPA has not established a Soil Screening Level for this Arochlor isomer, but the EPA has established Soil Screening Levels for two other Arochlor isomers (1016 and 1254). The lowest available EPA Soil Screening Level is for Arochlor-1254 at a concentration of 0.97 mg/kg. Thus, the concentration of Arochlor-1260 reported in sample OM-2 is believed to be protective of human health. Pesticides were not reported in any of the soil samples.

Storage Shack and empty storage racks.
