PHOTOS FROM EPA INSPECTION AUGUST 2014
(EPA INSPECTION REPORT NOT FINALIZED
FOR INFORMATION PURPOSES ONLY)

UNITED STATES ENVIRONMENTAL PROTECTION AGENCY

Photograph Log

Location: Western Refining - Gallup Refinery, 92 Giant Crossing Road		
City: Gallup	County: McKinley County	State: New Mexico

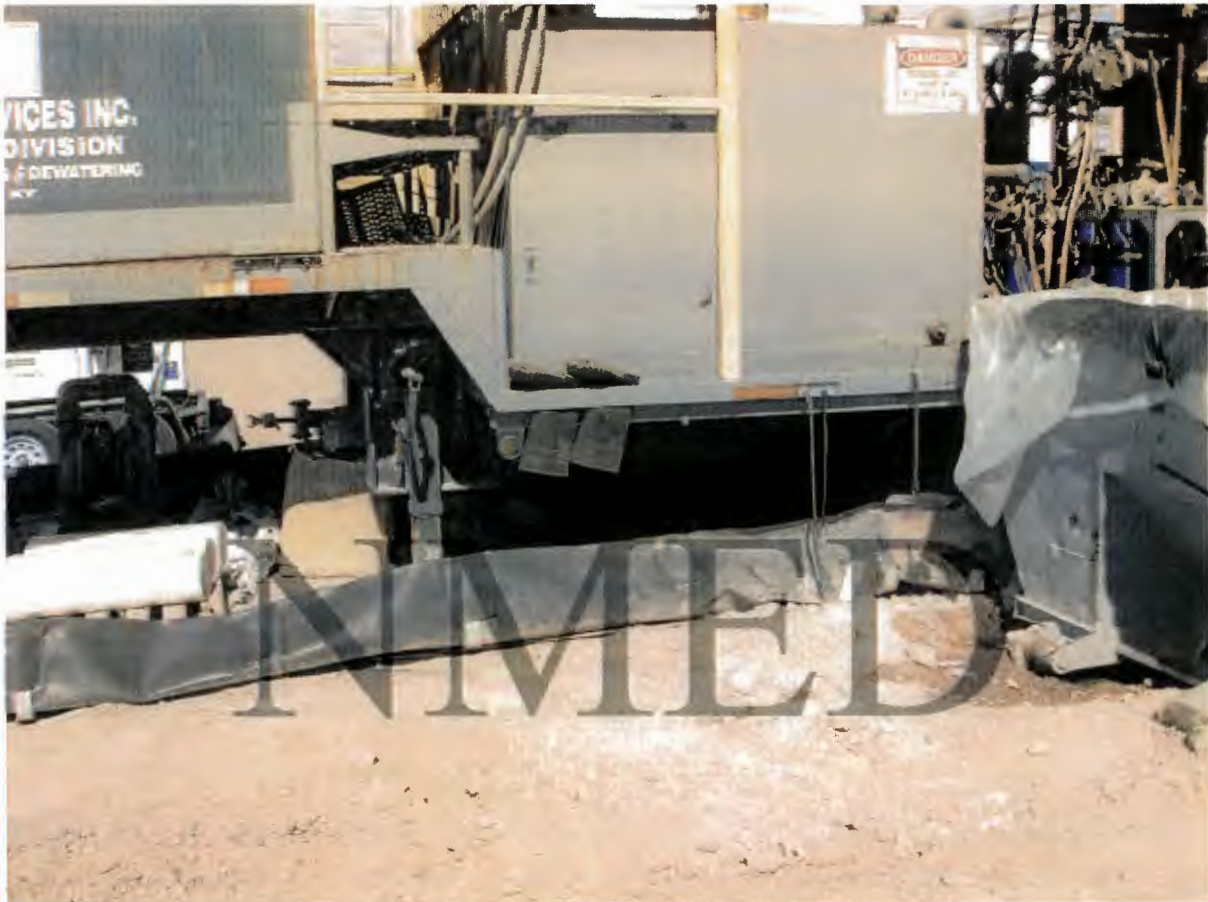
Photo No. 9

Description: WWTP Filter-Cake Press' roll-off box sitting outside of secondary containment. Noted some spillage on the ground, under and next to the roll-off box.

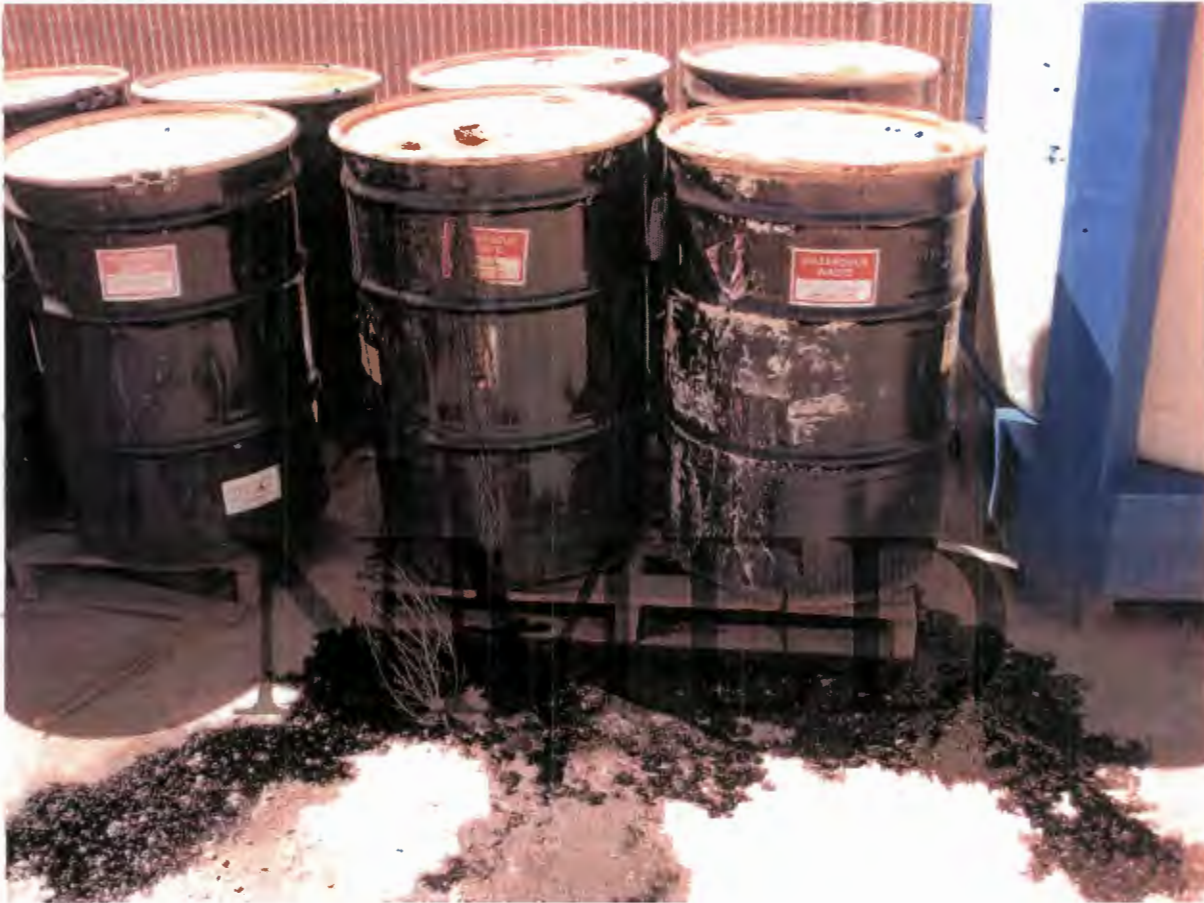
Photo No. 21

Description: 90-Day hazardous waste storage yard with leaking drum, labeled as "Hazardous Waste, Accumulation Start Date: 07-11-14, Contents: Iron Chelate". Other drums exceeded the 90 day storage limit (see Charles Barnes inspection photos).

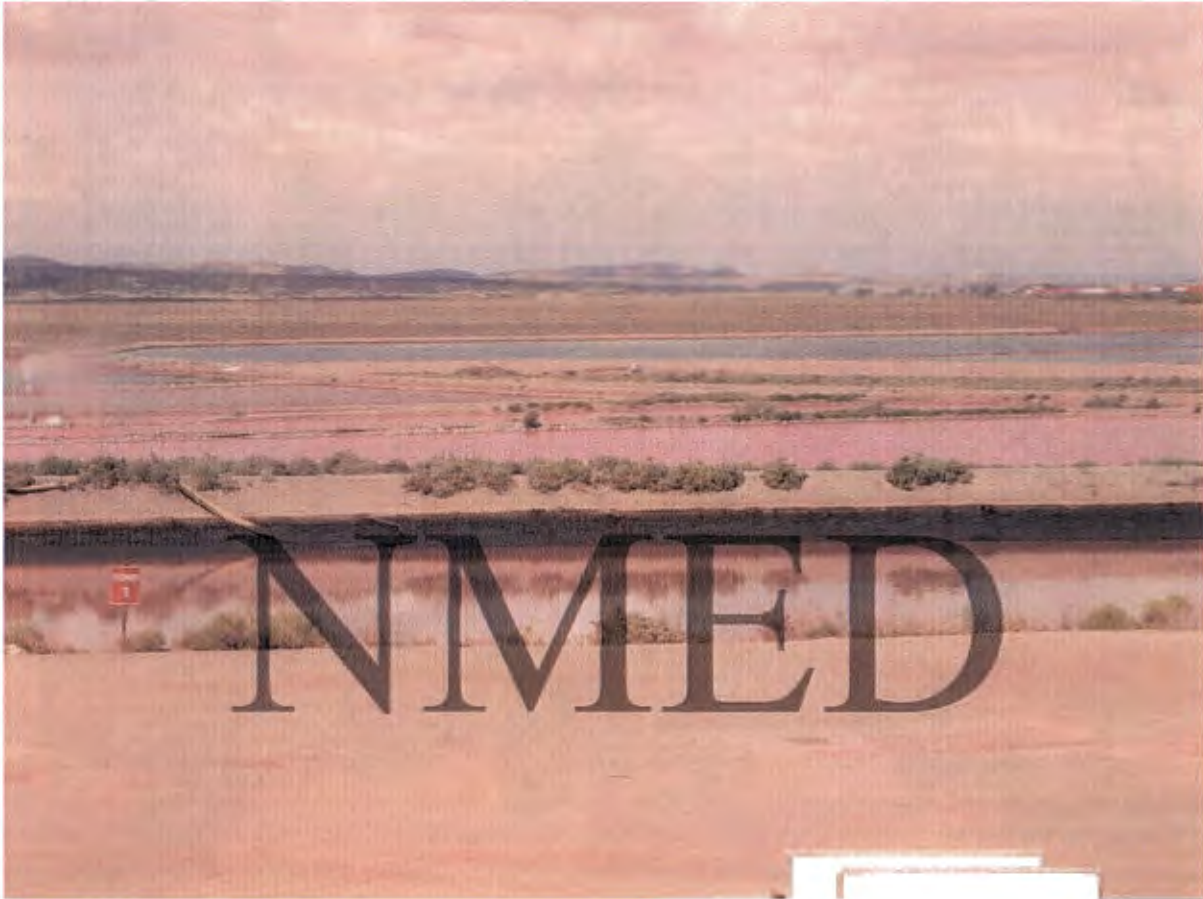
Photo No. 6

Description: Pond 1 and Evaporation ponds – Pink color noted.

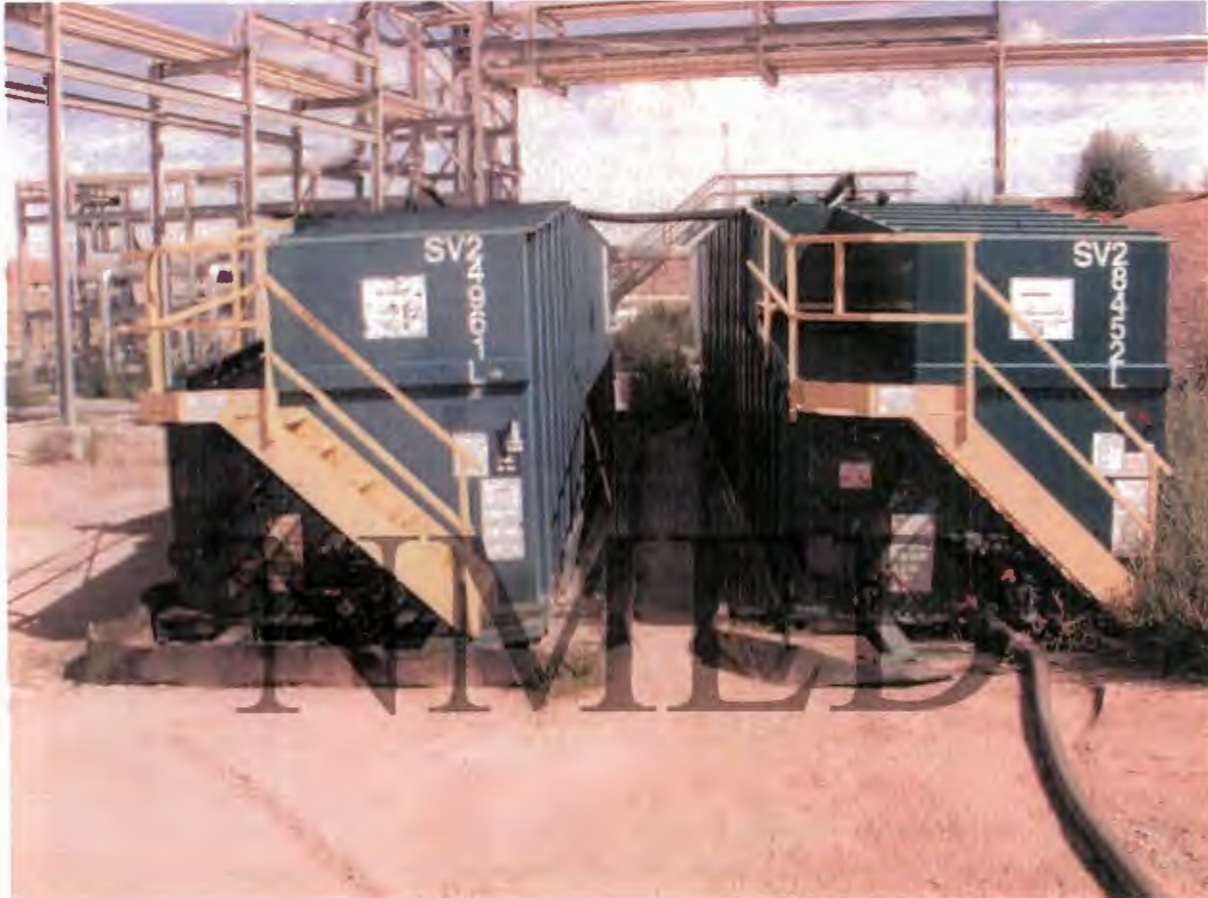
Photo No. 10

Description: WWTP - Baker tanks used as grit tanks to stored wastewater from the float tank. Inadequate secondary containment. It was also noted during the inspection that the tanks had an approximate 0.4-0.5 mile release on August 5, 2014.

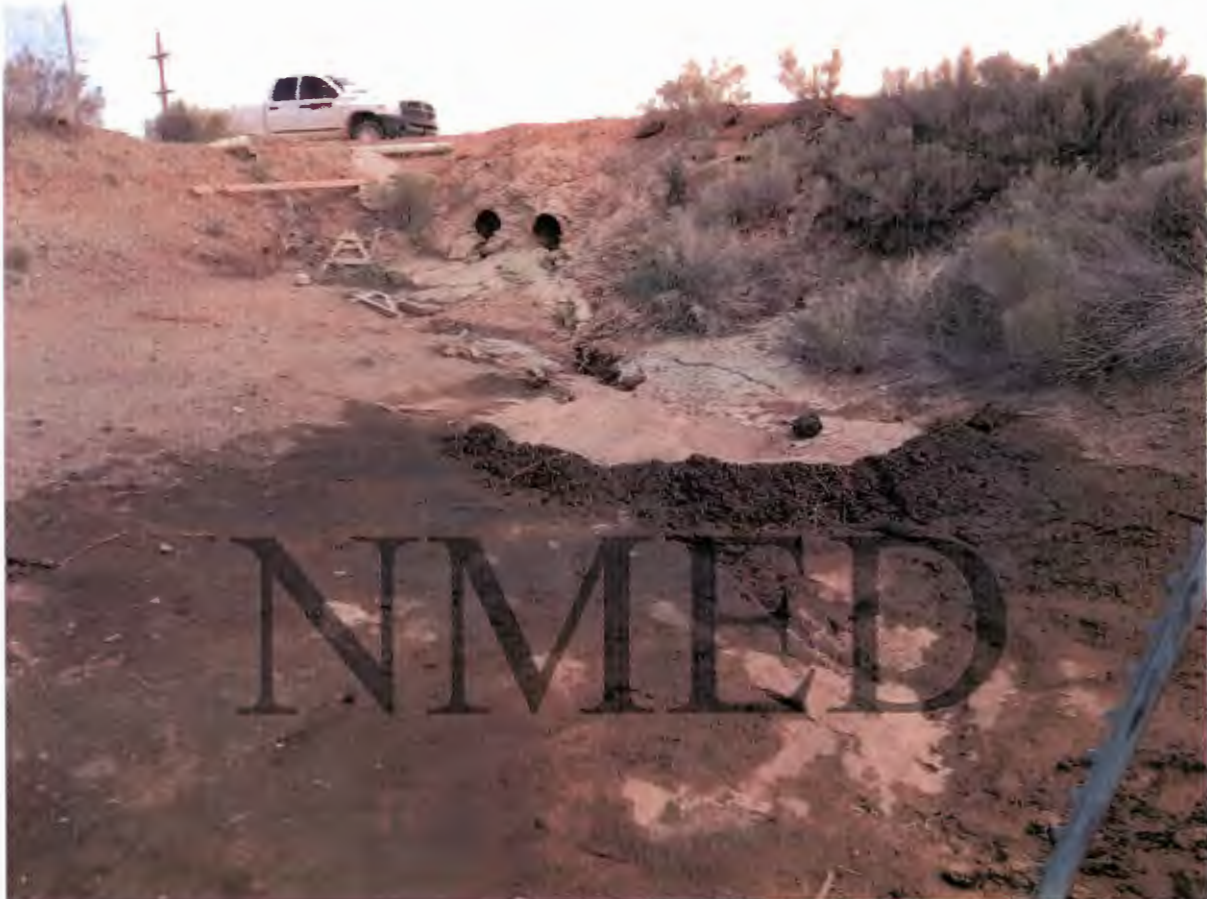
Photo No. 19

Photo File Name: 2154 Date
of Photo: 08/12/2014
Time of Photo: 1507
Photographer: Charles Barnes
Description: Seep Site

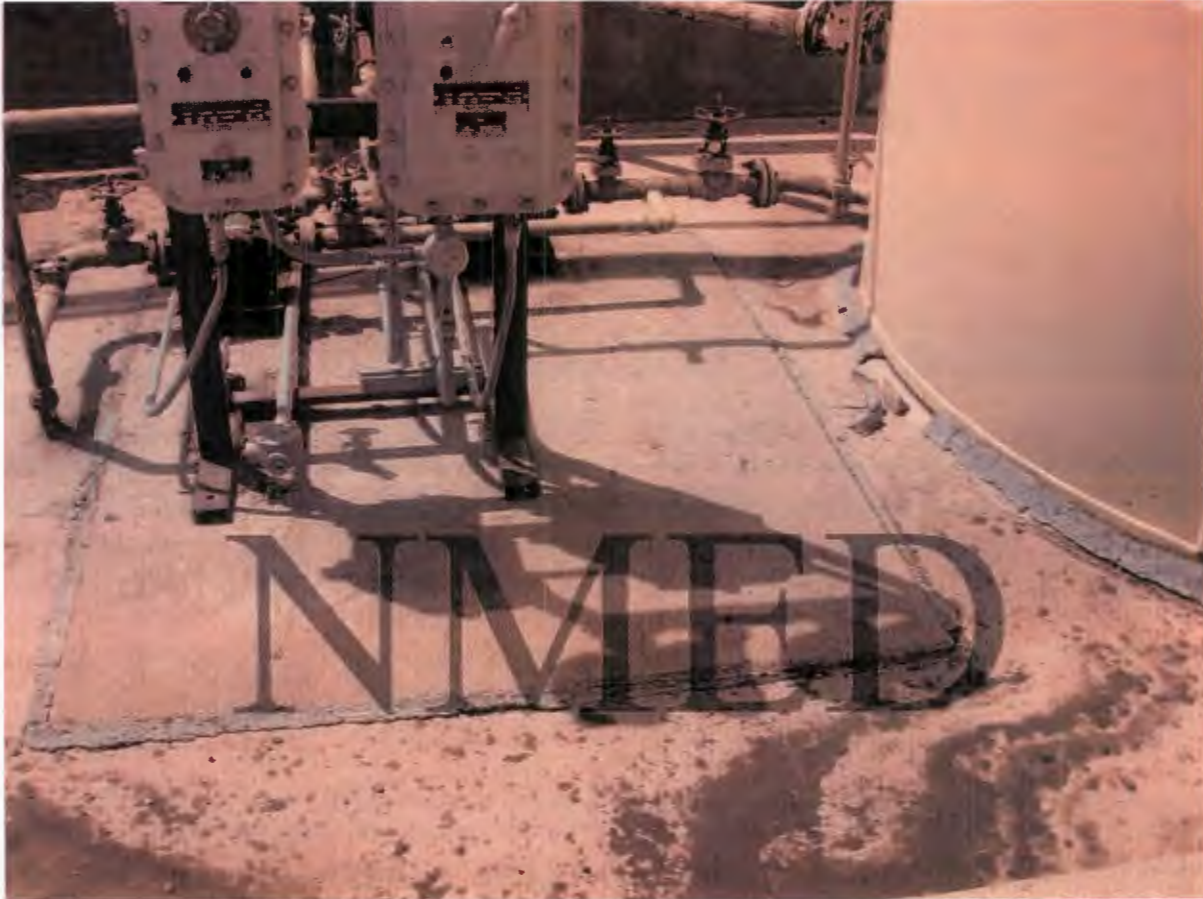
Photo No. 22

Description: SWMU-22 - Additive Tank Farm. Noted weak seal joints on the concrete floor of the secondary containment.

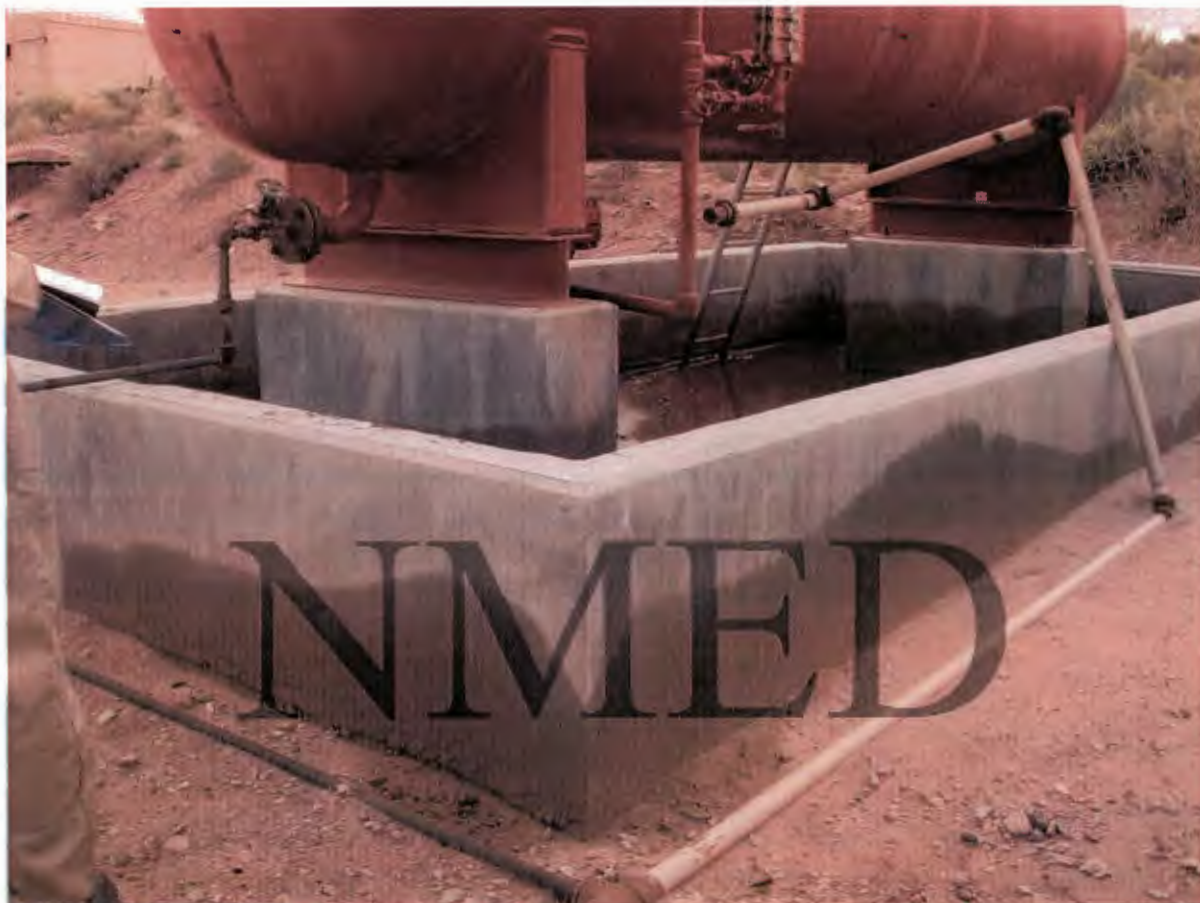
Photo No. 30

Description: Diesel tank @ Fire Training Area. Noted liquid seeping through secondary containment. Strong e diesel odor noted with soils affected.
