DEPARTMENT OF THE AIR FORCE  
HEADQUARTERS 377TH AIR BASE WING (AFMC)

This letter is your initial notification that the Restoration Branch has identified a site that, due to obvious contamination by petroleum, oil and lubricant (POL) wastes, will be treated as a Solid Waste Management Unit. The Restoration Branch will complete a Class I permit modification no later than 31 August 1994.

# TRESTLE SITE

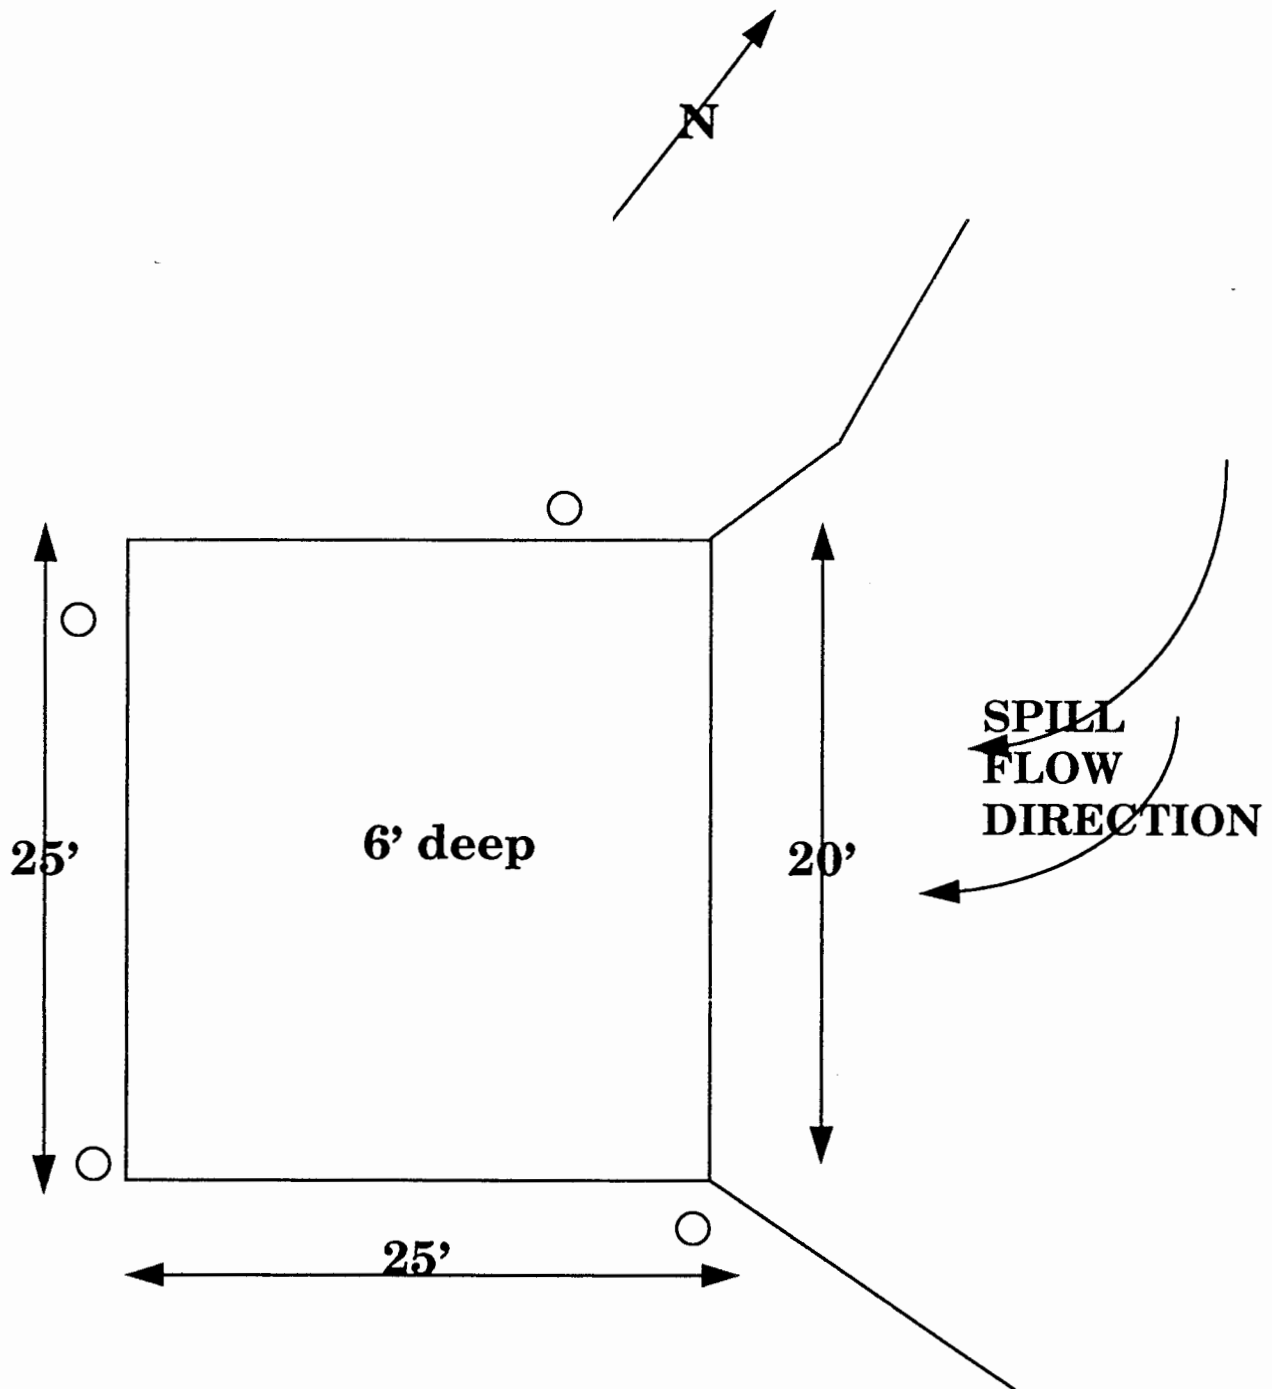
Figure 1.2

## AIRCRAFT PIT

We plan to initiate a RFI at this site in FY95. The RFI will adhere to the previously approved Stage 2C plans. We plan to investigate the site via 12, 25-foot-deep (minimum) boreholes with sampling at 0-, 5-, 10-, 17-, and 25-foot depths. Samples will be analyzed for VOCs, SVOCs, and metals, as well as other parameters EPA may direct. We've annotated the proposed borehole locations on the enclosed figure.

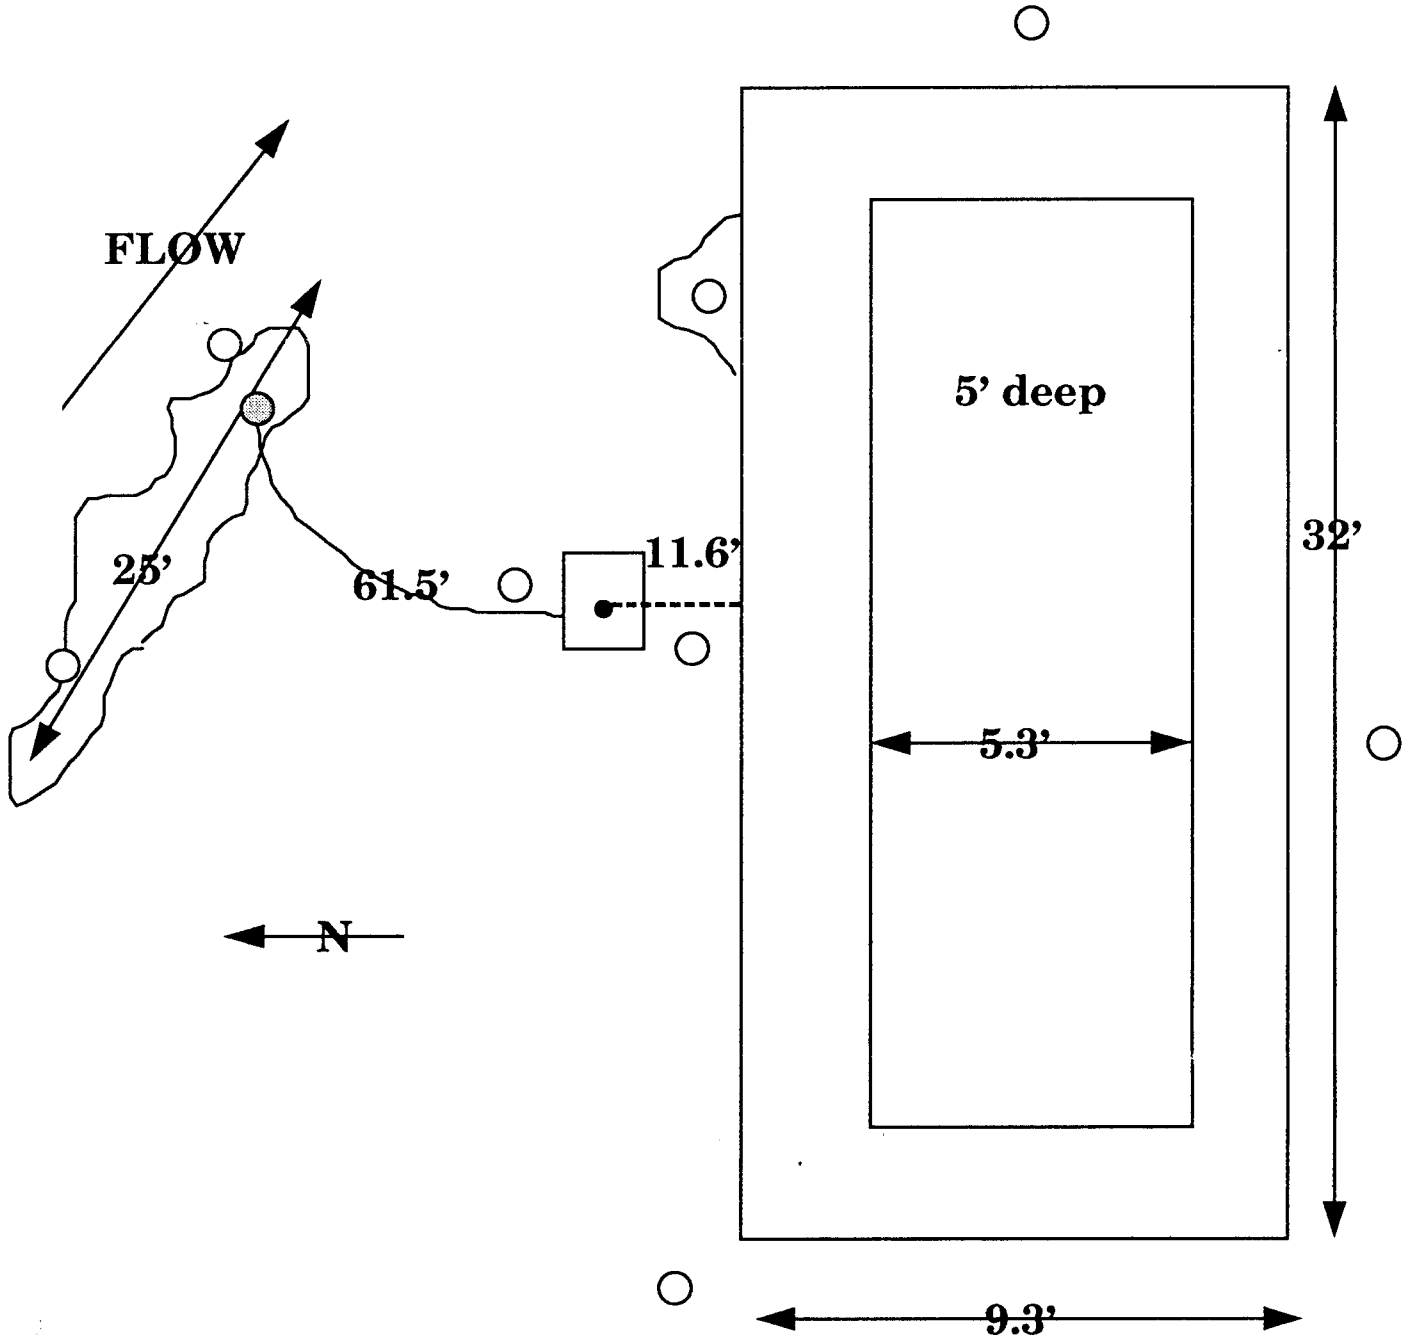
Figure 1.1

- a. An abandoned vehicle service ramp and pit. This portion of the site includes a visually contaminated concrete pit (described on the enclosed figure), visually contaminated soils immediately adjacent to the pit, a defunct oil/water separator containing a mix of water and POL, and soil contamination at the separator's outfall, with drainage connected to Tijeras Arroyo.
- b. An abandoned concrete aircraft fuel spill pit. This pit shows no obvious contamination (no staining or obvious drain pipes), but its existence implies the presence of an unused underground storage tank.

## VEHICLE PIT
